**RICS HOME SURVEY
LEVEL 2**
- SURVEY ONLY

Monday, 4 March 2024

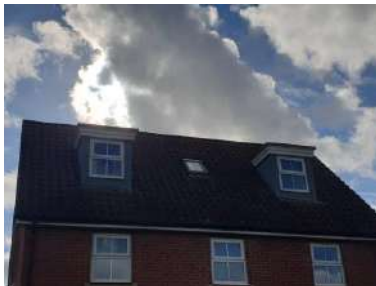
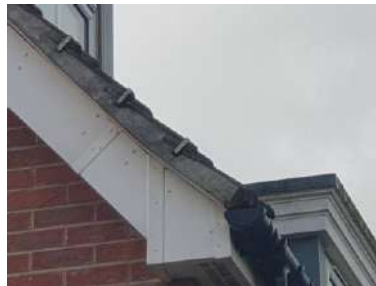
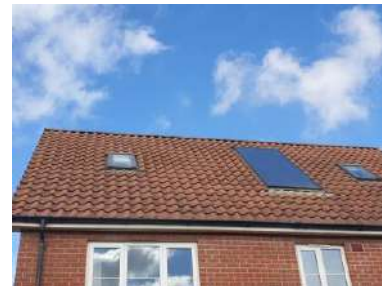
The roofline appears to be level and within normal tolerances with no signs of any significant deflection or undulation noted, indicating that the roof structure is adequate for the current roof covering. See Section E1 regarding the roof structure.

There is moss growth present on the roof slopes. This level of moss growth is not unusual on properties of this age and type. You should monitor the roof slopes especially where they are north facing or shaded by trees. At present no action is required. However, in the future if the growth becomes excessive then the moss should be cleaned off. Moss growth impedes the run-off of rainwater and leads to gutter blockage and can cause water penetration which may lead to rot or other defects in surrounding timbers.

There is no evidence of significant cracking or loosening of the mortar to the roof edge, but this should be checked periodically and repointed as necessary.

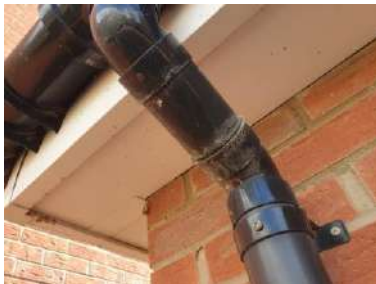
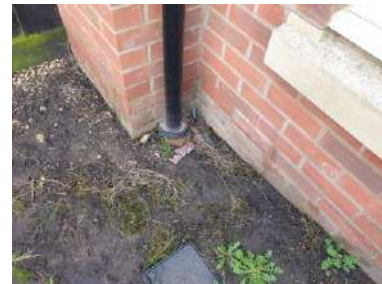
Some seepage was evident of the joints, most notably to the front downpipes suggesting that the joint seals have failed, and repairs will be required. You should make allowances for maintenance on taking occupation and may wish to seek quotations prior to purchase

uPVC rainwater goods have faded due to sunlight degradation and could be replaced for aesthetic purposes. It is possible they are now brittle and could be damaged during routine maintenance. Whilst there is no urgent requirement to do so, you may wish to obtain quotations to replace the dated installation as part of the overall improvement to the property.

You should ensure that the gutters are seasonally unblocked of moss and other debris.

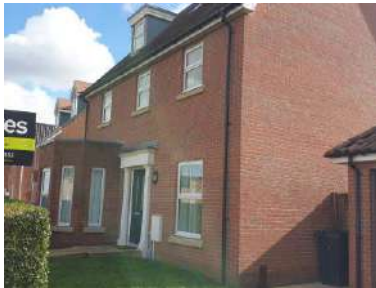
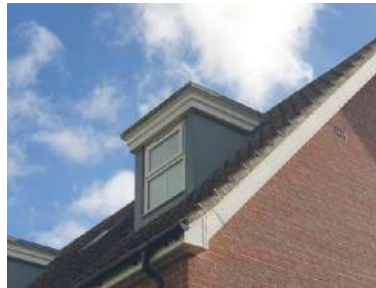
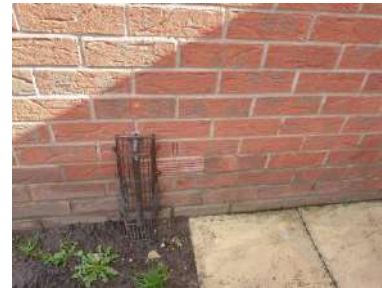
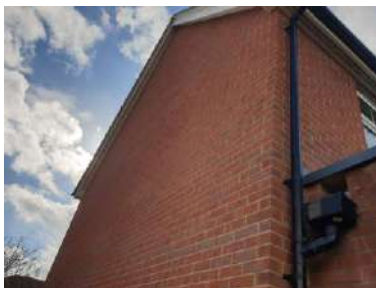
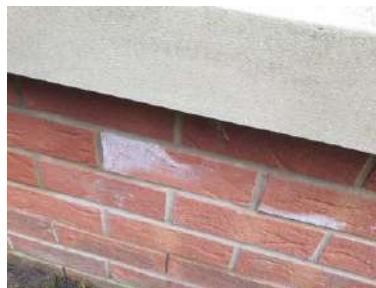
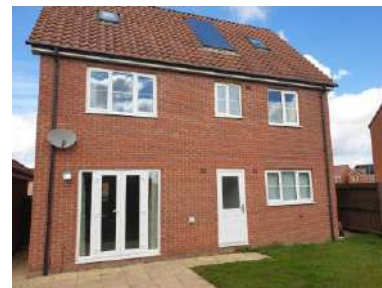
There is no evidence of significant cracking surrounding the window and door openings suggesting the lintels are performing satisfactorily.

Efflorescence can be seen on the external wall surfaces, as noted by white staining. This is an accumulation of naturally occurring salts in the bricks which are drawn to the external surfaces when wetted by rain and remain there upon drying out. The efflorescence does not cause any particular damage to the brickwork. Over a period of time these deposits will gradually disappear. If desired, cleaning off can be done by dry brushing, taking care not to scour the surface of the brickwork.

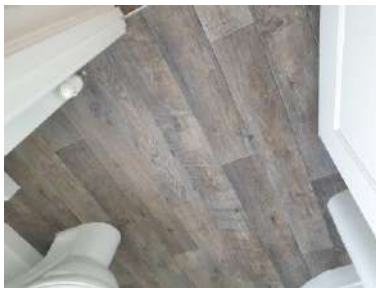
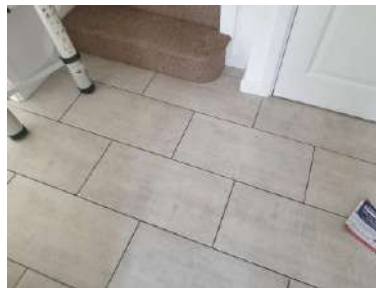
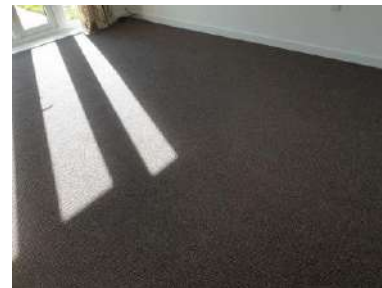
Vinyl coverings to the upstairs bathrooms can trap moisture beneath which could cause damage to suspended timber floors over time. No repair is urgently required but we recommend you replace this floor covering with a more suitable floor covering in the long term.

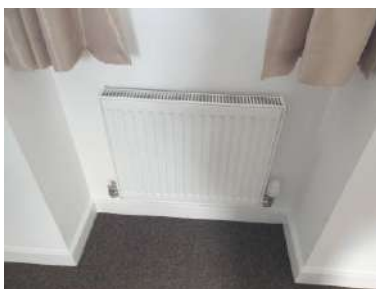
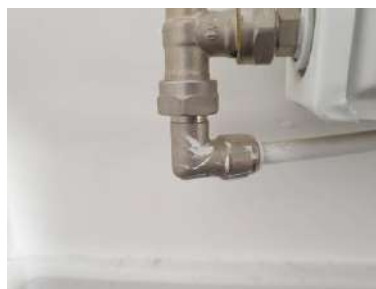
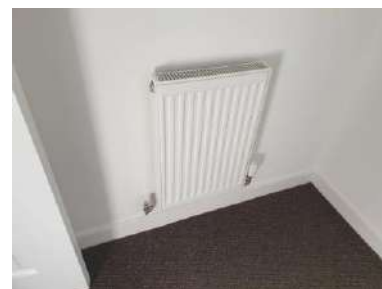
The microbore is out-dated and likely to be inefficient compared to modern pipework and consideration should be given to a complete overhaul of the central heating pipework and associated radiators as part of the overall improvement of the property. Such works will be both costly and disruptive and you may therefore wish to obtain quotations for all upgrading works through a reputable heating engineer prior to purchase.

A significant amount of the central heating pipework is buried within the construction and whilst there were no signs of leakage, this can occur undetected beneath floor finishes, particularly if pipework is not adequately protected.
