RICS HOME SURVEY LEVEL 3

██████████
Bury St Edmunds
Suffolk
IP33 1JH

Tuesday, 6 February 2024

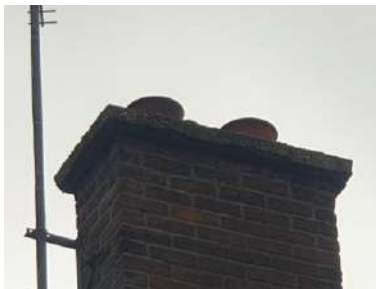
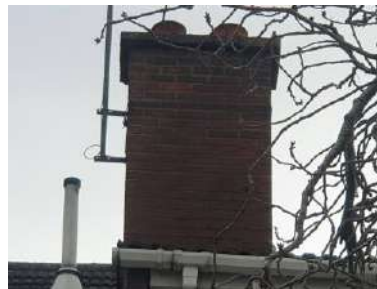
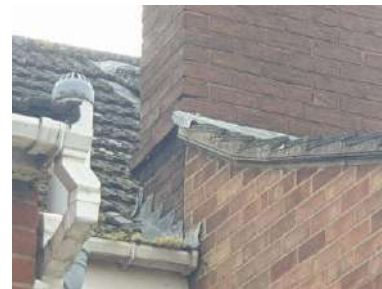
The chimney stack appeared to be straight to the eye with no signs of any significant bulging, lean or outward movement noted.

There are 2 visible chimney pots that appear to be straight to the eye with no signs of visible damage. Flashings to the chimney pots could not be seen. These should be periodically inspected to ensure that the chimney pots or flues remain adequately bedded.

The soakers [under flashings] that provide watertightness between the chimney stack edge and the roof are concealed and could not be viewed. However, there is no evidence of internal leakage at these positions to suggest that they are defective.

A back gutter is formed at the rear of the stack where the roof slope meets the chimney. This feature will require regular maintenance and can easily block resulting in damp penetration within the roof void and regular maintenance should be undertaken. At the time of the inspection we found no evidence of associated defect internally within the roof void.

A TV aerial is attached to the stack although we cannot confirm whether the fixings are adequate for their purpose and regular inspections during routine maintenance should be undertaken.

Condition Rating: **2**

Scaffolding or other means of safe access will be required to carry out future repairs which will increase the cost significantly and you should budget accordingly.

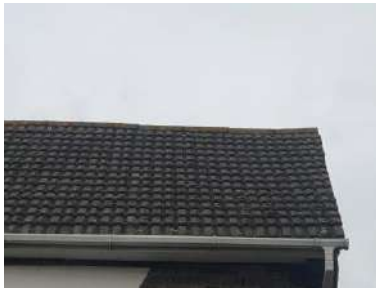
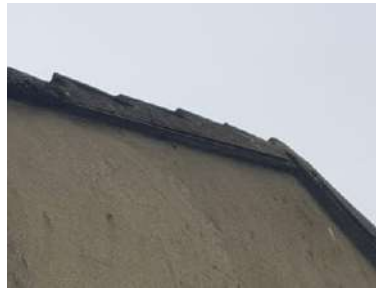
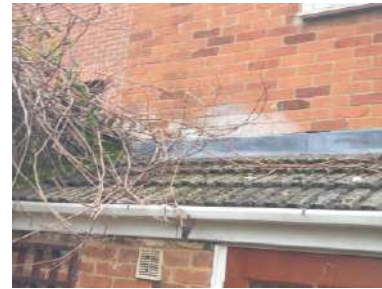
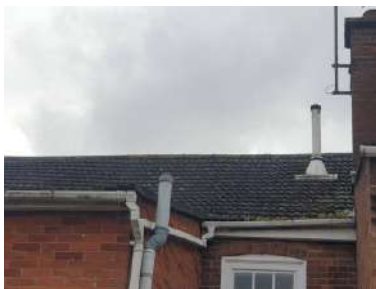
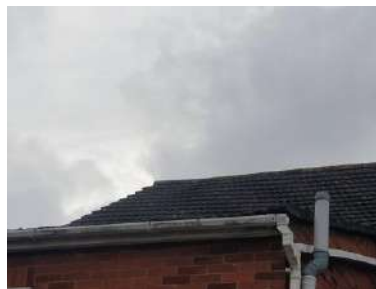
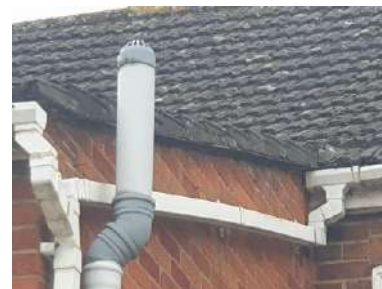
We are pleased to report the roof coverings appear to be complete with no signs of any slipped, missing or damaged covering noted.

There is moss growth present on the roof slopes. This level of moss growth is not unusual on properties of this age and type. You should monitor the roof slopes especially where they are north facing or shaded by trees. At present no action is required. However, in the future if the growth becomes excessive then the moss should be cleaned off. Moss growth impedes the run-off of rainwater and leads to gutter blockage and can cause water penetration which may lead to rot or other defects in surrounding timbers.

The mortar to the rear extension roof edge is cracked slightly. Whilst no remedial attention is required at present, repairs should be anticipated as a precaution in due course, and you should consider obtaining quotations for repair in order to budget accordingly.

Please note the roof verge under cloak may include asbestos containing materials, depending on their age. Care should be taken with future maintenance. See 'Local environment' of this report.

Condition Rating: **2**

Secure quotations to complete roof repairs, to include the cost of any required scaffolding for access

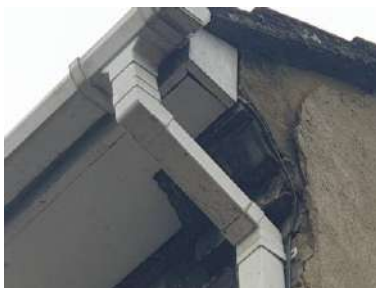
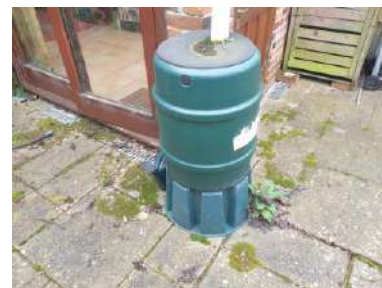
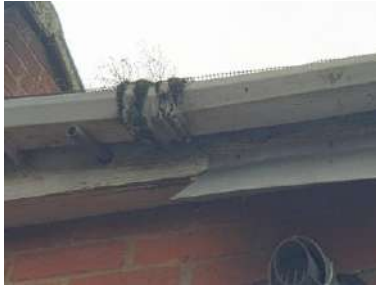
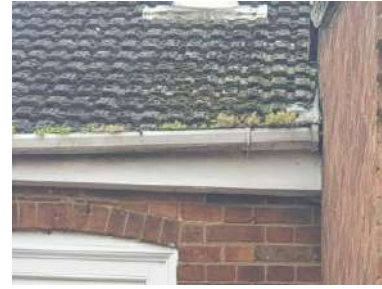
The rainwater goods are formed in uPVC and appear to be in a reasonable condition.

Where downpipes to the rear discharge directly onto the ground this is an unsatisfactory arrangement that can lead to a deterioration of the adjacent low-level masonry, localised penetrating dampness, and even changes in ground conditions. The downpipes should be modified so that they are connected to the underground installation or to a water butt, and you should seek quotations for such modifications prior to purchase.

The water butt to the rear should be checked regularly, as if allowed to overflow water butts can cause damp penetration on external walls and if unattended for prolonged period could lead to a change in ground conditions and resulting movement of the structure.

Condition Rating: 3

Secure quotations for repair or replacement of the rainwater fittings

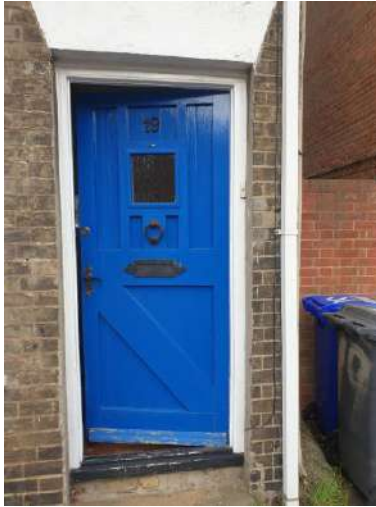
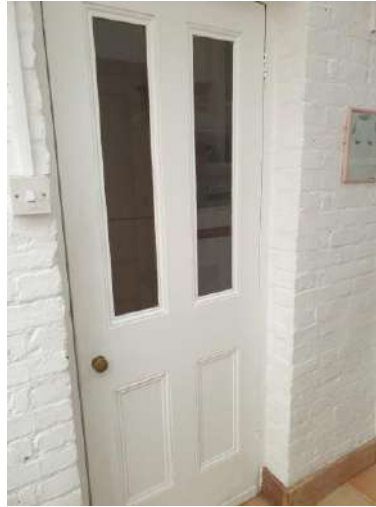
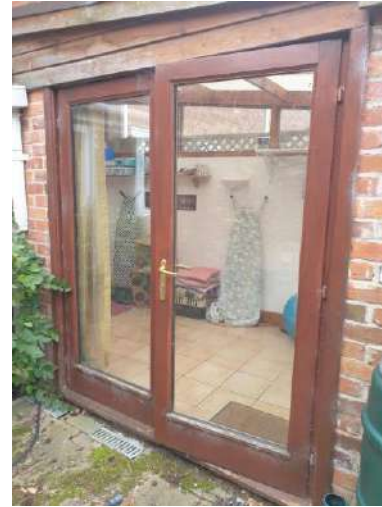
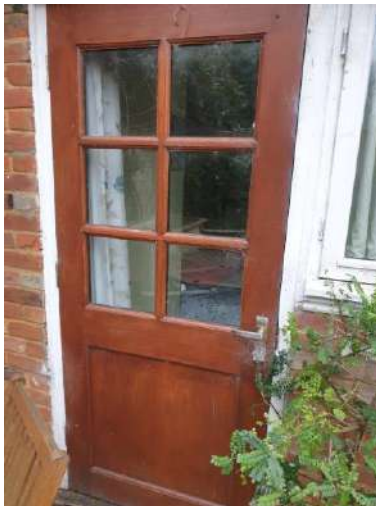
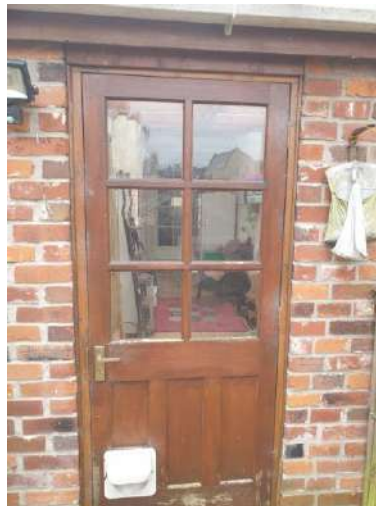
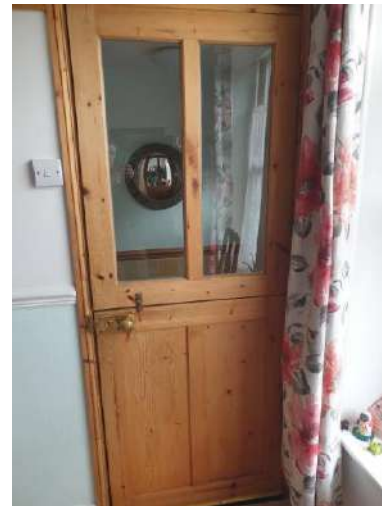
Doors open square to the eye with no signs of any significant movement or distortion noted.

Condition Rating: 3

We recommend you change all locks upon occupation to enhance security.

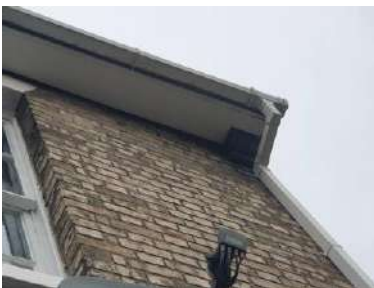
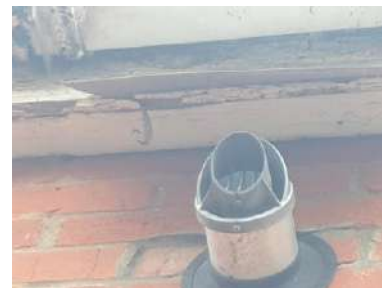
The external decorations have deteriorated (e.g. to the rear) and new decoration in reasonable course is required. This should include thorough preparation of the timber by removing all loose and flaking decorative finishes before priming the bare surfaces and re-applying appropriate decorative coatings. Much of this work will be undertaken at height and it is therefore recommended that you obtain quotations for this prior to purchase. Please note, a closer inspection of the timber may reveal some concealed deterioration and you should expect that localised repairs may be necessary prior to redecoration.

Condition Rating: 2

Seek quotations to repair/redecorate external joinery items

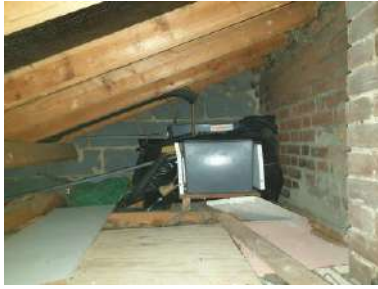
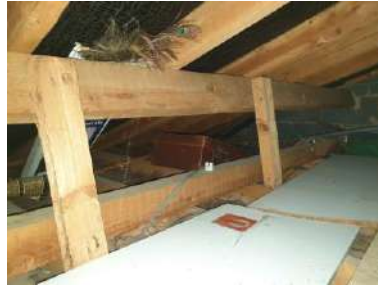
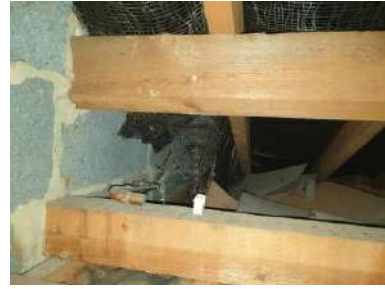
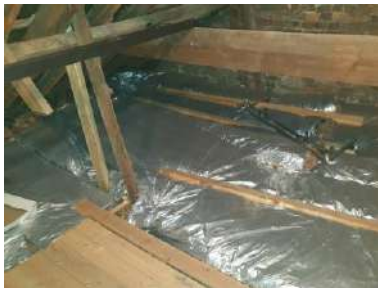
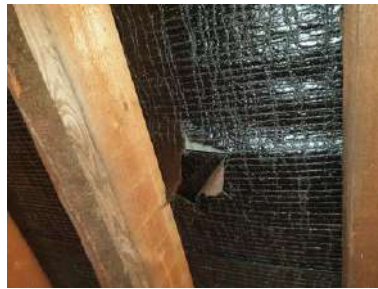
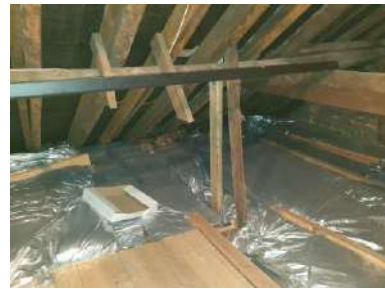
The cold-water storage tanks are of plastic construction and are adequately supported although improved covers and insulation are required. There are overflow pipes extending to the exterior of the property.

The roof space did contain items of storage, limiting the full extent of our inspection. Should you wish to use this area for storage it should be ensured that boarding is securely fixed, and storage limited in order to reduce possible over-loading of the roof and ceiling structure.

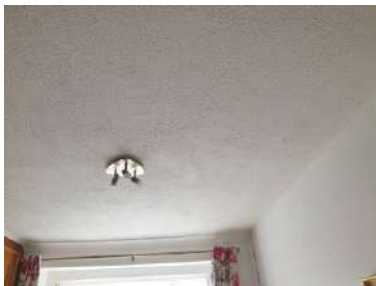
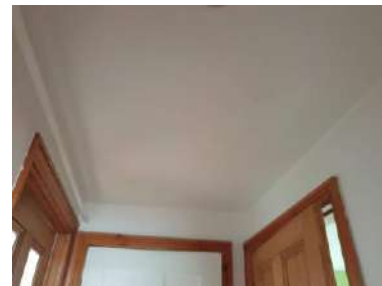
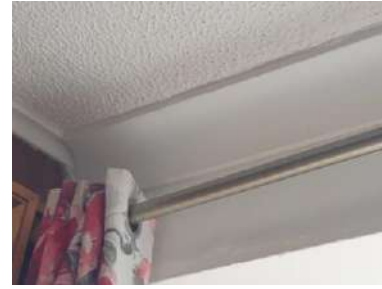
We are pleased to report the ceilings appear to be generally complete with no signs of significant cracking, undulation or distortion noted.

Cracks along the lines of plasterboard joints are not unusual. These cracks are not structurally significant and can be filled prior to redecoration.

Condition Rating: 2

Seek quotations for repairs to ceilings

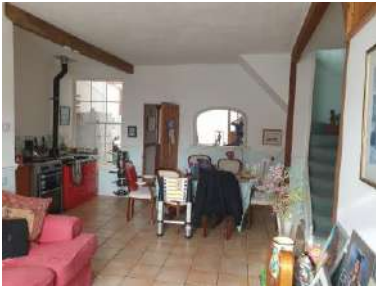
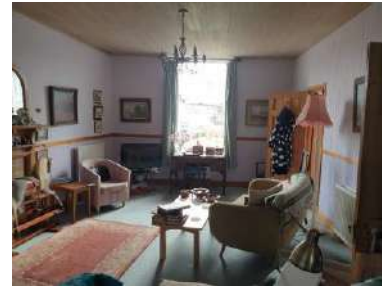
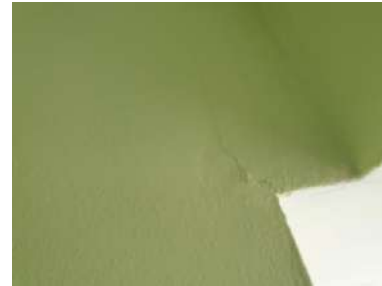
Slightly elevated moisture readings were noted close to ground level in localised areas across the ground floor. These readings are likely due to cold bridging where in a structure of this age, the ground floor construction is unlikely to be insulated. This is consistent with the age of the property and no remedial action is necessary although excessive condensation can result in unsightly mould growth forming if left unchecked.

Condition Rating: **2**

Seek quotations for localised repairs and/or making good of the internal walls

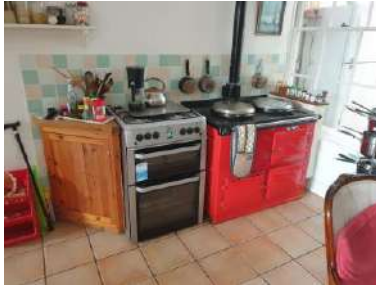
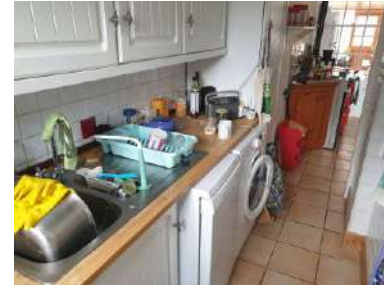
There is a gas-powered Aga and you should confirm with your legal adviser whether this has any Gas Safety Certification. See Section F2 of this report.

Most of the distribution and waste pipework is concealed behind the units and leaking pipework or other defects may not be readily apparent.

Condition Rating: 2

Seek quotations to undertake necessary repairs within the kitchen

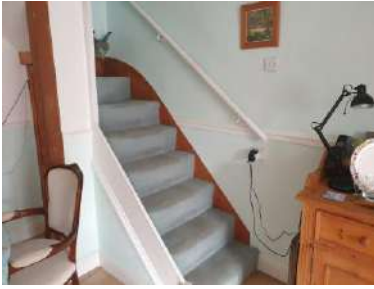
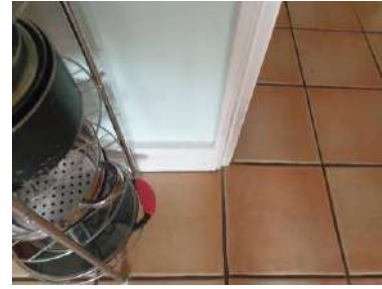
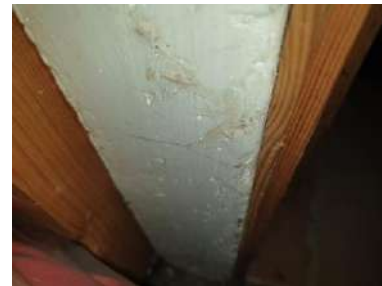
As the height of the banister rails does not fall within 900-1000mm, the banisters should be replaced on taking occupation as the current arrangements are hazardous. The new railings should be designed in a way to prevent climbing, i.e. avoid horizontal rails.

There is evidence of wood-boring insect infestation to the cupboard under the stairs and whilst there were no signs of recent activity, you should confirm whether previous treatments have been carried out and if so, whether guarantees can be transferred under the sale.

Condition Rating: **3**

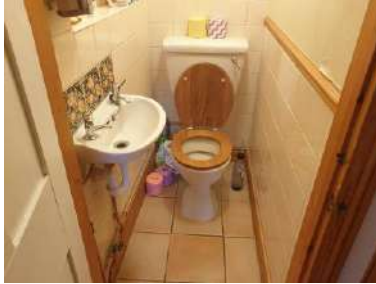
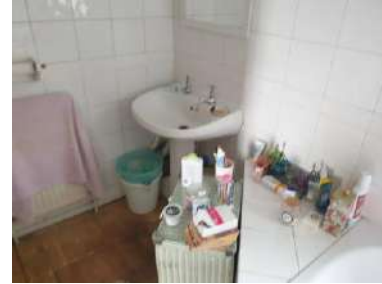
The water pressure was checked to several draw-off points and found to be adequate. Water pressure can vary seasonally and during times of high demand, both within the property and in the locality. It is recommended that should you wish to install water pressure sensitive items, such as a power shower, that further enquiries are made initially.

Most of the distribution and waste pipework is concealed beneath or behind sanitary ware items and whilst there were no obvious signs of leaks, the risk of hidden defects exists.

Condition Rating: 3

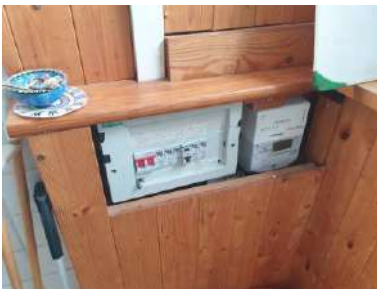
The electrical installation is provided with an RCD which is designed to protect the users from electric shock. These installations are extremely sensitive and consequently occasional tripping of switches will occur, effectively shutting down the affected circuit(s). It can often result when a light bulb fails, or it may be the result of a defective appliance. When this happens, the 'trip-switch' must be reset. If this occurs with any frequency, an electrician should be instructed to investigate.

Condition Rating: **3**

Although there were no particular areas of concern, we do endorse the Electrical Safety Council's recommendations and a precautionary electrical inspection should therefore still be undertaken, to ensure that circuitry complies with current electrical regulations, prior to a legal commitment to purchase. All recommendations should be fully costed and implemented.

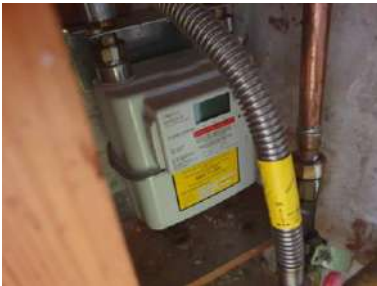
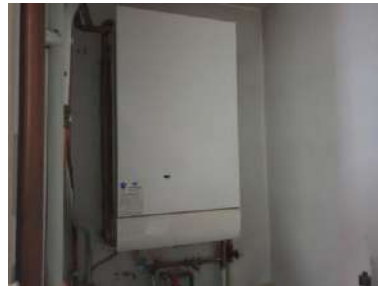
Condition Rating: **3**

For precautionary purposes it is recommended that the gas installation be inspected by a Gas Safe registered engineer prior to legal commitment to purchase in the absence of any documentary evidence dated in the last 12 months. All recommendations for improvement to ensure compliance with current Gas Regulation standards should be implemented.

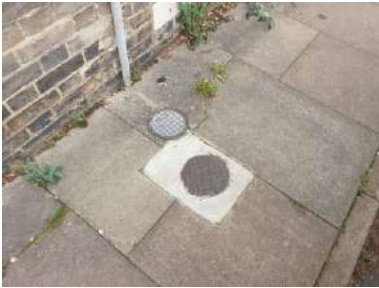
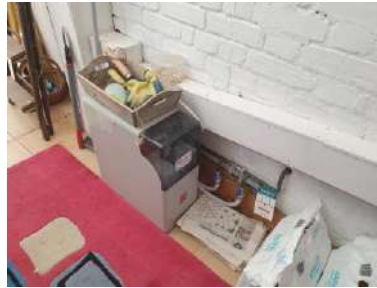
The internal stop tap was hidden from view, and you should confirm its location prior to taking occupation.

The external stop tap is located in the front path. You should confirm whether a water meter is provided.

Condition Rating: 2

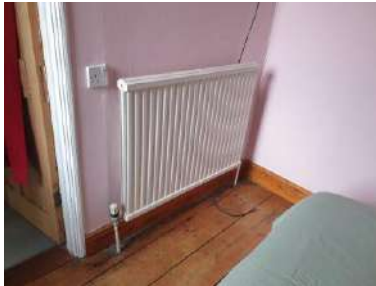
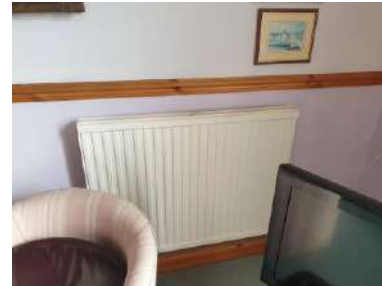
Thermostatic radiator valves (TRVs) have been provided to radiators. These will allow for individual control over each unit which will improve the thermal efficiency of the dwelling.

A significant amount of the central heating pipework is buried within the construction and whilst there were no signs of leakage, this can occur undetected beneath floor finishes, particularly if pipework is not adequately protected.

Condition Rating: **3**

Undertake a test of the dated boiler installation with quotations obtained for all required improvements, to include replacement if necessary, prior to purchase

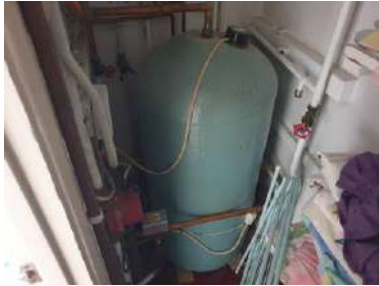
We are not suitably qualified to comment on the state and condition of the hot water installation and a test on the installation is outside the scope of this report.

Condition Rating: **3**

You should be aware that hot water systems require regular maintenance, and it is recommended that they are serviced annually alongside the central heating boiler installation. You should request a copy of any recent service history through your legal adviser. In the absence of such documentation dated within the last 12 months, you should arrange for a precautionary inspection through a reputable plumber or heating engineer.

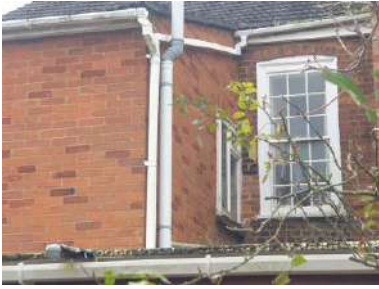
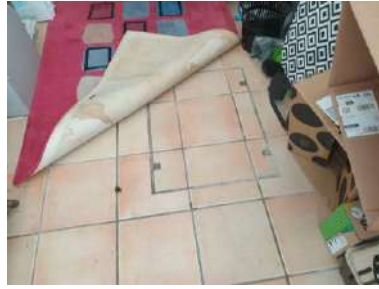
The soil and vent pipe is of uPVC construction and is in serviceable condition at present

The drainage installation has been constructed over when constructing the conservatory. You should confirm the relevant consents were sought in this respect.

Condition Rating: **2**
