## RICS HOME SURVEY LEVEL 2

- SURVEY & VALUATION

**PROPERTY ADDRESS:**

Address

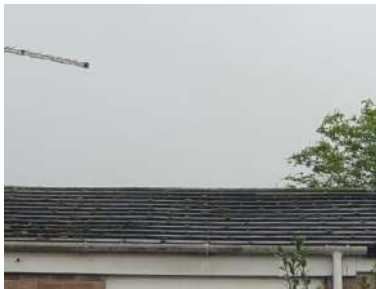
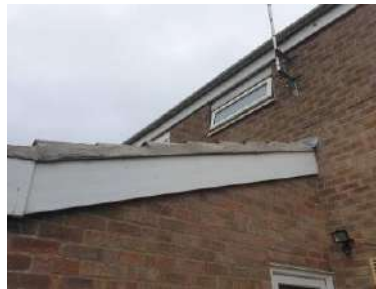
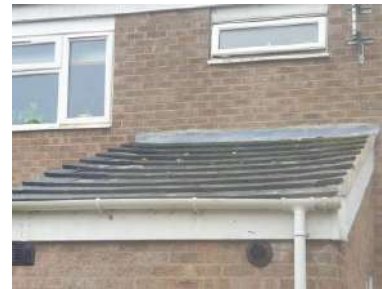
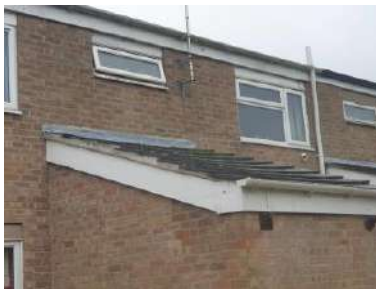
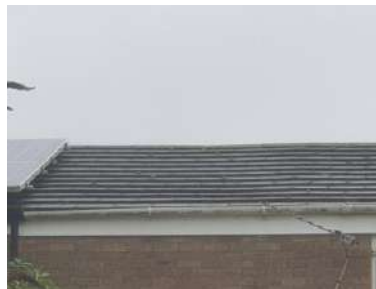
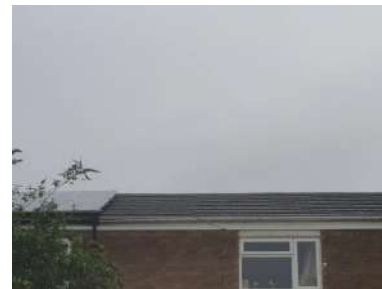
The roofline appears to be level and within normal tolerances with no signs of any significant deflection or undulation noted, indicating that the roof structure is adequate for the current roof covering. See Section E1 regarding the roof structure.

We are pleased to report the roof coverings appear to be complete with no signs of any slipped, missing or damaged covering noted.

There is moss growth present on the roof slopes. This level of moss growth is not unusual on properties of this age and type. You should monitor the roof slopes especially where they are north facing or shaded by trees. At present no action is required. However, in the future if the growth becomes excessive then the moss should be cleaned off. Moss growth impedes the run-off of rainwater and leads to gutter blockage and can cause water penetration which may lead to rot or other defects in surrounding timbers.

There is no evidence of significant cracking or loosening of the mortar to the roof edge, but this should be checked periodically and repointed as necessary.

Please note the roof verge under cloak may include asbestos containing materials, depending on their age. Care should be taken with future maintenance. See 'Local environment' of this report.

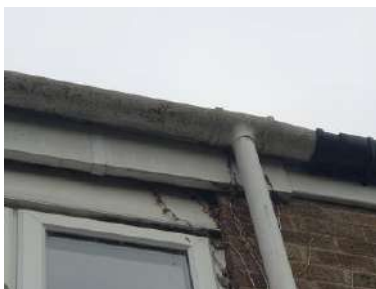
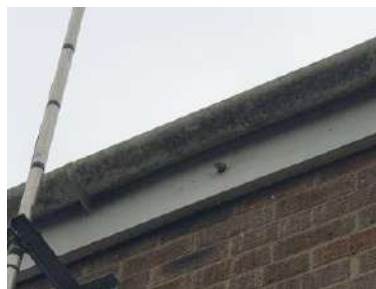
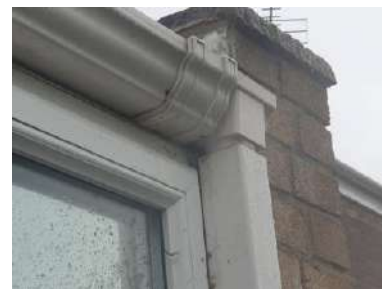
The rainwater goods are formed in uPVC and appear to be in a reasonable condition.

We are pleased to report that rainwater goods appear to be adequately aligned with no signs of any significant twisting or distortion noted.

Staining to the gutters to the front suggests they may be blocked. Alternatively, this staining may be due to deterioration of the underfelt which may no longer lap into the gutter adequately, although this cannot be confirmed from our limited visual inspection alone. This would allow rainwater to be channelled into the eaves construction resulting in decay and damage. Rainwater can also find its way into the internal walls of the building through the eaves causing damage to the fabric of the building. It would be prudent to instruct a reputable roofing contractor to inspect with any necessary repairs fully costed prior to commitment to purchase.

You should ensure that the gutters are seasonally unblocked of moss and other debris.

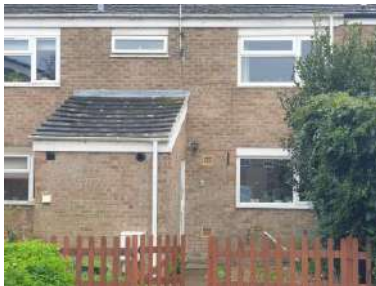
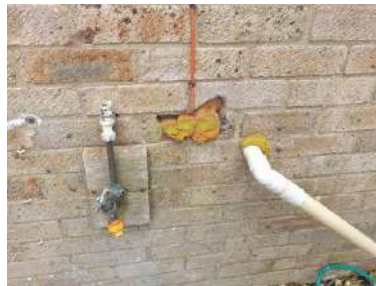
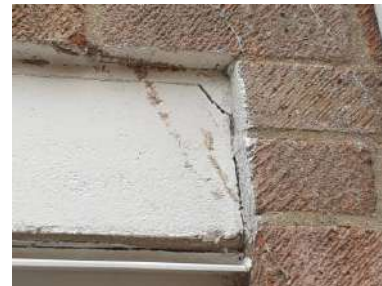
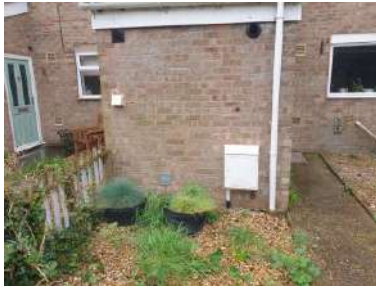
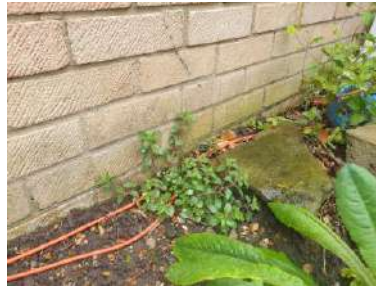
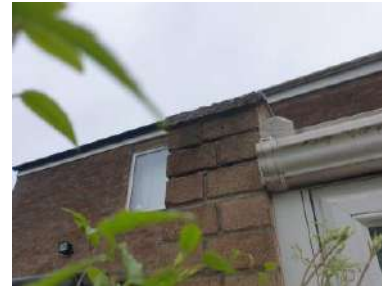
The foundations have not been exposed. Whilst there is a risk of unseen defects, there are no above ground signs of defective foundations. The building is likely to be constructed upon a subsoil subject to seasonable shrinkage and expansion which can cause structural movement.

It has not been possible to inspect the ties holding together the inner and outer leaves of the cavity walls. Metal wall ties can suffer gradual corrosion with time. With some types of ties, this corrosion is sometimes accompanied by rust expansion, causing horizontal cracks to appear at intervals in the external wall surfaces. No evidence of wall tie corrosion was recorded visually to the external walls.

There is no evidence of significant cracking surrounding the window and door openings suggesting the lintels are performing satisfactorily.

There appears to be a PVC damp-proof course set into the base of the conservatory walls and the recommended height above ground level is not achieved.

It is recommended that the ground levels are lowered where required, ideally with a surface water drainage channel constructed along the base of the wall to divert water away from the structure. Such drainage channels should be 100mm wide and 150mm deep. Further contractors' advice and quotations should be sought regarding this matter and consideration will need to be given to the discharge of surface water where the ground levels will be altered.

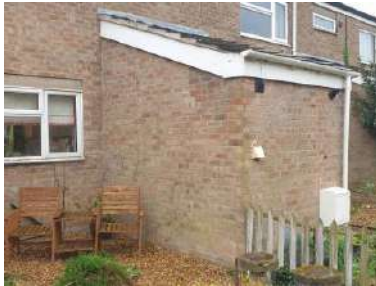
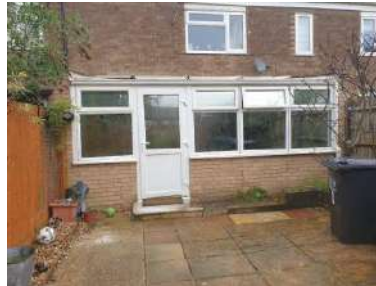
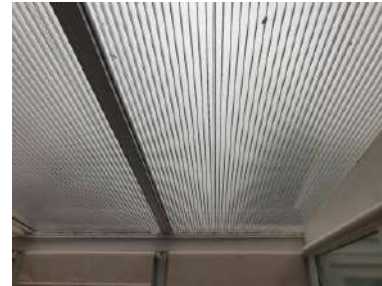
shallower depth than would be acceptable for the main building which increases the risk of movement, distortion and cracking.

There is a brick-built porch constructed beneath a tiled roof structure, which was in reasonable condition and appears to be original to the construction of the property.

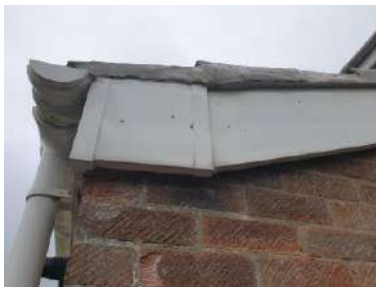
Where these uPVC replacement boards have been provided, it is not possible to determine whether they are fixed directly on top of any original decaying joinery. It is not possible to comment on any concealed section of woodwork which can only be examined by the removal of the uPVC covering.

Given the age of the property materials containing asbestos may be concealed beneath the PVC although we are unable to confirm this, and care should be taken during future maintenance.

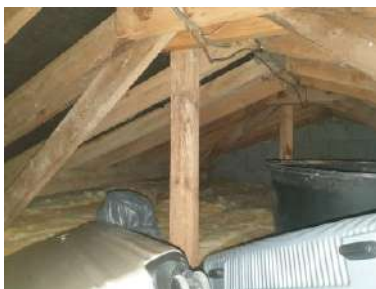
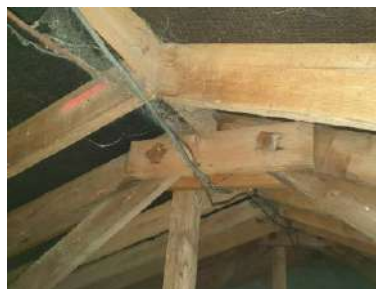
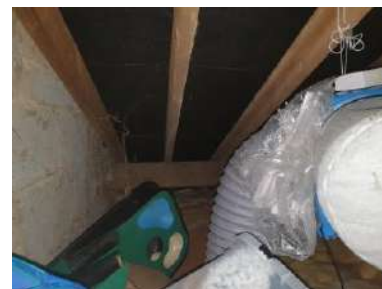
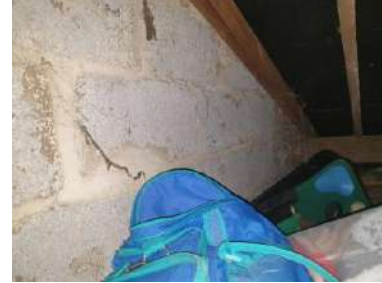
There is a redundant cold-water tank within the roof space and although they present little nuisance now, you should be aware that it would be costly and disruptive to move these items in the future, if you were to convert the loft space for example.

The roof space did contain items of storage, limiting the full extent of our inspection. Should you wish to use this area for storage it should be ensured that boarding is securely fixed, and storage limited in order to reduce possible over-loading of the roof and ceiling structure.

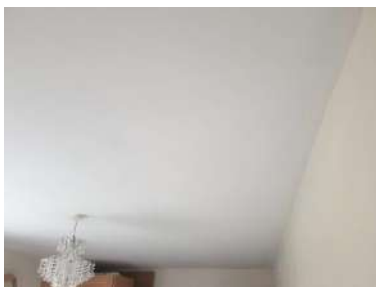
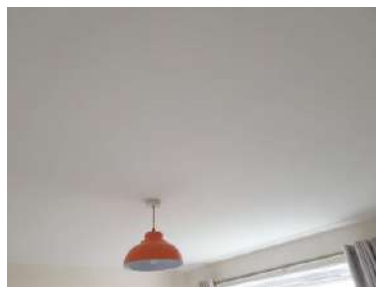
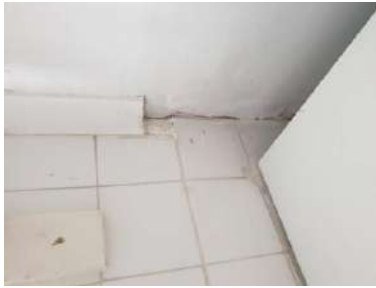
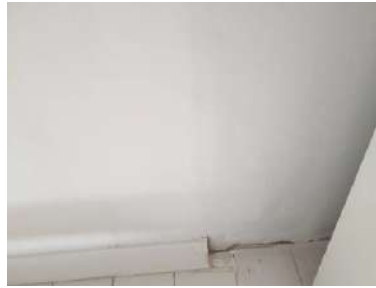
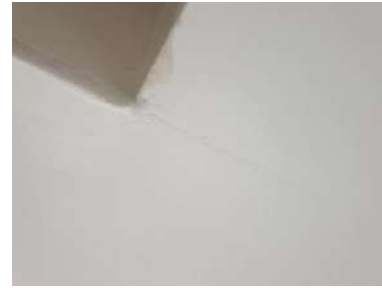
Minor irregularities and shrinkage cracks are present, but these are not unusual for this type and age of property. Cosmetic works upon redecoration will be required.

Cracks along the lines of plasterboard joints are not unusual. These cracks are not structurally significant and can be filled prior to redecoration.

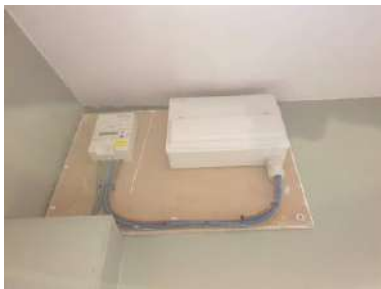
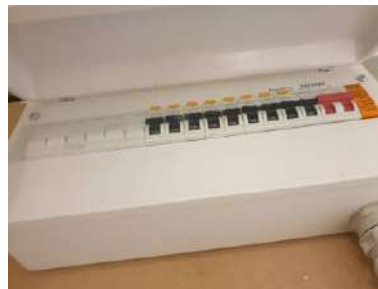
Although there were no particular areas of concern, we do endorse the Electrical Safety Council's recommendations and a precautionary electrical inspection should therefore still be undertaken, to ensure that circuitry complies with current electrical regulations, prior to a legal commitment to purchase. All recommendations should be fully costed and implemented.

The electrical installation is provided with an RCD which is designed to protect the users from electric shock. These installations are extremely sensitive and consequently occasional tripping of switches will occur, effectively shutting down the affected circuit(s). It can often result when a light bulb fails, or it may be the result of a defective appliance. When this happens, the 'trip-switch' must be reset. If this occurs with any frequency, an electrician should be instructed to investigate.

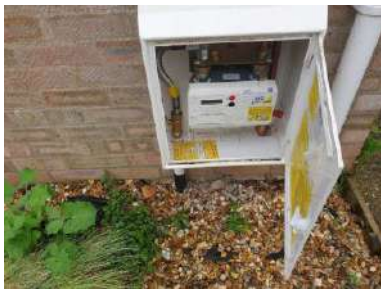
For precautionary purposes it is recommended that the gas installation be inspected by a Gas Safe registered engineer prior to legal commitment to purchase in the absence of any documentary evidence dated in the last 12 months. All recommendations for improvement to ensure compliance with current Gas Regulation standards should be implemented.

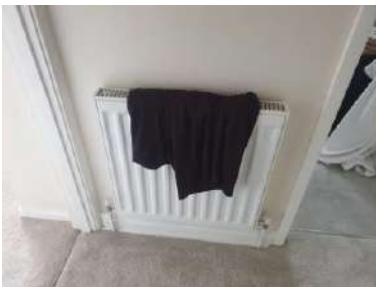
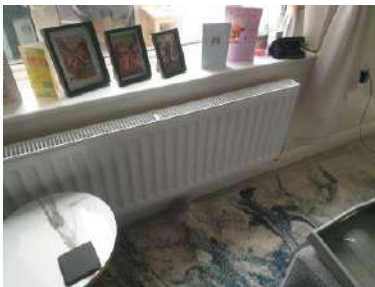
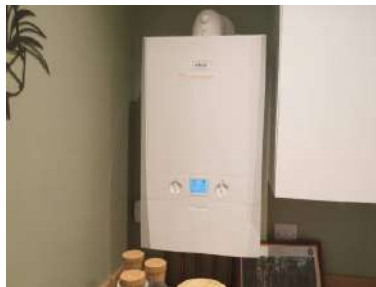
We believe that the replacement boiler was installed approximately 2 years ago. You should request a copy of the Building Regulations Compliance certificate for the installation prior to purchase. In the absence of any such paperwork, the installation may not comply with Building Regulations, and this would need to be investigated further by an appropriately registered heating engineer. There may be guarantees for the installation that can be transferred upon sale.

Heat is provided to a number of pressed steel radiators via 15mm pipework. The radiators and visible pipework appear in satisfactory condition, with no significant corrosion or leakages noted.

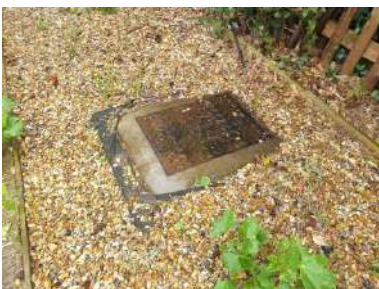
There were no above ground signs of blockage or damage or other significant defects at the time of our inspection however without a full inspection by a drainage specialist, you must accept the risk of such defects existing.

The soil and vent pipe is ducted internally and therefore hidden from view.
