RICS HOME SURVEY
LEVEL 3

PROPERTY ADDRESS:

CLIENT NAME(S):

DATE OF INSPECTION:

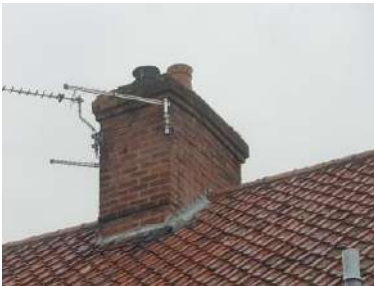
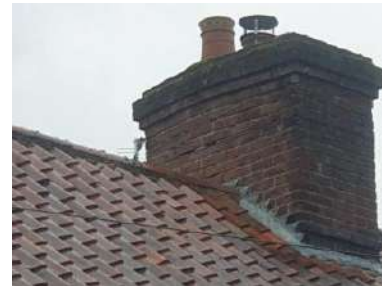
The chimney stack appeared to be straight to the eye with no signs of any significant bulging, lean or outward movement noted.

There is 1 visible chimney pot that appear to be straight to the eye with no signs of visible damage. Flaunchings to the chimney pots could not be seen. These should be periodically inspected to ensure that the chimney pots or flues remain adequately bedded.

The soakers [under flashings] that provide watertightness between the chimney stack edge and the roof are concealed and could not be viewed. However, there is no evidence of internal leakage at these positions to suggest that they are defective.

A TV aerial is attached to the stack although we cannot confirm whether the fixings are adequate for their purpose and regular inspections during routine maintenance should be undertaken.

Secure quotations to complete chimney repairs, to include the cost of any required scaffolding for access

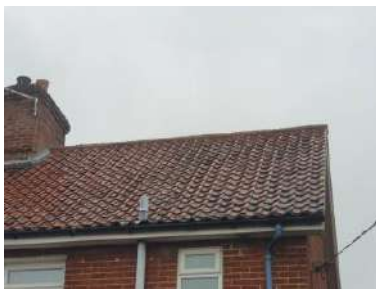
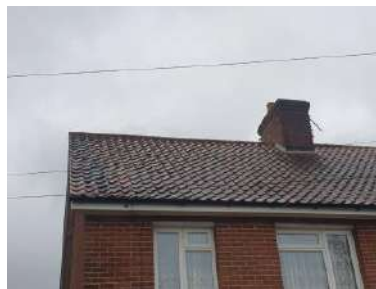
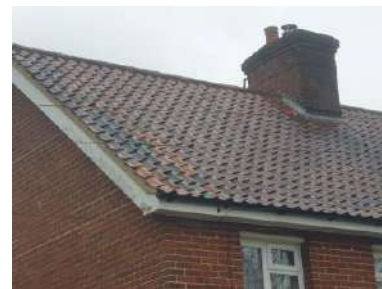
We are pleased to report the roof coverings appear to be complete with no signs of any slipped, missing or damaged covering noted.

Ventilation is a requirement under current regulations, and this is achieved via soffit vents.

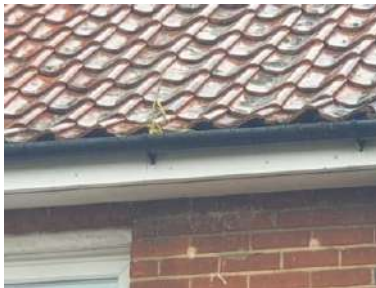
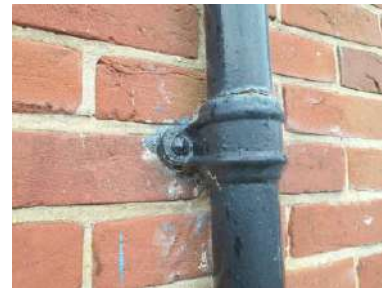
The water butt to the outbuilding should be checked regularly, as if allowed to overflow water butts can cause damp penetration on external walls and if unattended for prolonged period could lead to a change in ground conditions and resulting movement of the structure.

You should ensure that the gutters are seasonally unblocked of moss and other debris.

Secure quotations for repair or replacement of the rainwater fittings

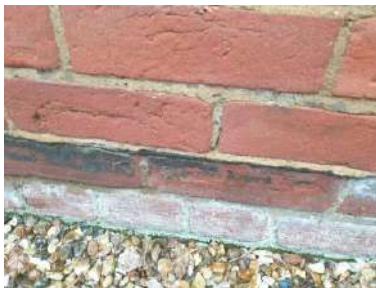
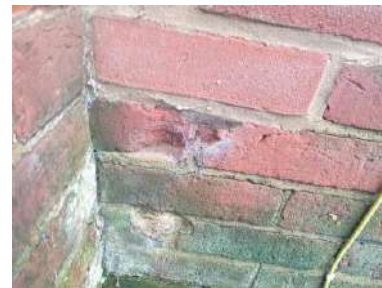
There are holes around penetrations in the rear elevation wall. Any holes should be repaired and filled in the short term to prevent damp or debris entering the wall.

Seek quotations for repairs to the external walls

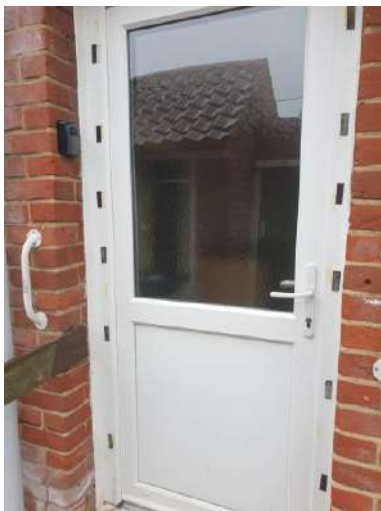
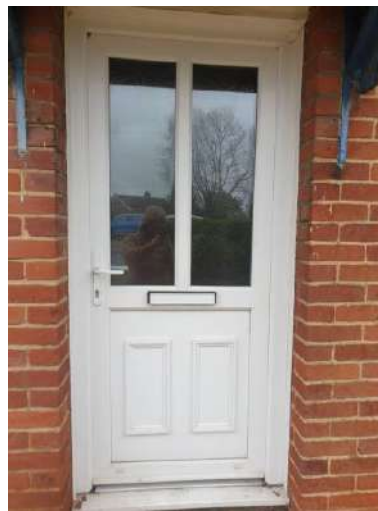
The doors to the front were locked during our inspection and no key was provided, therefore we cannot confirm their functionality. It would be prudent to confirm their satisfactory operation prior to commitment to purchase.

We recommend you change all locks upon occupation to enhance security.

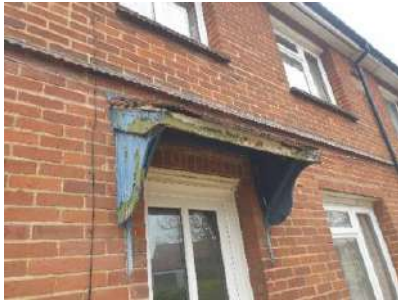
There is a small timber canopy porch to the front of the property, which was in poor condition and you should obtain quotes for replacement prior to a legal commitment to purchase.

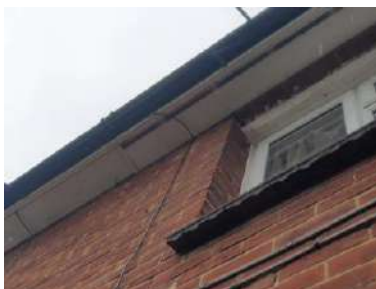
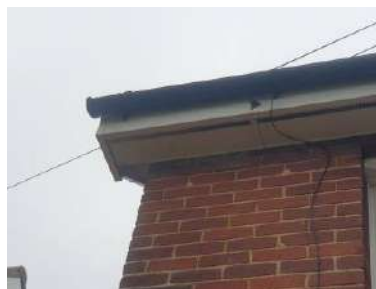
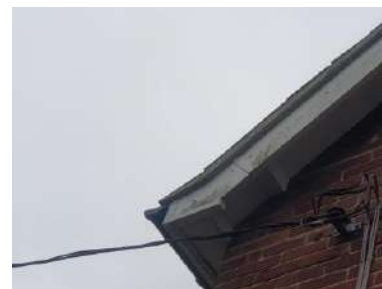
Where these uPVC replacement boards have been provided, it is not possible to determine whether they are fixed directly on top of any original decaying joinery. It is not possible to comment on any concealed section of woodwork which can only be examined by the removal of the uPVC covering.

Given the age of the property materials containing asbestos may be concealed beneath the PVC although we are unable to confirm this, and care should be taken during future maintenance.

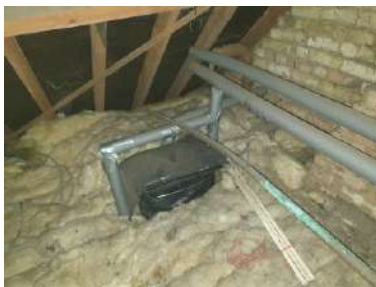
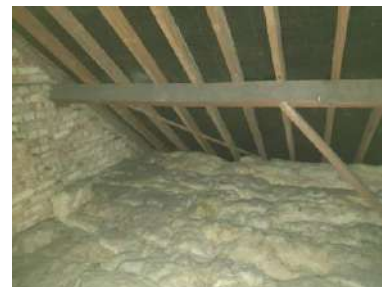
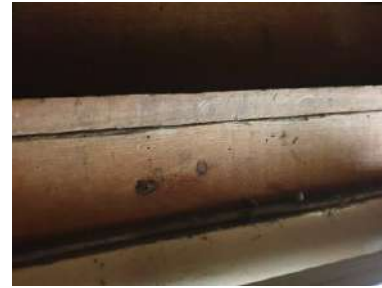
In places, electrical wiring is present beneath the loft insulation. This can cause overheating and in extreme cases lead to fires. All covered cables must be re-positioned on top of the insulation, and this should be assessed as part of a specialist Electrical test. Please see also section F1 of this report.

Given the age of the property there is a possibility the cold-water storage tank could be of asbestos construction.

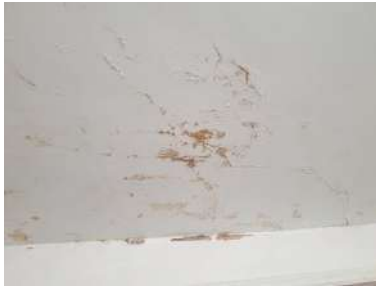
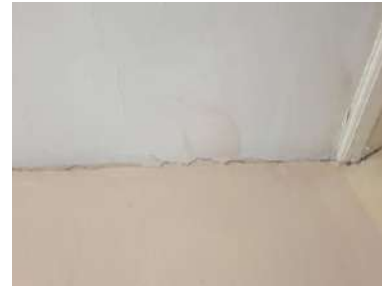
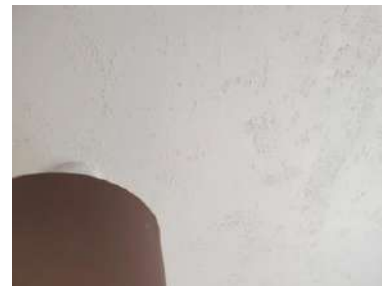
Irregularities and shrinkage cracks are present, but these are not unusual for this type and age of property. Cosmetic works upon redecoration will be required.

Discolouration and deterioration was observed to the ceiling finishes within bedroom 2. These areas were found to be dry when tested with an electronic moisture meter and the growth is attributed to condensation.

Seek quotations for repairs to ceilings

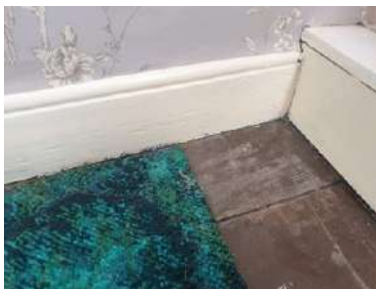
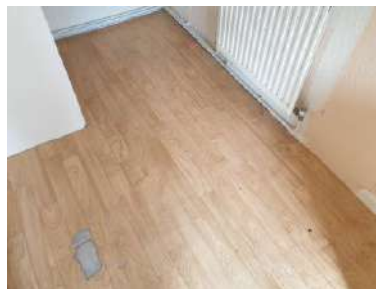
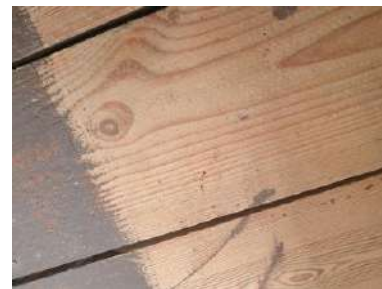
The flooring beneath the sanitary fittings could not be inspected as this would involve damaging investigations which are beyond the scope of a normal survey. If there has been leakage, such as from concealed pipework or through gaps in wall tiles, or around the shower, dampness may have caused serious rot in the floor. We found no evidence of timber decay, but further investigations would be necessary to establish whether any defects exist. If such work is to be undertaken, there will be some resultant damage and appropriate contractors should be appointed to undertake this work, with the vendor's permission, so that any replacement of panelling or flooring can be carefully undertaken.

The floor coverings throughout the property are old and you should consider replacing these to your own taste as part of the general improvement to the property.

Seek quotations to complete repairs to the floors

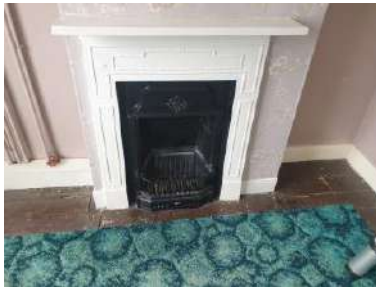
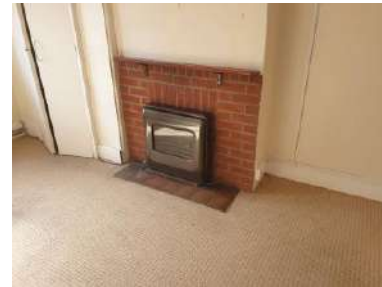
We cannot confirm whether the flue liners have been provided where appliances are fitted to open flues and recommend that a specialist be instructed to check that the installation complies with current regulations.

The chimney breasts appear sound. However, it was not possible within the limits of this report to inspect the flues in detail or to assess the internal condition of flues or flue liners and we can give no assurances as to the practicalities of reinstating the fireplaces. Further contractor's advice will need to be sought in this regard should you wish to utilise the fireplaces.

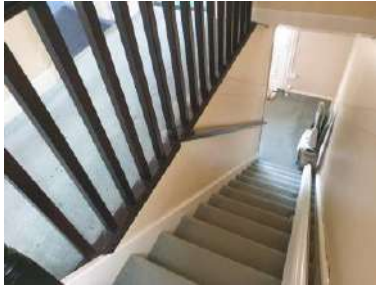
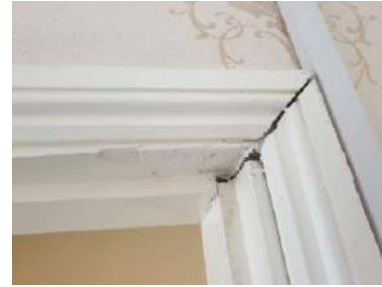
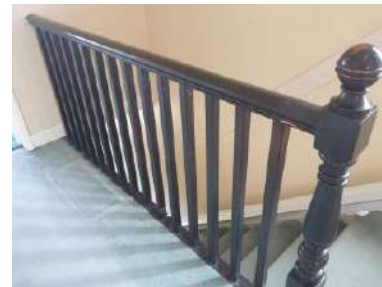
Banisters and balustrading appear to be complete with no signs of any defect noted. The gaps between spindles are 100mm or less which will comply with current Building Regulation standards.

There is evidence of wood-boring insect infestation to the bannisters and whilst there were no signs of recent activity, you should confirm whether previous treatments have been carried out and if so, whether guarantees can be transferred under the sale.

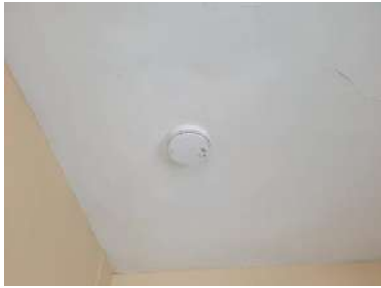
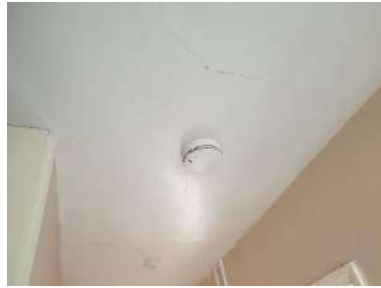
Carbon monoxide alarms should be provided in all rooms which house a fuel-burning appliance.

Where there is an oil-fired boiler, carbon monoxide alarms should be installed adjacent to the appliance in line with the alarm manufacturer's guidelines as a matter of urgency.

Seek quotations to install carbon monoxide detectors adjacent to fuel-burning appliances

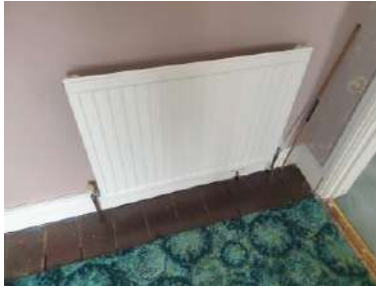
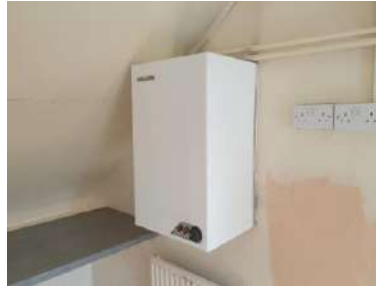
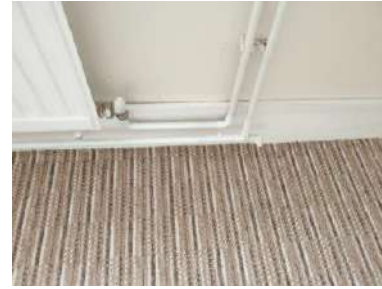
Given the age of the radiators they are likely to be inefficient compared to modern equivalents and you may wish to consider upgrading as part of the overall improvement of the property.

A significant amount of the central heating pipework is buried within the construction and whilst there were no signs of leakage, this can occur undetected beneath floor finishes, particularly if pipework is not adequately protected.

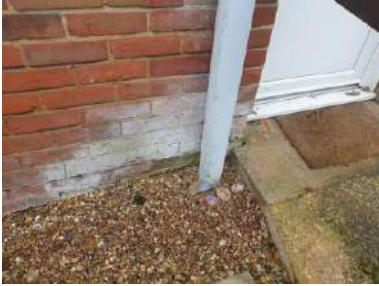
The soil and vent pipe is of uPVC construction and is in serviceable condition at present

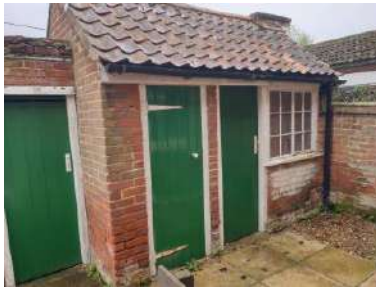
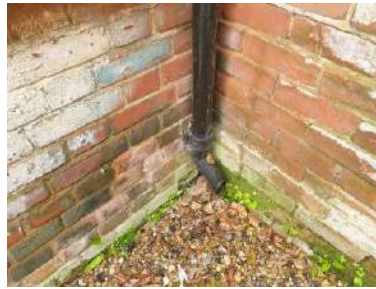
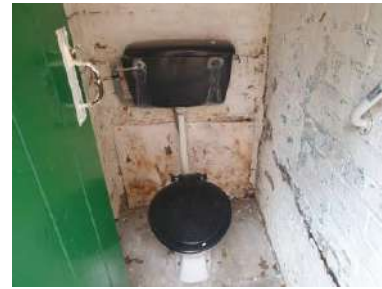
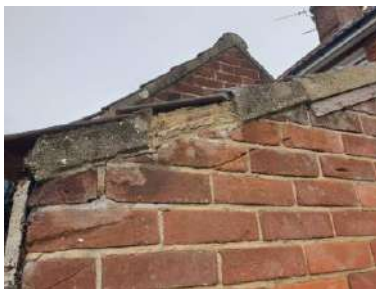
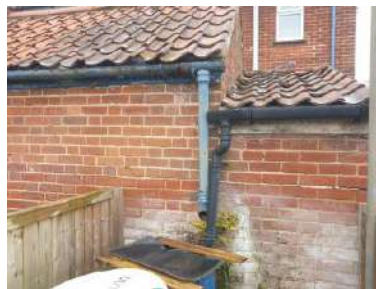
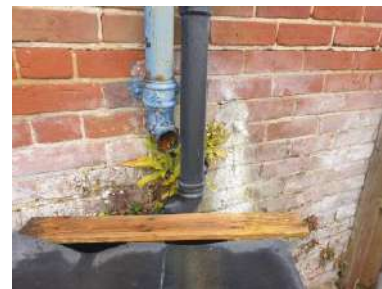
-Single glazed timber windows to be replaced with uPVC equivalents
-External joinery in poor condition
-Timber doors to be replaced with double-glazed uPVC equivalents
-Brickwork above toilet door in poor condition
