**RICS HOME SURVEY
LEVEL 2**
- SURVEY ONLY

Friday 18 October 2024

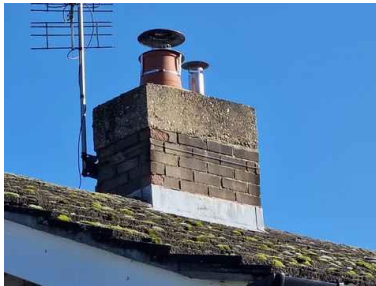
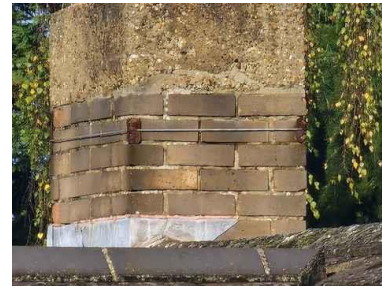
There is evidence of deteriorated mortar bedding to the front face.

Some masonry has deteriorated to the rear due to freeze/thaw action commonly referred to as 'spalling'. Spalling occurs when brickwork becomes wet due to rain. If freezing conditions occur before the bricks dry out, the entrapped moisture expands and forces off the hard face of the brick, so exposing the softer inner core.

Whilst the level of deterioration is relatively minimal at this time with no requirement for repair, you should be aware that spalling is progressive, unsightly and if allowed to continue may ultimately result in structural failure of the stack. The affected masonry should be periodically monitored and the need to cut-out and replace individual bricks in the future cannot be ruled out.

The top section of the chimney stack is covered in render. No significant defects were observed however you should be aware that exposed render can deteriorate without warning which can allow for moisture to ingress beneath the render and cause dampness and damage to the concealed masonry. During your occupation you will need to carefully monitor and periodically maintain the render coating.

A TV aerial is attached to the stack although we cannot confirm whether the fixings are adequate for their purpose and regular inspections during routine maintenance should be undertaken.

Whilst repairs are not urgently required, it is recommended that you obtain quotations for future repointing works through a reputable roofing contractor prior to purchase, to budget accordingly.

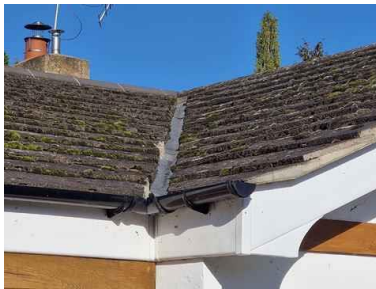
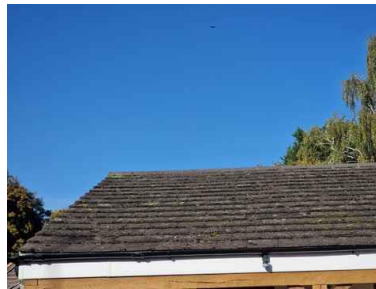
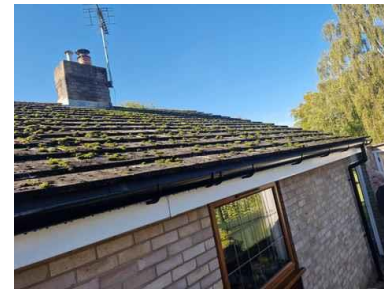
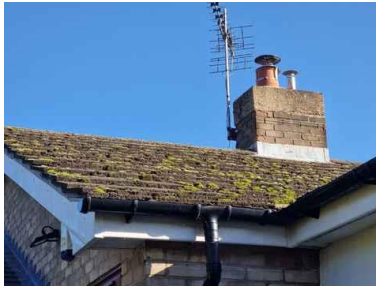
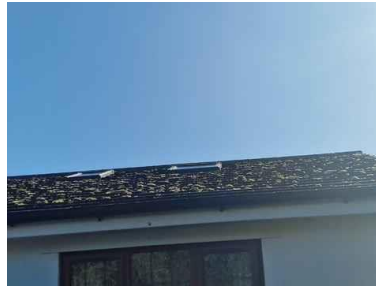
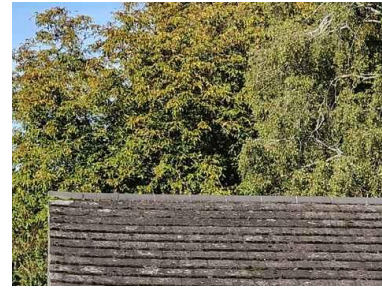
We are pleased to report the roof coverings appear to be complete with no signs of any slipped, missing or damaged covering noted.

Please note the roof verge under cloak to the original house may include asbestos containing materials, depending on their age. Care should be taken with future maintenance. See 'Local environment' of this report.

The valleys are formed in lead and appear to be in a satisfactory condition where viewed from ground level. Moss should be cleared from within the valleys periodically to prevent overspill. Valley gutters can fail unexpectedly, and regular maintenance is necessary. Even valley gutters that are in sound condition can quickly become blocked by leaves, snow, or ice, causing water levels to rise above the edges of the joints and so seep into the fabric of the building. It should be noted that maintenance and repair costs, when needed, tend to be expensive, and you may therefore wish to arrange for a precautionary up-close inspection prior to purchase.

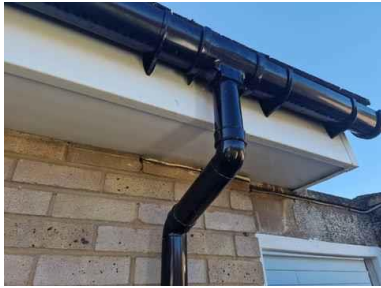
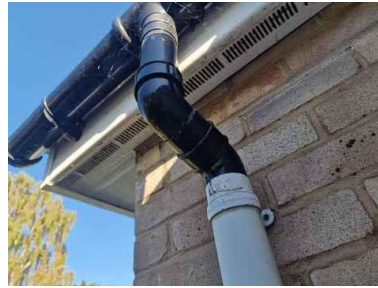
You should ensure that the gutters are seasonally unblocked of moss and other debris.

In view of the trees in the surrounding areas, it is recommended that gutters are annually inspected, preferably after autumn leaf fall, to ensure the gutters and downpipes are not blocked. It is also recommended that leaf guards are fitted to gutter channels to prevent the build-up of leaves in the guttering, enabling water to discharge.

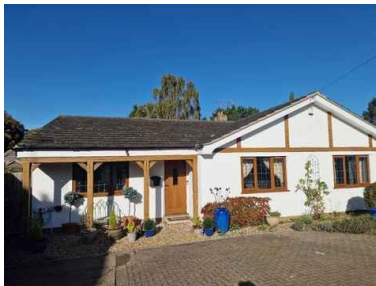
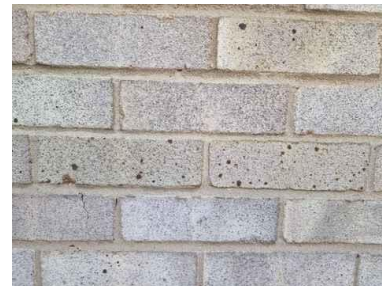
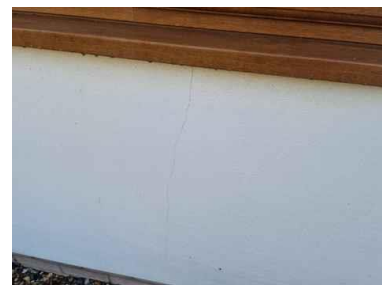
The iron content can effectively rust over time, and this can cause spalling (delamination) of the face of the masonry, which exposes the soft inner core of the brick and can lead to penetrating dampness and progressive deterioration of the brickwork.

We found no evidence of any significant associated defect within the masonry at the time of the inspection; however, it must be appreciated that the risk remains, and you should regularly monitor the brickwork for changes.

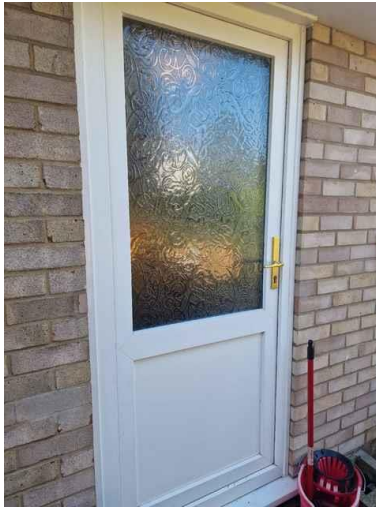
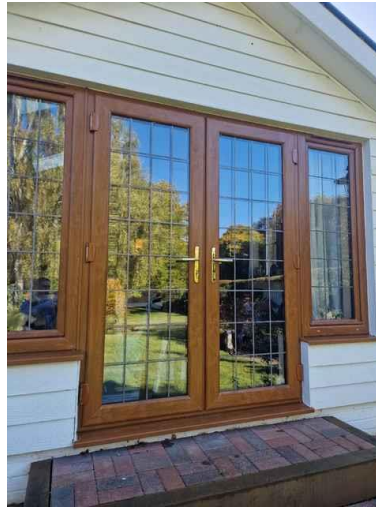
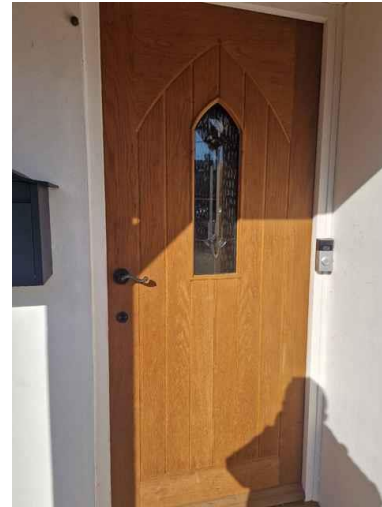
Doors open square to the eye with no signs of any significant movement or distortion noted.

We recommend you change all locks upon occupation to enhance security.

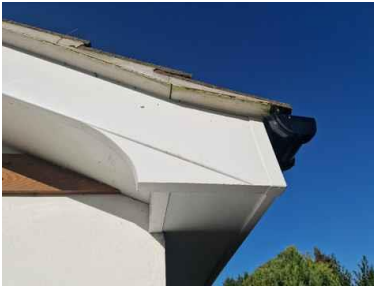
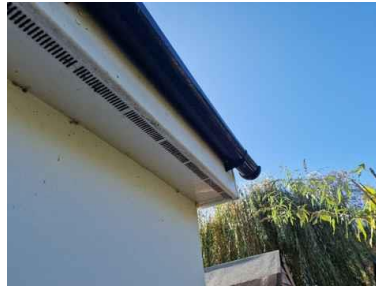
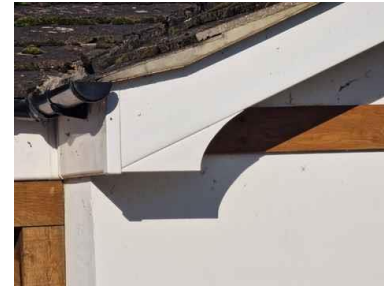
Where these uPVC replacement boards have been provided to the original house, it is not possible to determine whether they are fixed directly on top of any original decaying joinery. It is not possible to comment on any concealed section of woodwork which can only be examined by the removal of the uPVC covering.

Given the age of the original house, materials containing asbestos may be concealed beneath the PVC although we are unable to confirm this, and care should be taken during future maintenance.

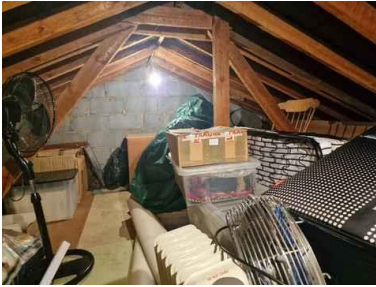
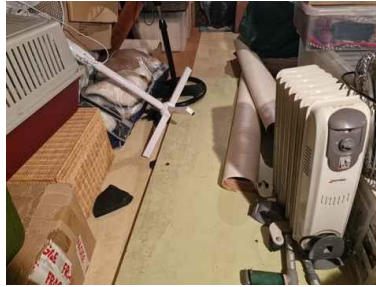
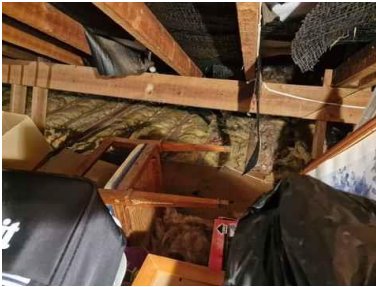
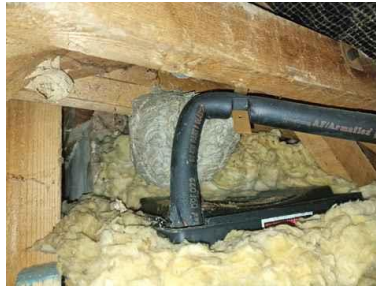
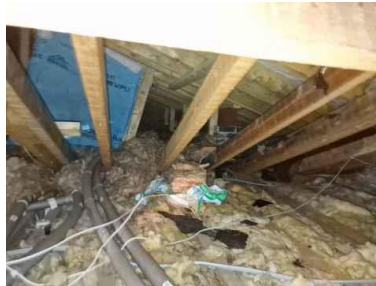
The roof space did contain items of storage, limiting the full extent of our inspection. Should you wish to use this area for storage it should be ensured that boarding is securely fixed, and storage limited in order to reduce possible over-loading of the roof and ceiling structure.

There were wasps' nests visible in the attic space. These appeared to be dormant, but you should be mindful of further nests that may be present in hot summer months. Large nests should be safely removed as they are obstructing the eaves.

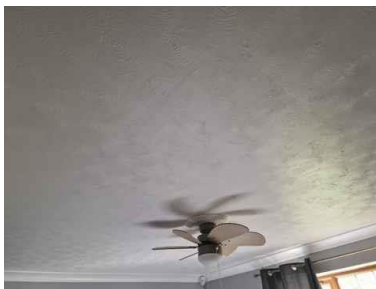
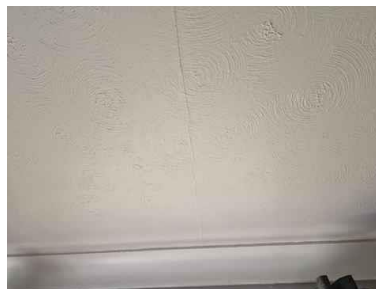
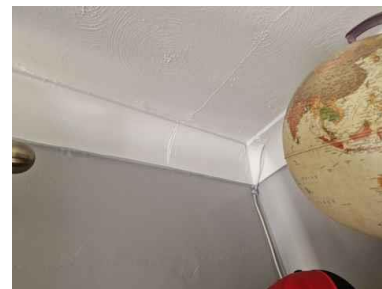
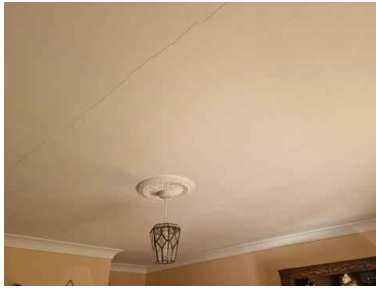
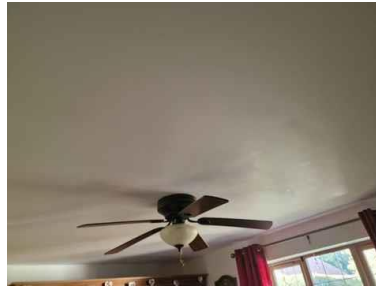
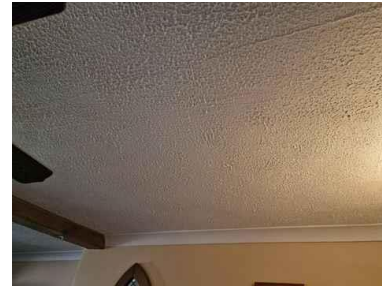
Minor irregularities and shrinkage cracks are present, but these are not unusual for this type and age of property. Cosmetic works upon redecoration will be required.

Cracks along the lines of plasterboard joints are not unusual. These cracks are not structurally significant and can be filled prior to redecoration.

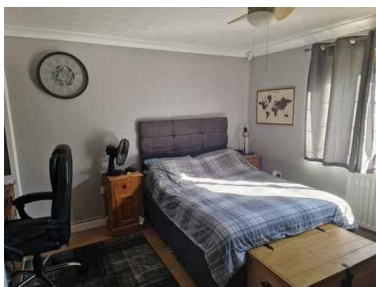
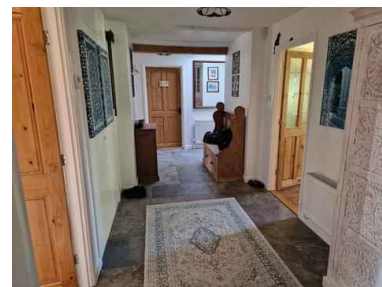
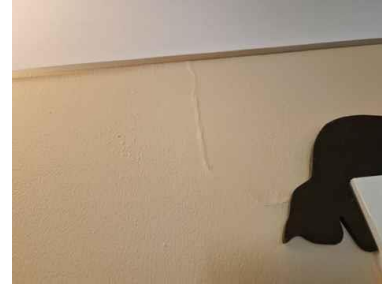
Moisture content readings were taken throughout the walls at regular intervals with an electronic damp meter and no significant dampness was recorded, suggesting the damp-proof course is operating effectively.

We also found no evidence of any significant penetrating dampness within the property.

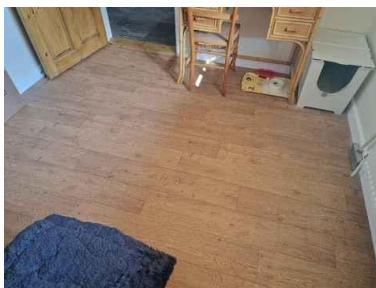
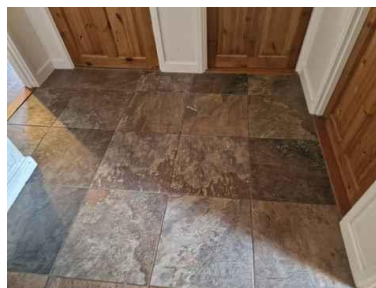
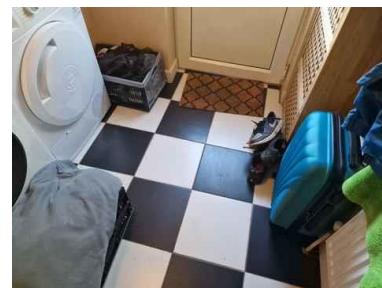
The solid floors appear firm and level underfoot when viewed through the floor finishes.

Given the age of the property, solid ground floors in the original house are unlikely to incorporate insulation in line with current standards. As a result, this can contribute to cold bridging and condensation forming on the floors and adjacent wall surfaces if left unchecked.

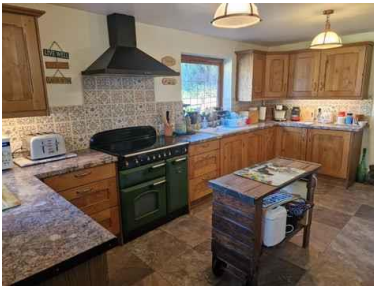
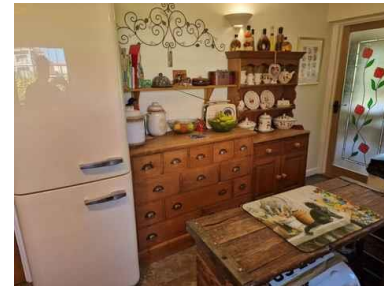
Ventilation appears adequate and should be regularly maintained.

Most of the distribution and waste pipework is concealed behind the units and leaking pipework or other defects may not be readily apparent.

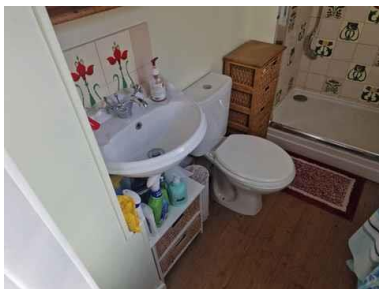
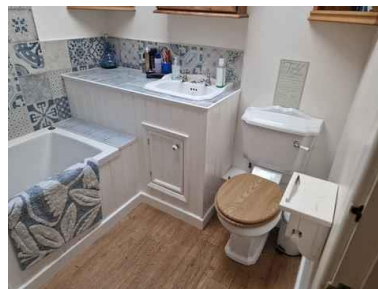
The water pressure was checked to several draw-off points and found to be adequate. Water pressure can vary seasonally and during times of high demand, both within the property and in the locality. It is recommended that should you wish to install water pressure sensitive items, such as a power shower, that further enquiries are made initially.

Most of the distribution and waste pipework is concealed beneath or behind sanitary ware items and whilst there were no obvious signs of leaks, the risk of hidden defects exists.

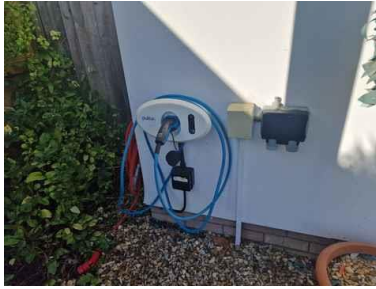
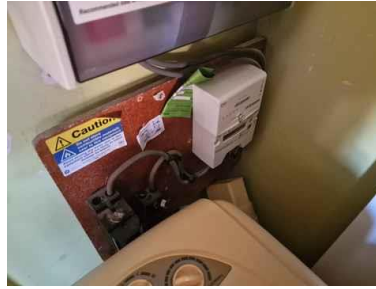
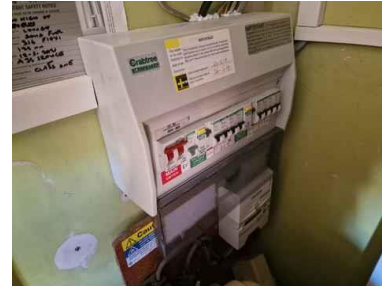
The electrical installation is provided with an RCD which is designed to protect the users from electric shock. These installations are extremely sensitive and consequently occasional tripping of switches will occur, effectively shutting down the affected circuit(s). It can often result when a light bulb fails, or it may be the result of a defective appliance. When this happens, the 'trip-switch' must be reset. If this occurs with any frequency, an electrician should be instructed to investigate.

There is an electric vehicle charging station installed to the front. Such installations should be installed to the prevailing Building Regulations and require such a certificate from the electrician who installed the device. There may also be guarantees that can be transferred under the sale. Legal advisors to confirm.

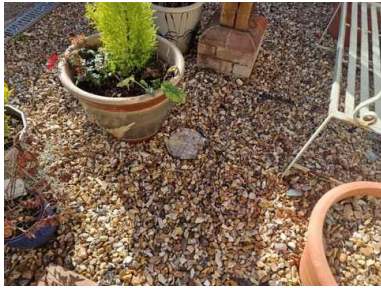
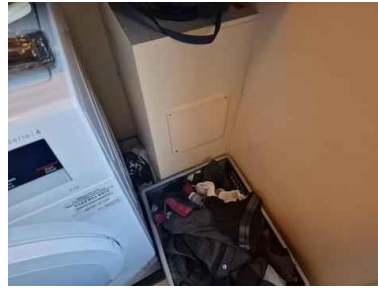
The internal rising main and stop tap are located in the utility room and boxed in to the right of the washing machine.

The external stop tap is located in the gravel to the front of the main entrance door. You should confirm whether a water meter is provided.

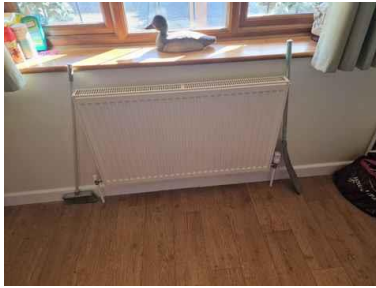
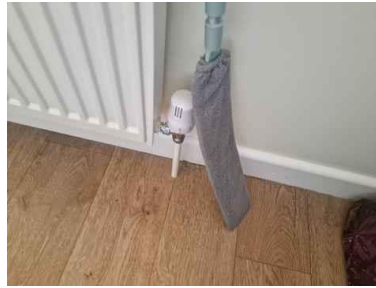
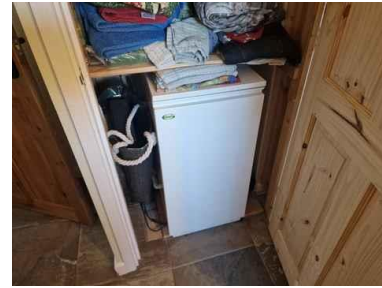
Thermostatic radiator valves (TRVs) have been provided to radiators. These will allow for individual control over each unit which will improve the thermal efficiency of the dwelling.

A significant amount of the central heating pipework is buried within the construction and whilst there were no signs of leakage, this can occur undetected beneath floor finishes, particularly if pipework is not adequately protected.

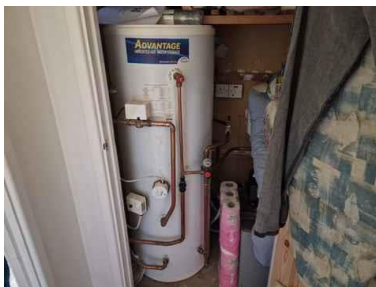
We are not suitably qualified to comment on the state and condition of the hot water installation and a test on the installation is outside the scope of this report.

You should be aware that hot water systems require regular maintenance, and it is recommended that they are serviced annually alongside the central heating boiler installation. You should request a copy of any recent service history through your Legal Advisor. In the absence of such documentation dated within the last 12 months, you should arrange for a precautionary inspection through a reputable plumber or heating engineer.

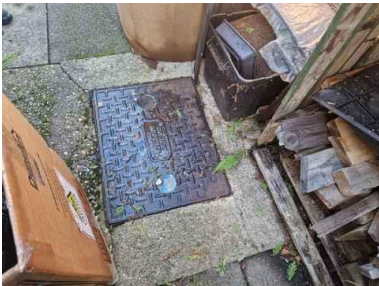
There were no above ground signs of blockage or damage or other significant defect at the time of our inspection however without a full inspection by a drainage specialist, you must accept the risk of such defects existing.

The soil and vent pipe is ducted internally and therefore hidden from view.

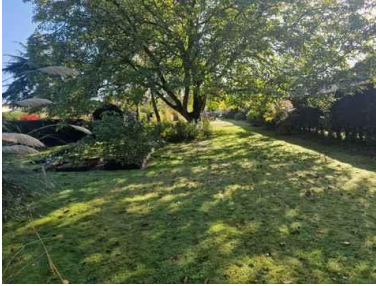
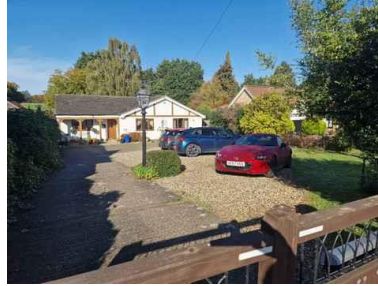
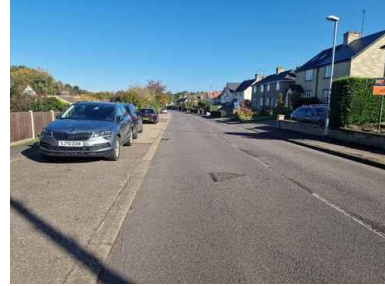
There is vegetation within the vicinity of the property. There is the potential for root spread towards drainage channels and the property, although no associated damage was observed to warrant further investigation. It would be prudent for periodic maintenance to be undertaken to ensure that vegetation remains in healthy condition and so assist in minimising against the potential for falling branches. Consideration should also be given to periodic pruning to prevent vegetation becoming too large.

You should upgrade paths and patios, which are in need of improvement.
