**RICS HOME SURVEY  
LEVEL 3**

Wednesday 2 October 2024

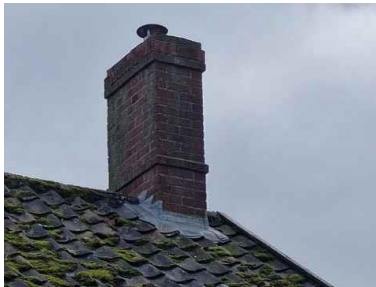
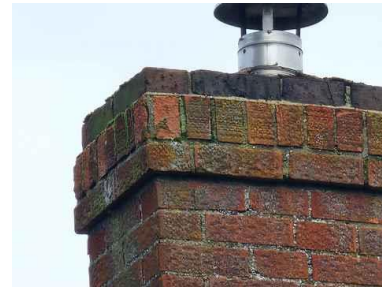
The chimney stack appeared to be straight to the eye with no signs of any significant bulging, lean or outward movement noted.

There is 1 visible chimney pot that appears to be straight to the eye with no signs of visible damage. Flaunching to the chimney pot could not be seen. These should be periodically inspected to ensure that the chimney pots or flues remain adequately bedded.

Lichen and moss should be cleared from the top courses periodically to prevent early deterioration of brickwork pointing. The level of moss growth is not significant at this time. Please be aware, it may be necessary to repoint brickwork once moss has been cleared during future maintenance.

There is evidence of deteriorated mortar bedding to the top courses of the front face (for example).

The flashings consist of lead. The lead flashings appear adequately dressed to the roof covering and pointed into the masonry.

The soakers [under flashings] that provide watertightness between the chimney stack edge and the roof are concealed and could not be viewed. However, there is no evidence of internal leakage at these positions to suggest that they are defective.

Whilst repairs are not urgently required, it is recommended that you obtain quotations for future repointing works through a reputable roofing contractor prior to purchase, to budget accordingly.

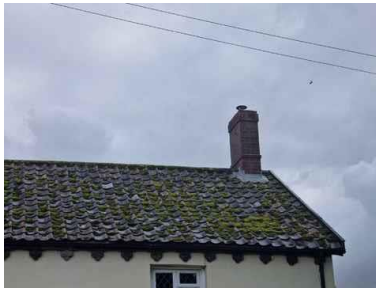
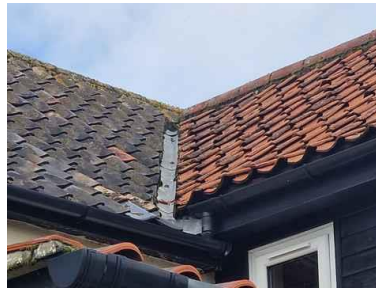
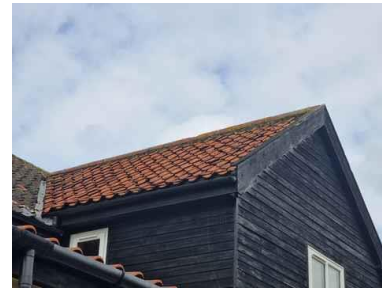
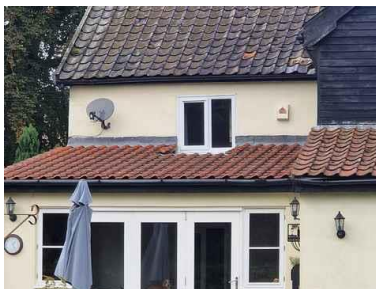
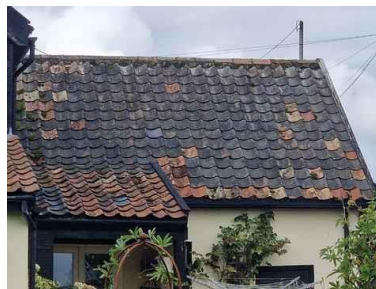
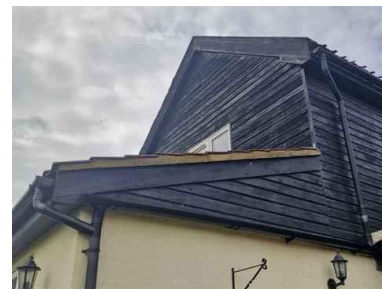
The roofline appears to be level and within normal tolerances with no signs of any significant deflection or undulation noted, indicating that the roof structure is adequate for the current roof covering. See Section E1 regarding the roof structure.

We are pleased to report the roof coverings appear to be complete with no signs of any slipped, missing or damaged covering noted.

There is no evidence of significant cracking or loosening of the mortar to the roof edge, but this should be checked periodically and repointed as necessary.

The valleys are formed in lead and appear to be in a satisfactory condition where viewed from ground level. Moss should be cleared from within the valleys periodically to prevent overspill. Valley gutters can fail unexpectedly, and regular maintenance is necessary. Even valley gutters that are in sound condition can quickly become blocked by leaves, snow, or ice, causing water levels to rise above the edges of the joints and so seep into the fabric of the building. It should be noted that maintenance and repair costs, when needed, tend to be expensive, and you may therefore wish to arrange for a precautionary up-close inspection prior to purchase.

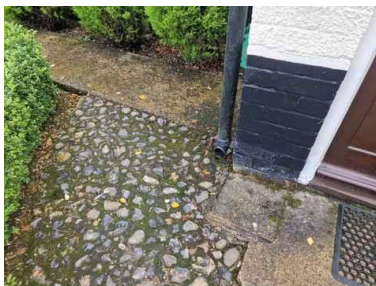
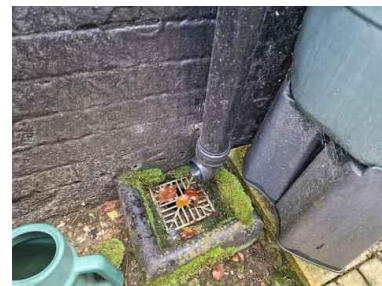
The rainwater goods are formed in uPVC and appear to be in a reasonable condition.

Please note it was not raining during the course of the inspection so we cannot confirm that rainwater goods are watertight at the joint sections. It is recommended that you inspect rainwater goods during a period of heavy rain in order to establish their effectiveness, with repairs addressed as found to be necessary.

You should ensure that the gutters are seasonally unblocked of moss and other debris.

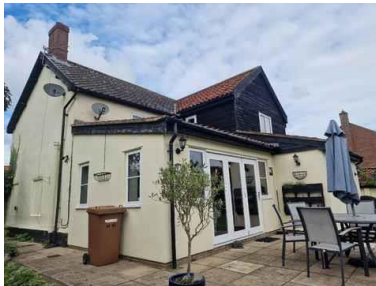
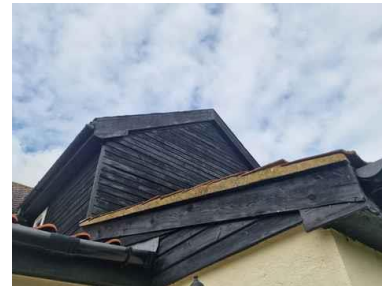
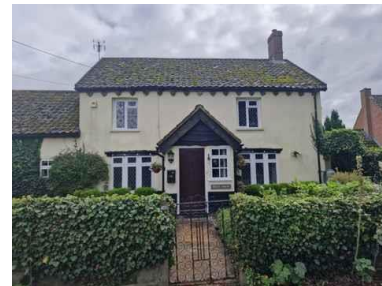
Walls and openings appear square to the eye with no signs of any significant movement or distortion noted.

We are pleased to report we saw no evidence of any significant cracks or bulges to indicate any failure or uneven loading with the foundations or structure of the subject property at this time.

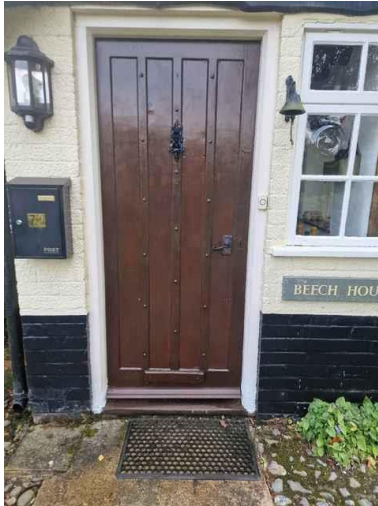
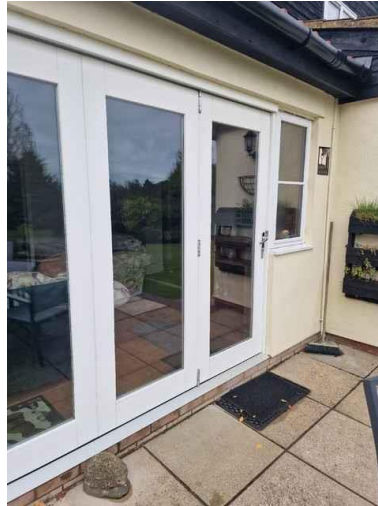
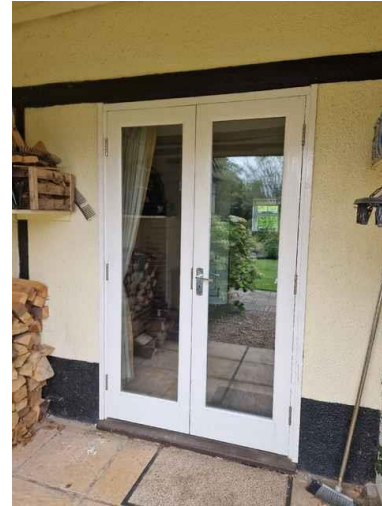
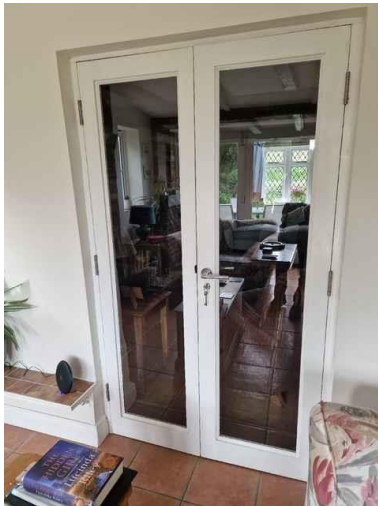
Doors open square to the eye with no signs of any significant movement or distortion noted.

We recommend you change all locks upon occupation to enhance security.

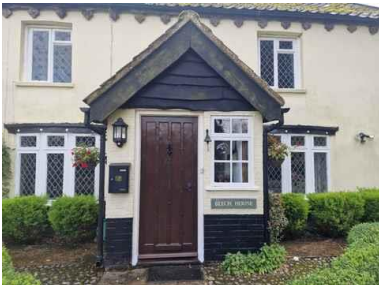
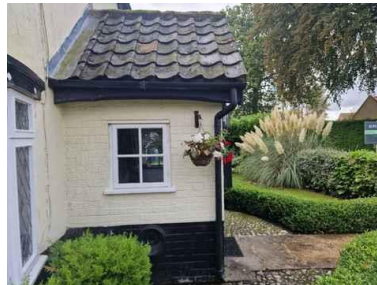
There is a brick-built porch constructed beneath a tiled roof structure, which was in reasonable condition.

The porch is a later addition to the property and given the overall size of the structure, together with the presence of a fixed door to the main dwelling, Local Authority consents and Building Regulations approval are not thought to have been required for the construction.

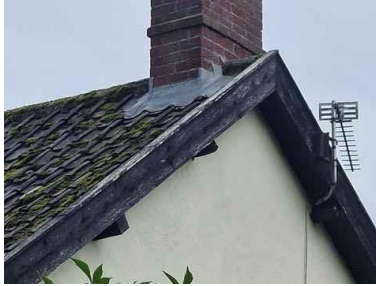
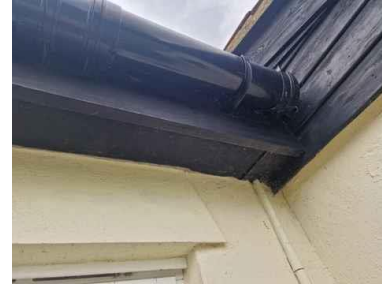
The external decorations are deteriorated and new decoration in reasonable course is required. This should include thorough preparation of the timber by removing all loose and flaking decorative finishes before priming the bare surfaces and re-applying appropriate decorative coatings. Much of this work will be undertaken at height and it is therefore recommended that you obtain quotations for this prior to purchase.

Please note, a closer inspection of the timber may reveal some concealed deterioration and you should expect that localised repairs may be necessary prior to redecoration.

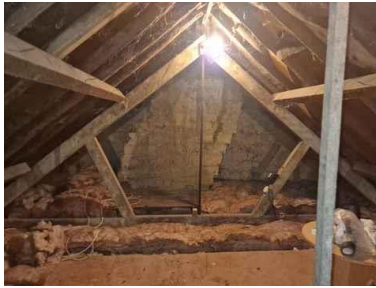
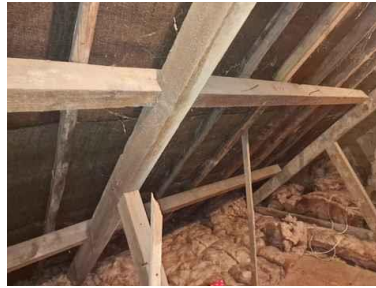
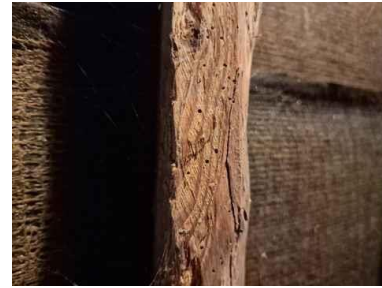
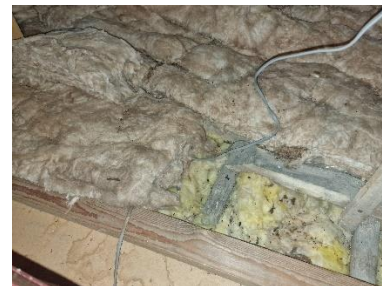
Droppings were noted which may be an indicator of recent activity.

The situation should be monitored, if an active presence of vermin is discovered on occupation, it would be prudent to investigate further with a suitably qualified pest control contractor.

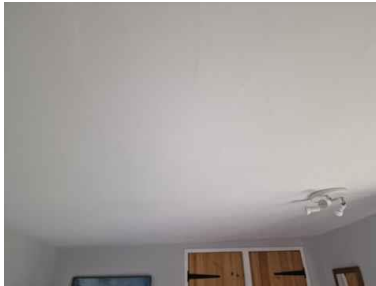
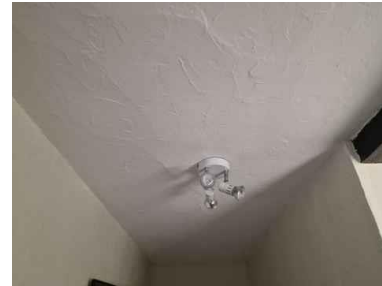
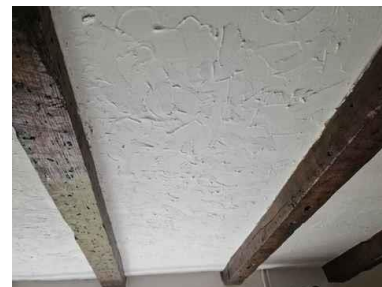
Minor irregularities and shrinkage cracks are present, but these are not unusual for this type and age of property. Cosmetic works upon redecoration will be required.

Lath and plaster ceilings are vulnerable to cracking and loosening as they age. Due to the relatively fragile nature of this type of ceiling, failings can occur. The risk of unevenness and failure of the ceilings will increase with time, and you must anticipate the need for future repair and replacement work.

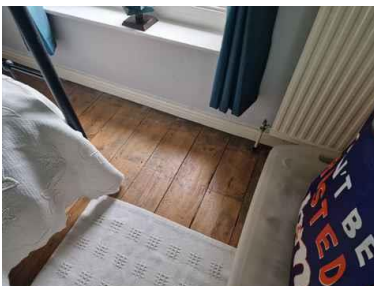
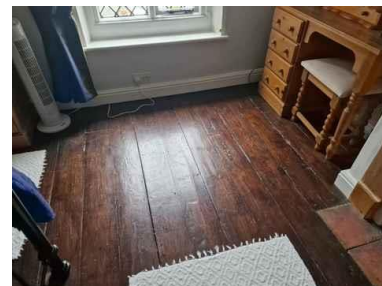
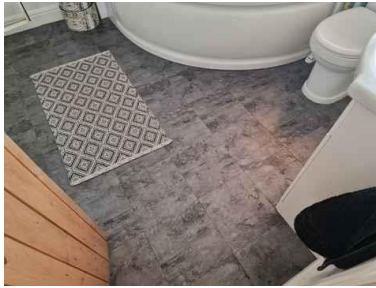
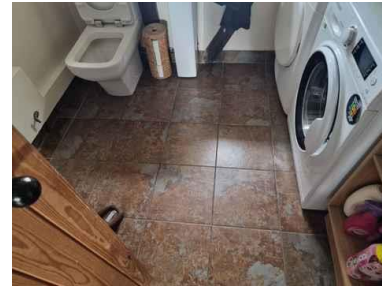
There is evidence of wood-boring insect infestation to exposed floorboards and whilst there were no signs of recent activity, you should confirm whether previous treatments have been made and if so, whether guarantees can be transferred under the sale.

The flooring beneath the sanitary fittings could not be inspected as this would involve damaging investigations which are beyond the scope of a normal survey. If there has been leakage, such as from concealed pipework or through gaps in wall tiles, or around the bath/shower, dampness may have caused serious rot in the floor. We found no evidence of timber decay, but further investigations would be necessary to establish whether any defects exist. If such work is to be undertaken, there will be some resultant damage and appropriate contractors should be appointed to undertake this work, with the vendor's permission, so that any replacement of panelling or flooring can be carefully undertaken.

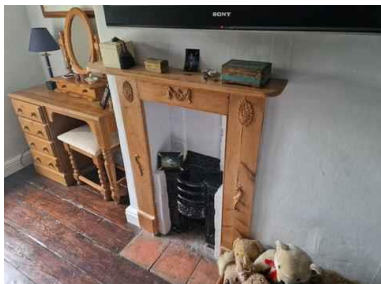
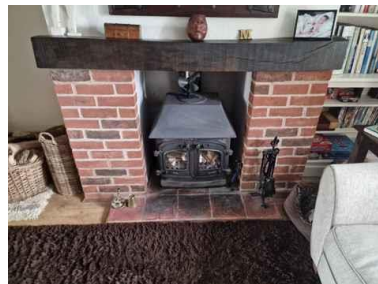
We cannot confirm whether the flue liners have been provided where appliances are fitted to open flues and recommend that a specialist be instructed to check that the installation complies with current regulations.

The stack to the left elevation has been taken down to below the roof line. There were no structural concerns noted to the remaining stack and breasts. Legal advisor should request any associated documentation for this work.

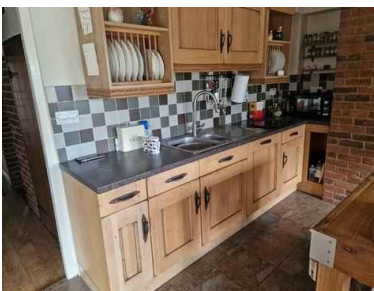
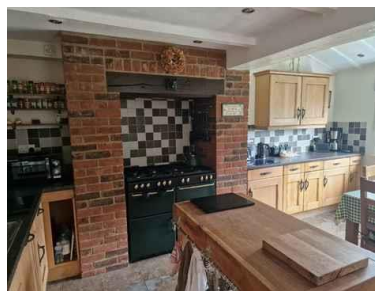
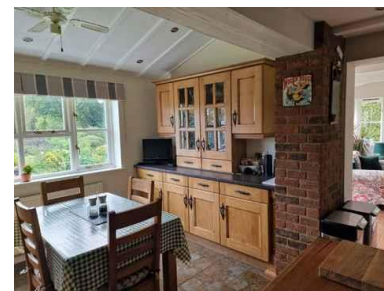
There is a gas hob fitted, and you should confirm with your legal adviser whether this has any Gas Safety Certification. See Section F2 of this report.

Most of the distribution and waste pipework is concealed behind the units and leaking pipework or other defects may not be readily apparent.

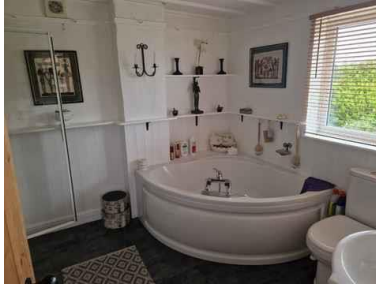
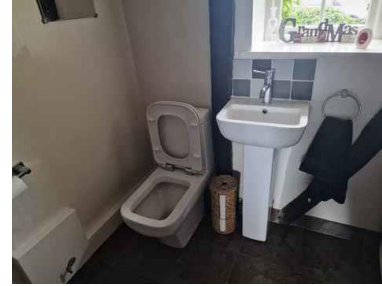
The water pressure was checked to several draw-off points and found to be adequate. Water pressure can vary seasonally and during times of high demand, both within the property and in the locality. It is recommended that should you wish to install water pressure sensitive items, such as a power shower, that further enquiries are made initially.

Most of the distribution and waste pipework is concealed beneath or behind sanitary ware items and whilst there were no obvious signs of leaks, the risk of hidden defects exists.

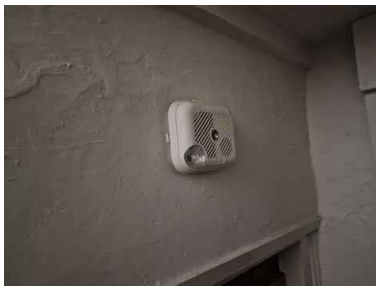
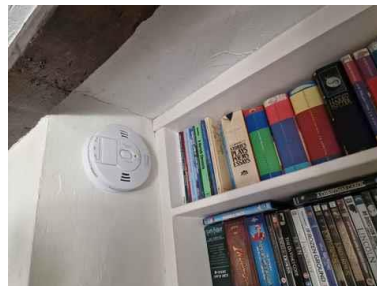
Carbon monoxide alarms should be provided in all rooms which house a fuel-burning appliance.

Where there is an active fire, carbon monoxide alarms have been installed and should be maintained in line with the alarm manufacturer's guidelines.

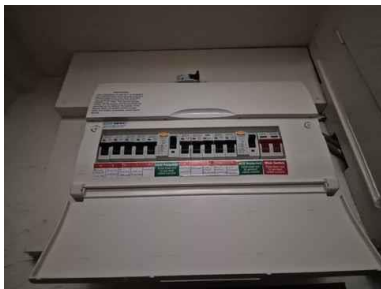
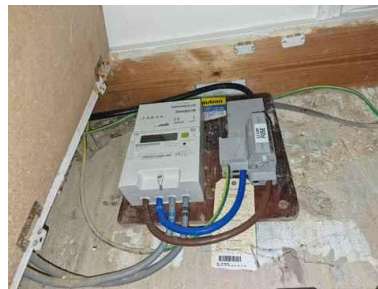
Although there were no particular areas of concern, we do endorse the Electrical Safety Council's recommendations and a precautionary electrical inspection should therefore still be undertaken, to ensure that circuitry complies with current electrical regulations, prior to a legal commitment to purchase. All recommendations should be fully costed and implemented.

The electrical installation is provided with an RCD which is designed to protect the users from electric shock. These installations are extremely sensitive and consequently occasional tripping of switches will occur, effectively shutting down the affected circuit(s). It can often result when a light bulb fails, or it may be the result of a defective appliance. When this happens, the 'trip-switch' must be reset. If this occurs with any frequency, an electrician should be instructed to investigate.

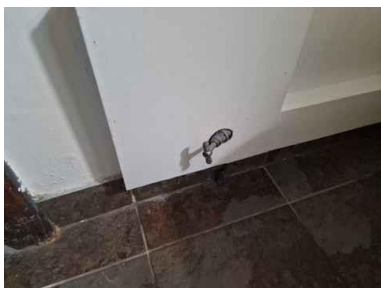
The internal rising main and stop tap are located in the WC.

The external stop tap is located in the grass verge to the front. You should confirm whether a water meter is provided.

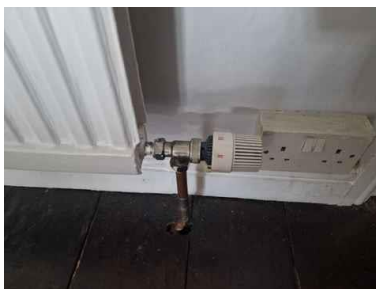
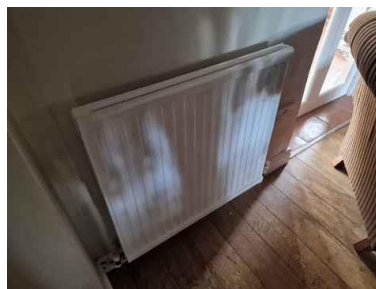
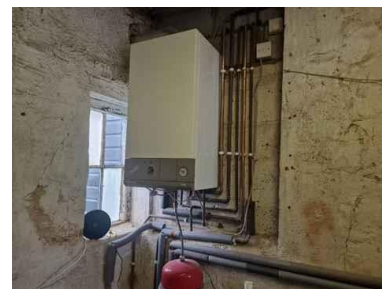
Heat is provided to a number of pressed steel radiators via 15mm pipework. The radiators and visible pipework appear in satisfactory condition, with no significant corrosion or leakages noted.

A significant amount of the central heating pipework is buried within the construction and whilst there were no signs of leakage, this can occur undetected beneath floor finishes, particularly if pipework is not adequately protected.

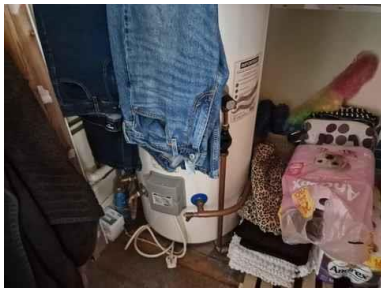
We are not suitably qualified to comment on the state and condition of the hot water installation and a test on the installation is outside the scope of this report.

You should be aware that hot water systems require regular maintenance, and it is recommended that they are serviced annually alongside the central heating boiler installation. You should request a copy of any recent service history through your legal adviser. In the absence of such documentation dated within the last 12 months, you should arrange for a precautionary inspection through a reputable plumber or heating engineer.

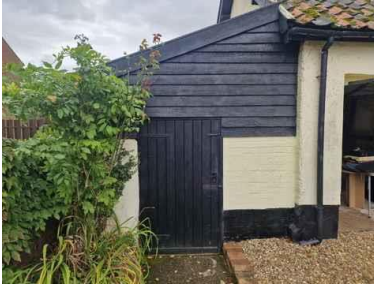
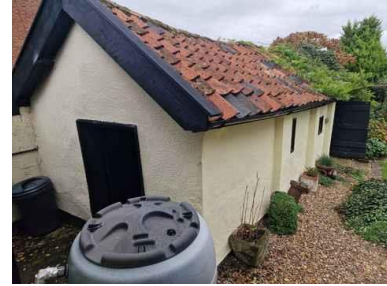
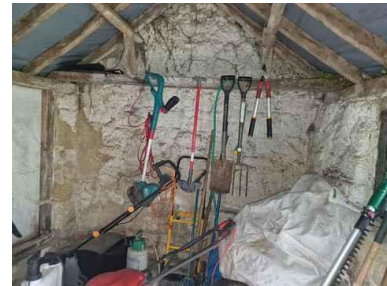
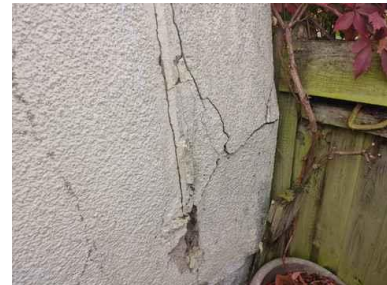
There is a clay lump outbuilding to the rear which is constructed beneath a pitched and tiled roof. There were no significant structural issues noted to the outbuilding at the time of the inspection. There is evidence of wood-boring insect infestation to the roof timbers within the outbuilding and whilst there were no signs of recent activity, you should confirm whether previous treatments have been made and if so, whether guarantees can be transferred under the sale. The render to the rear is in poor condition as is the outbuilding generally. Depending on your intended usage you may wish to obtain quotes for repair and upgrading works prior to a legal commitment to purchase. The electrical services to the outbuilding should be tested by a qualified electrician alongside the electrics to the property. Please see also section F1 of this report. Timber outhouses such as sheds and summerhouses are considered to be temporary and beyond the scope of the report and have not been inspected.

Seek quotations for repairs/improvements to the outbuilding

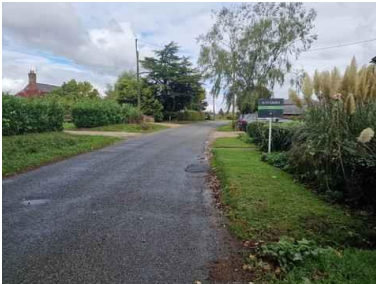
The outside areas and gardens appear to be adequately maintained.

Where there are boundary walls, these features will require high levels of maintenance and are currently suffering from deterioration, evidenced by the front wall. You should seek quotations for repairs prior to commitment to purchase in order to budget accordingly
