**RICS HOME SURVEY
LEVEL 3**

DATE OF INSPECTION:

Monday, 19 August 2024

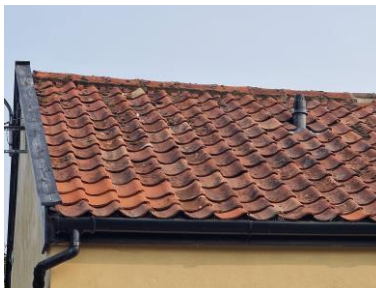
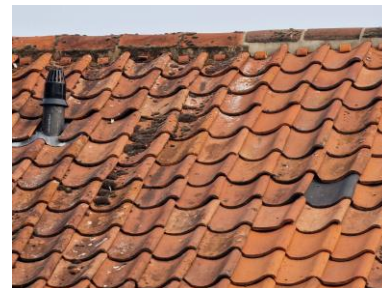
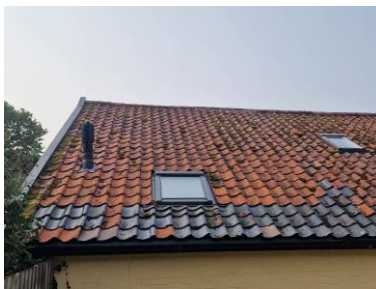
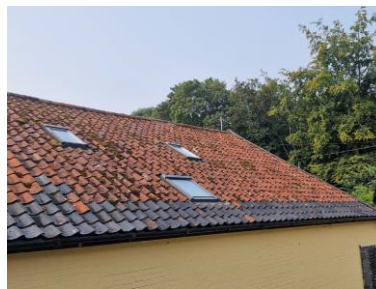
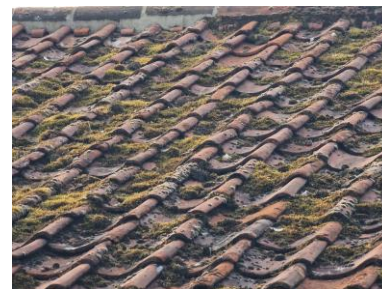
We are pleased to report the roof coverings appear to be complete with no signs of any slipped, missing or damaged covering noted.

Sections of tiles have been replaced as evidenced on the front roof slope. This section of tiles has been lined with a breathable membrane as observed within the roof void, whereas the rest of the front slope is lined with a bitumen felt.

The original clay tiles are of a type which is quite often found to give problems on ageing as they are susceptible to freeze/thaw action. This causes the clay to delaminate with the result being that the tile slowly disintegrates, with a potential for the fixing nibs or nails holes to break eventually allowing for slippages, especially where they are laid onto felt or boarding. The progress of deterioration can continue over a period of 10-20 years or so before complete failure of the tile occurs.

There are high levels of moss growth present on the rear roof slopes. Excessive moss growth should be cleaned off as soon as possible. Moss growth impedes the run-off of rainwater and leads to gutter blockage and can cause water penetration which may lead to rot or other defects in surrounding timbers. The level of moss build-up limited our inspection of the roof coverings, and the risk of unseen defects must exist.

Secure quotations to complete roof repairs, to include the cost of any required scaffolding for access

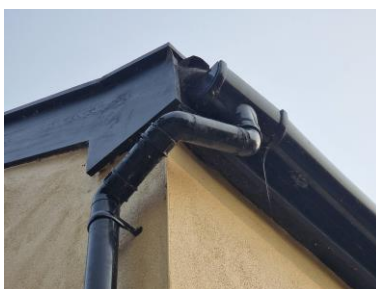
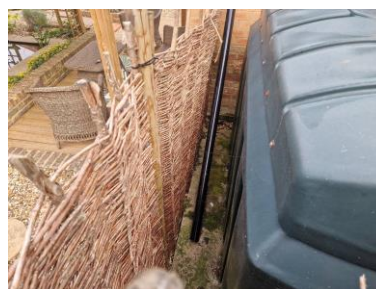
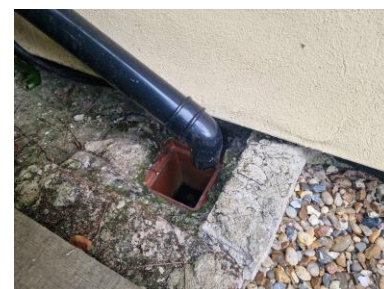
The rainwater goods are formed in uPVC and appear to be in a good condition.

We are pleased to report that rainwater goods appear to be adequately aligned with no signs of any significant twisting or distortion noted.

Where the downpipe to the conservatory discharges directly onto the ground this is an unsatisfactory arrangement that can lead to a deterioration of the adjacent low-level masonry, localised penetrating dampness, and even changes in ground conditions. The downpipes should be modified so that they are connected to the underground installation or to a water butt, and you should seek quotations for such modifications prior to purchase.

Secure quotations for repair or replacement of the rainwater fittings

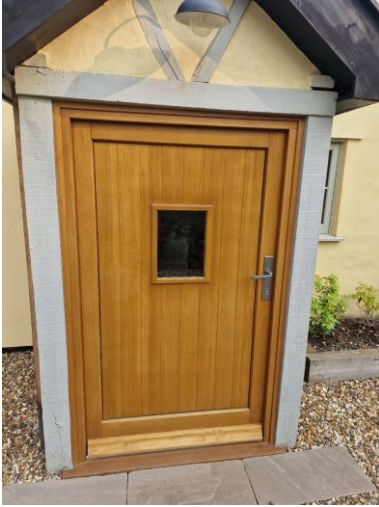
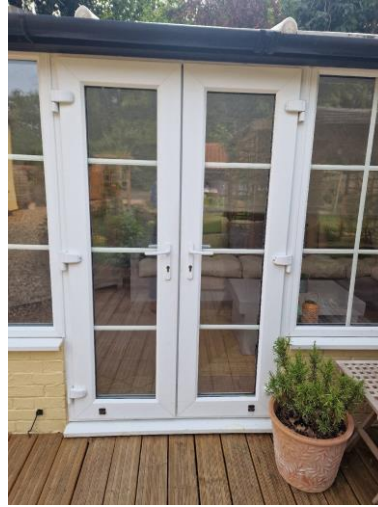
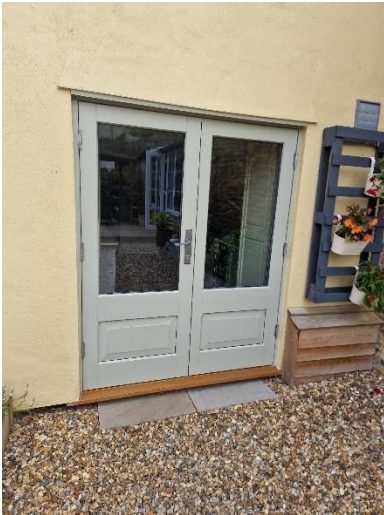
Doors open square to the eye with no signs of any significant movement or distortion noted.

We recommend you change all locks upon occupation to enhance security.

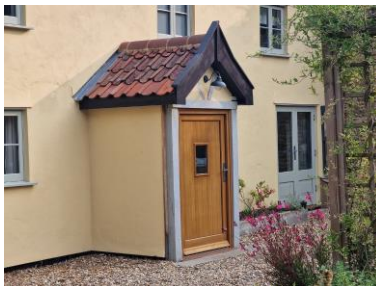
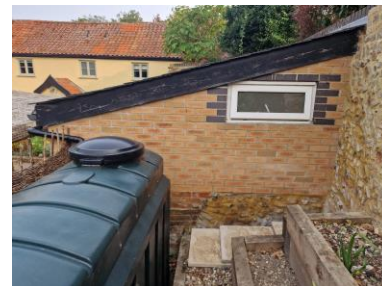
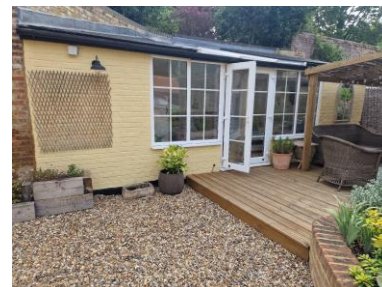
D7 Conservatory and porches

There is a timber-built porch constructed beneath a tiled roof structure, which was in good condition.

The porch is a later addition to the property and given the overall size of the structure, together with the presence of a fixed door to the main dwelling, Local Authority consents and Building Regulations approval are not thought to have been required for the construction.

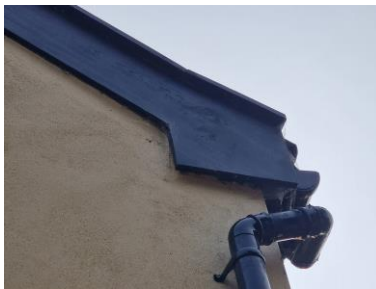
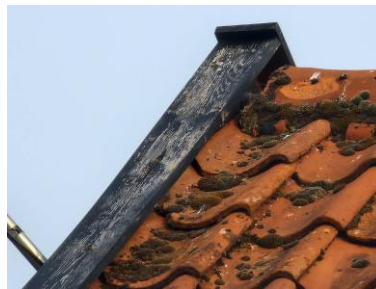
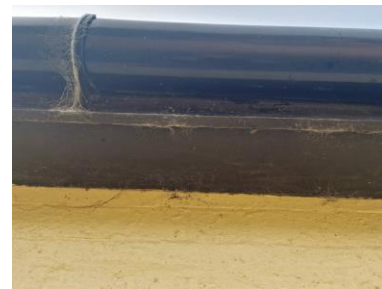
The external decorations are deteriorated in sections and new decoration in reasonable course is required. This should include thorough preparation of the timber by removing all loose and flaking decorative finishes before priming the bare surfaces and re-applying appropriate decorative coatings. Much of this work will be undertaken at height and it is therefore recommended that you obtain quotations for this prior to purchase.

Please note, a closer inspection of the timber may reveal some concealed deterioration and you should expect that localised repairs may be necessary prior to redecoration.

Seek quotations to repair/redecorate external joinery items

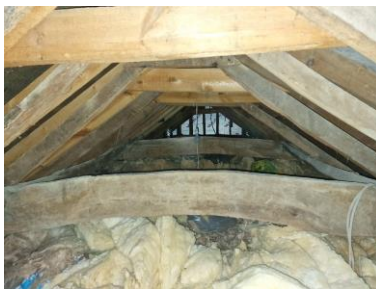
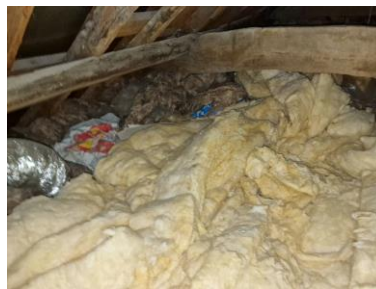
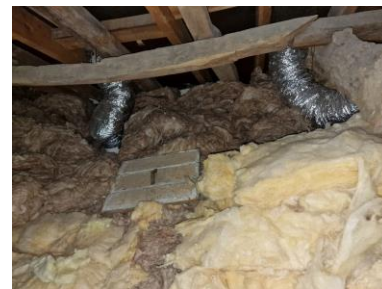
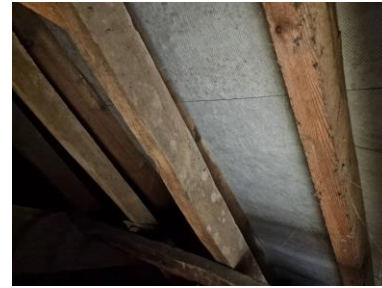
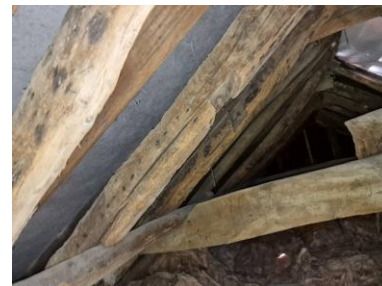
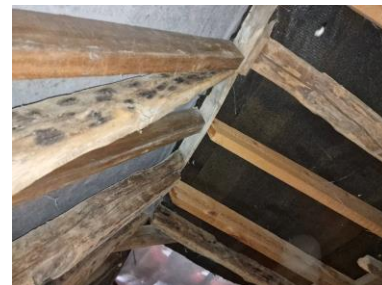
Insulation is provided to a depth of 300mm, which appears to comply with current standards.

In places, electrical wiring is present beneath the loft insulation. This can cause overheating and in extreme cases lead to fires. All covered cables must be re-positioned on top of the insulation, and this should be assessed as part of a specialist Electrical test. Please see also section G1 of this report.

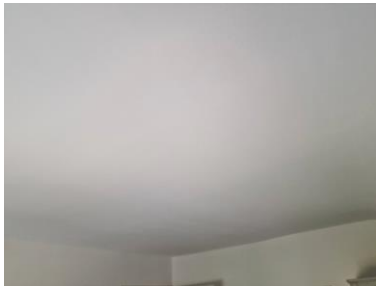
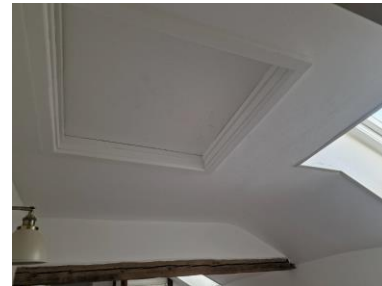
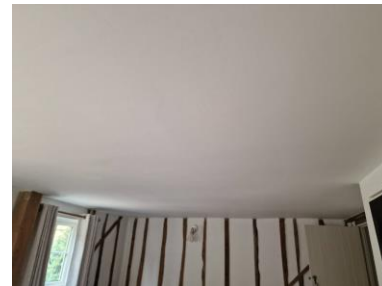
Minor irregularities and shrinkage cracks are present, but these are not unusual for this type and age of property. Cosmetic works upon redecoration will be required.

Cracks along the lines of plasterboard joints are not unusual. These cracks are not structurally significant and can be filled prior to redecoration.

Seek quotations for repairs to ceilings

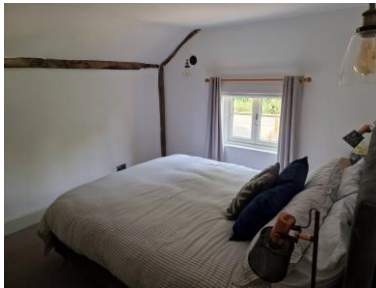
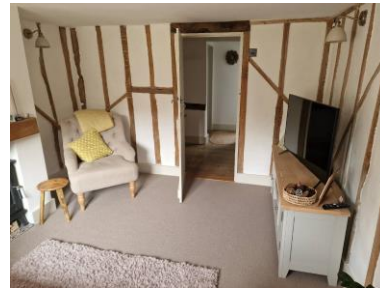
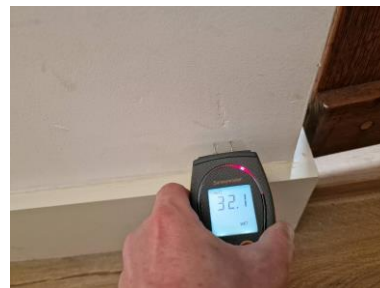
Moisture content readings were taken throughout the ground floor walls with an electronic damp meter and dampness was noted to the wall adjacent to front door, rear kitchen wall, under stairs and ground floor bedroom, evidencing the absence of a damp-proof course. As discussed in section D4, this is not unusual in a property of this type, and remedial measure are not recommended.

Please be aware that older properties are likely to suffer a degree of dampness, and you will have to decide on what level of dampness you are prepared to accept before proceeding.

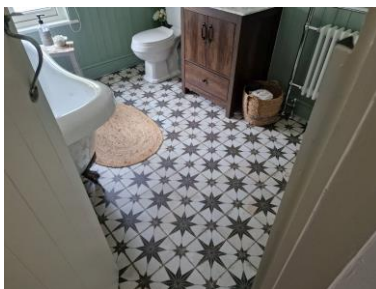
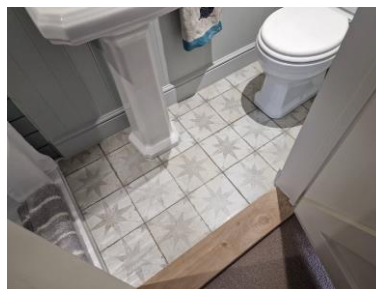
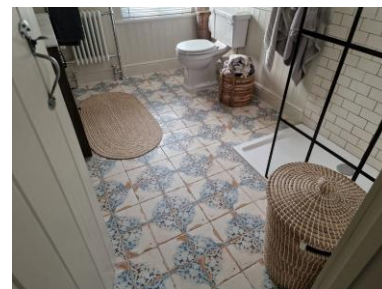
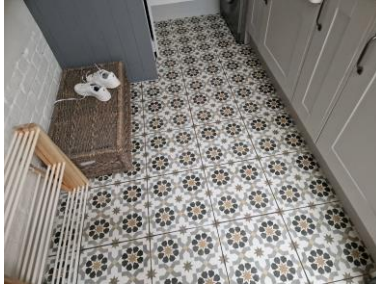
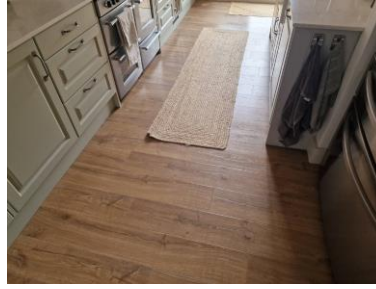
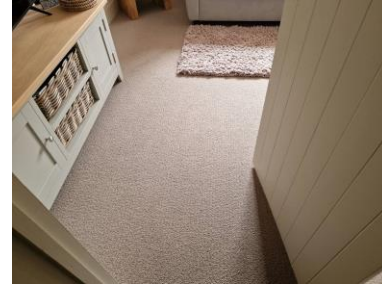
Ceramic tiles have been laid in the upstairs bathrooms. These tiles are currently in a sound condition, but it must be recognised that they are inherently brittle and can become cracked when laid on timber flooring due to the natural springiness of the floor construction. Future defects may occur, and you may wish to replace these coverings with a more suitable finish in the long-term.

The flooring beneath the sanitary fittings could not be inspected as this would involve damaging investigations which are beyond the scope of a normal survey. If there has been leakage, such as from concealed pipework or through gaps in wall tiles, or around the showers, dampness may have caused serious rot in the floor. We found no evidence of timber decay, but further investigations would be necessary to establish whether any defects exist. If such work is to be undertaken, there will be some resultant damage and appropriate contractors should be appointed to undertake this work, with the vendor's permission, so that any replacement of panelling or flooring can be carefully undertaken.

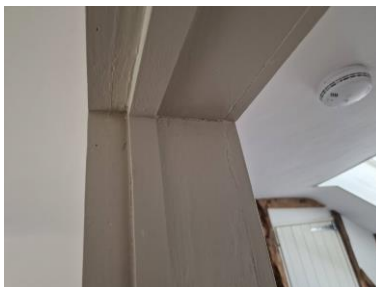
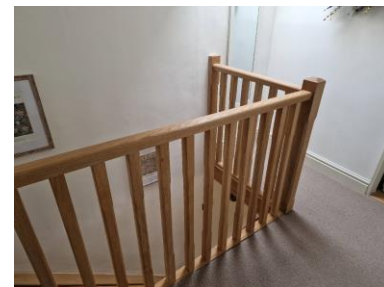
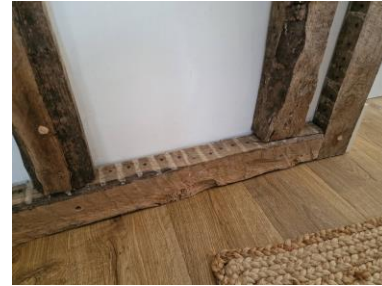
Banisters and balustrading appear to be complete with no signs of any defect noted. The gaps between spindles are 100mm or less which will comply with current Building Regulation standards.

There is evidence of wood-boring insect infestation to the internal timber frame and whilst there were no signs of recent activity, you should confirm whether previous treatments have been carried out and if so, whether guarantees can be transferred under the sale.

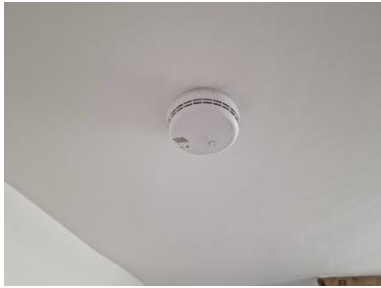
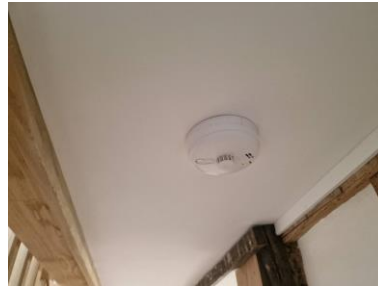
Where there is an oil-fired boiler, carbon monoxide alarms should be installed adjacent to the appliance in line with the alarm manufacturer's guidelines as a matter of urgency.

Buildings insurance cover requirements for timber framed buildings are often more stringent than more modern properties and this can include the presence of fire extinguishers, regular testing of the electrical installations and spark arrestors or other modifications to multi-fuel burners and you should seek further advice prior to purchase.

Seek quotations to install carbon monoxide detectors adjacent to fuel-burning appliances

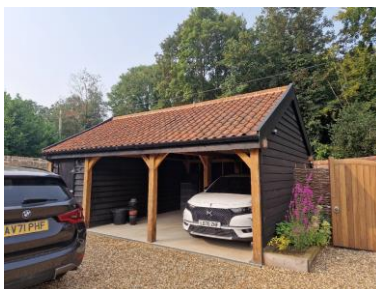
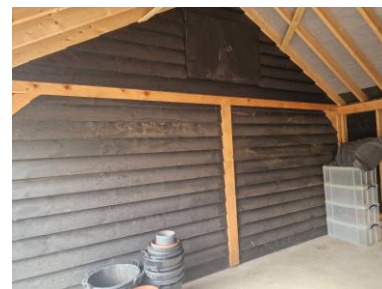
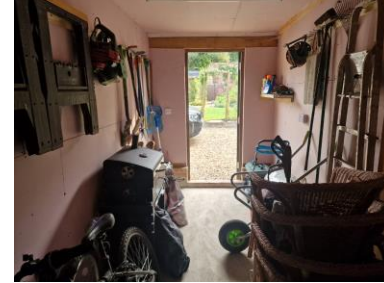
2 loose bricks were noted to the cupboard threshold, and you may wish to obtain quotations for repair prior to purchase.

The electrical services to the carport should be tested by a qualified electrician alongside the electrics to the property. Please see also section F1 of this report.

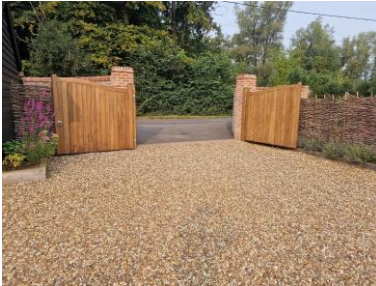
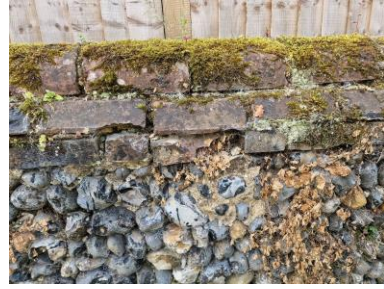
The timber boundaries to the rear are leaning somewhat. This will require repair in the long-term and you should seek quotations for this prior to purchase.

Where there are boundary walls, these features will require high levels of maintenance and the rear flint dwarf wall is currently suffering from deterioration, evidenced by the deteriorated and missing brick and flint work. You should seek quotations for repairs prior to commitment to purchase in order to budget accordingly, as these works may be costly.
