**RICS HOME SURVEY
LEVEL 3**

DATE OF INSPECTION:

Thursday 17 October 2024

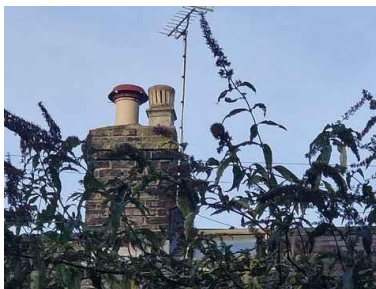
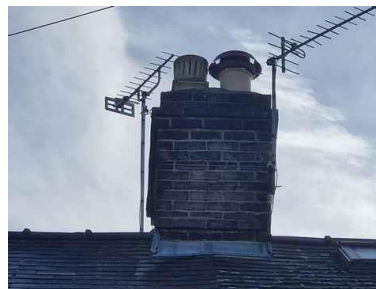
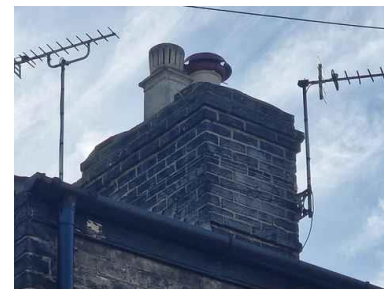
The chimney stack appeared to be straight to the eye with no signs of any significant bulging, lean or outward movement noted.

There is 1 visible chimney pot that appears to be straight to the eye with no signs of visible damage. Flaunching to the chimney pot could not be seen. These should be periodically inspected to ensure that the chimney pots or flues remain adequately bedded.

Lichen and moss should be cleared from the top courses periodically to prevent early deterioration of brickwork pointing. The level of moss growth is not significant at this time. Please

The soakers [under flashings] that provide watertightness between the chimney stack edge and the roof are concealed and could not be viewed. However, there is no evidence of internal leakage at these positions to suggest that they are defective.

A TV aerial is attached to the stack although we cannot confirm whether the fixings are adequate for their purpose and regular inspections during routine maintenance should be undertaken.

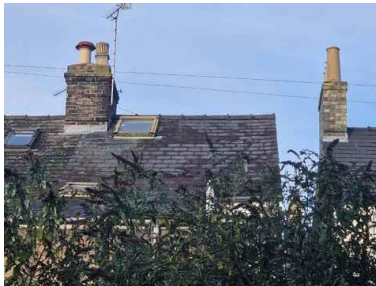
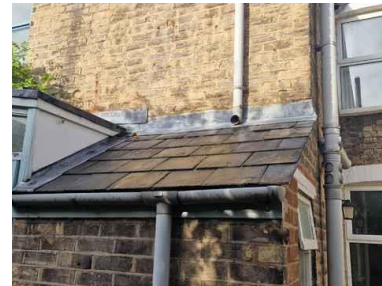
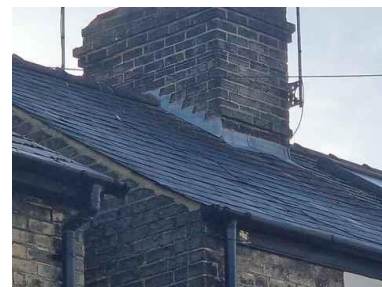
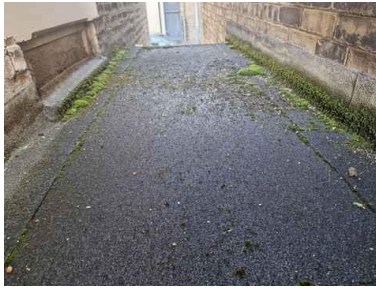
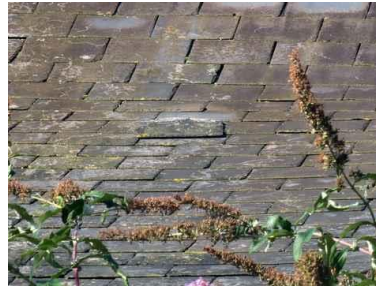
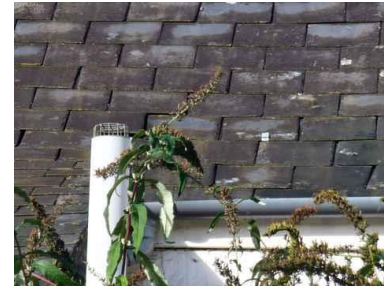
The roofline appears to be level and within normal tolerances with no signs of any significant deflection or undulation noted, indicating that the roof structure is adequate for the current roof covering. See Section F1 regarding the roof structure.

We are pleased to report the roof coverings appear to be complete with no signs of any missing or covering noted. A slate appears to have been dislodged to the rear slope (above the bathroom) and it would be prudent to arrange for a precautionary inspection and obtain quotes for repair prior to purchase.

The slate covering is showing signs of ageing and deterioration, as a number of metal clips, known as tingles, are visible where slates have been re-fixed following previous slippage (e.g. see picture 4-front roof slope). This indicates that nails are rusting away and there is the potential for further slippages. We found no evidence of any further slippages or deterioration at the time of the inspection however the situation should be closely monitored and the need for sudden failures and ongoing repairs must be anticipated and accepted.

There is moss growth present on the roof slopes. This level of moss growth is not unusual on properties of this age and type. You should monitor the roof slopes especially where they are north facing or shaded by trees. At present no action is required. However, in the future if the growth becomes excessive then the moss should be cleaned off. Moss growth impedes the run-off of rainwater and leads to gutter blockage and can cause water penetration which may lead to rot or other defects in surrounding timbers.

There is no evidence of significant cracking or loosening of the mortar to the roof edge, but this should be checked periodically and repointed as necessary.

The flat roof coverings appear to be in a serviceable condition although it should be appreciated flat roofs can fail unexpectedly and regular maintenance should be completed to prolong the life of the coverings.

In addition, when the flat roof requires re-covering, the opportunity should also be taken to review and upgrade the levels of insulation and ventilation to the roof structure in an attempt to improve heat retention and guard against condensation occurring, which could damage timbers. Any decking found to be defective will need to be renewed at such a time.

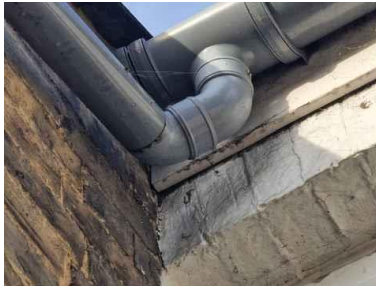
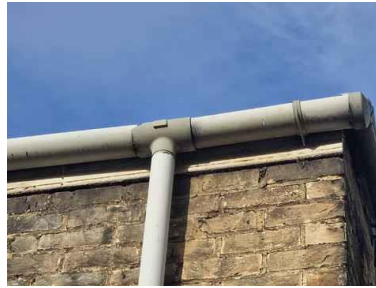
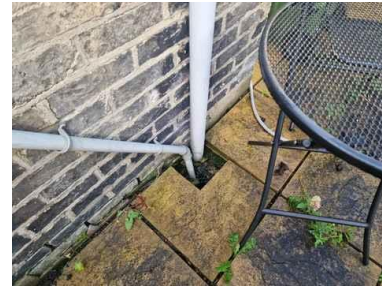
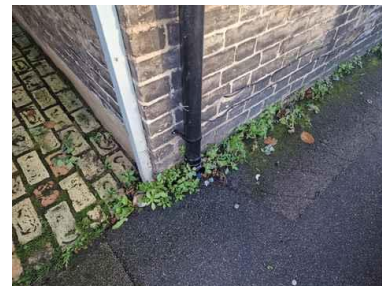
Please note it was not raining during the course of the inspection so we cannot confirm that rainwater goods are watertight at the joint sections. It is recommended that you inspect rainwater goods during a period of heavy rain in order to establish their effectiveness, with repairs addressed as found to be necessary.

You should ensure that the gutters are seasonally unblocked of moss and other debris.

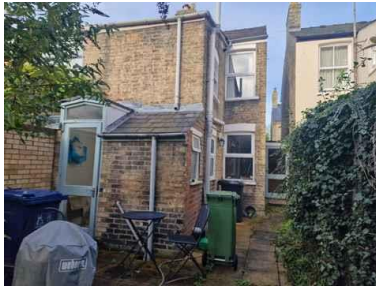
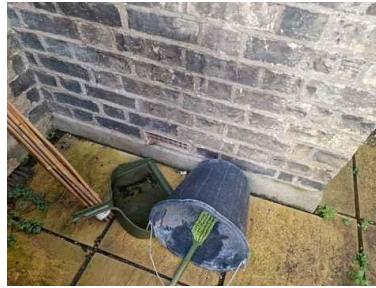
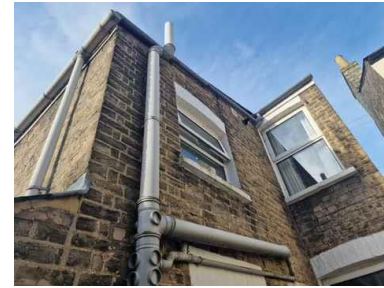
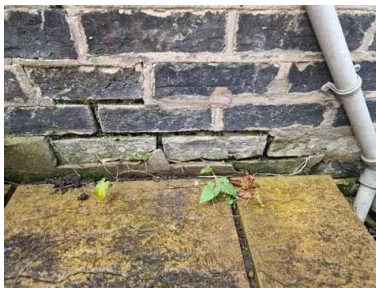
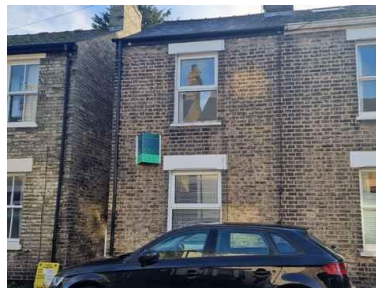
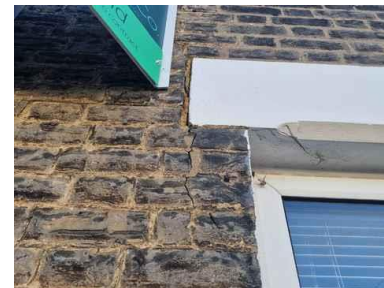
Areas of worn and missing pointing were identified to a number of locations including to the rear elevation (adjacent to the back door). Contractors should be instructed to provide quotations for raking out and repointing defective brickwork.

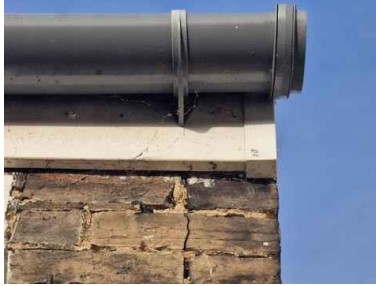
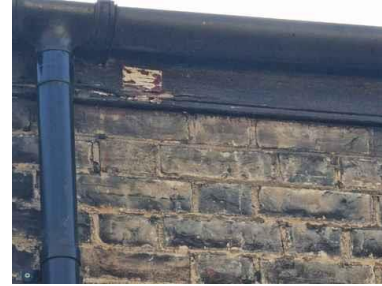
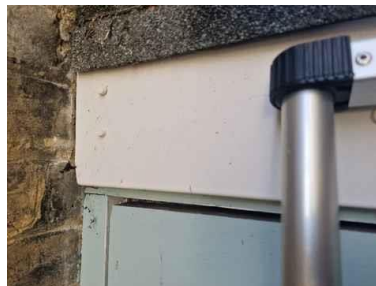
Please note, a closer inspection of the timber may reveal some concealed deterioration, and you should expect that localised repairs may be necessary prior to redecoration.

There is evidence of historic wood-boring insect infestation to the fascia board to the front of the porch. Your legal advisor should seek evidence of any previous treatments and associated guarantees.

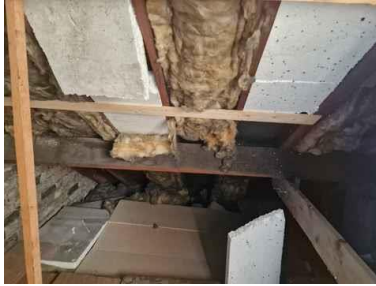
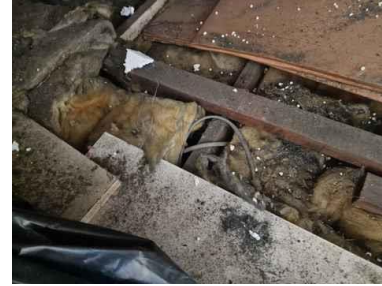
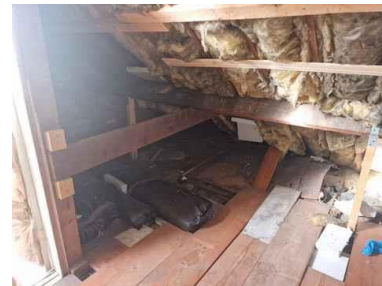
In places, electrical wiring is present beneath the loft insulation. This can cause overheating and in extreme cases lead to fires. All covered cables must be re-positioned on top of the insulation, and this should be assessed as part of a specialist Electrical test. Please see also section G1 of this report.

Velux windows have been installed within the rear roof slopes which would have required structural alterations to the original roof frame. These works should have been completed in accordance with Local Authority consents; legal advisers to confirm.

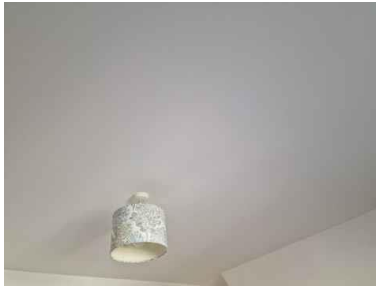
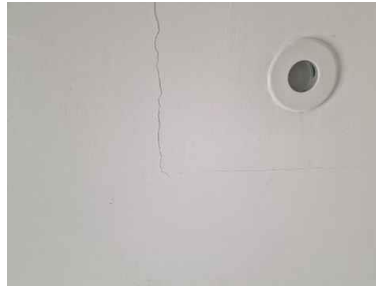
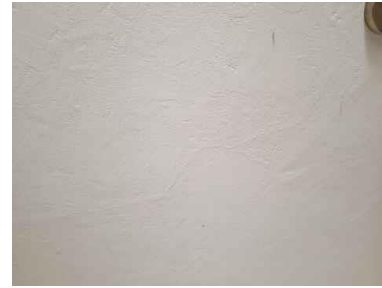
Minor irregularities and shrinkage cracks are present, but these are not unusual for this type and age of property. Cosmetic works upon redecoration will be required.

Cracks along the lines of plasterboard joints are not unusual. These cracks are not structurally significant and can be filled prior to redecoration.

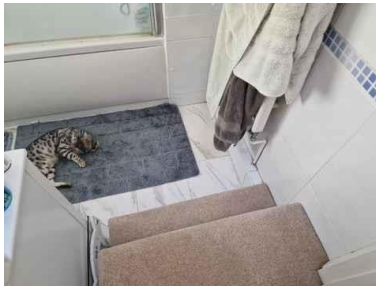
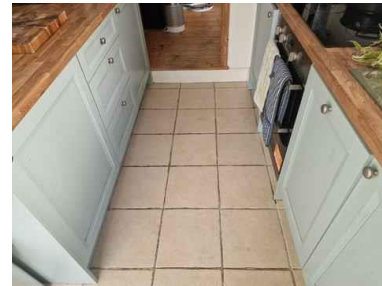
Ceramic tiles have been laid in the bathroom. These tiles are currently in a sound condition, but it must be recognised that they are inherently brittle and can become cracked when laid on timber flooring due to the natural springiness of the floor construction. Future defects may occur, and you may wish to replace these coverings with a more suitable finish in the long-term.

The flooring beneath the sanitary fittings could not be inspected as this would involve damaging investigations which are beyond the scope of a normal survey. If there has been leakage, such as from concealed pipework or through gaps in wall tiles, or around the bath, dampness may have caused serious rot in the floor. We found no evidence of timber decay, but further investigations would be necessary to establish whether any defects exist. If such work is to be undertaken, there will be some resultant damage and appropriate contractors should be appointed to undertake this work, with the vendor's permission, so that any replacement of panelling or flooring can be carefully undertaken.

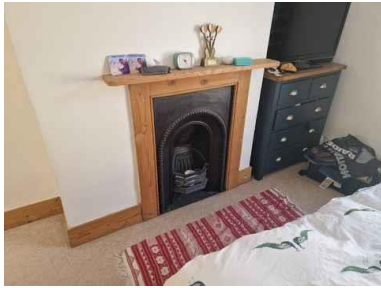
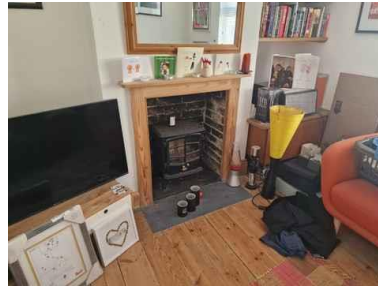
There is an open fireplace within the lounge.

The chimney breast appears sound. However, it was not possible within the limits of this report to inspect the flues in detail or to assess the internal condition of flues or flue liners and we can give no assurances as to the practicalities of using the fireplaces. Further contractor's advice will need to be sought in this regard should you wish to utilise the fireplaces.

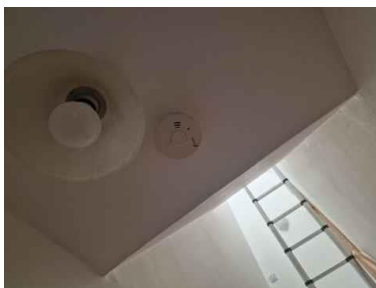
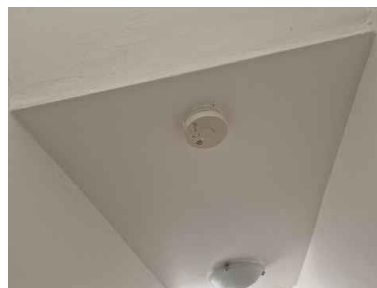
Carbon monoxide alarms should be provided in all rooms which house a fuel-burning appliance.

Where there is a gas-fired boiler, carbon monoxide alarms should be installed adjacent to the appliance in line with the alarm manufacturer's guidelines as a matter of urgency.

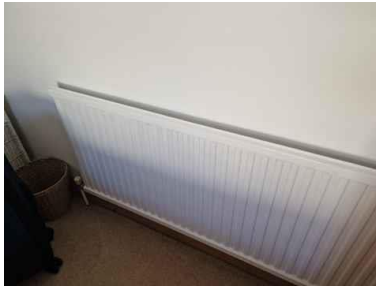
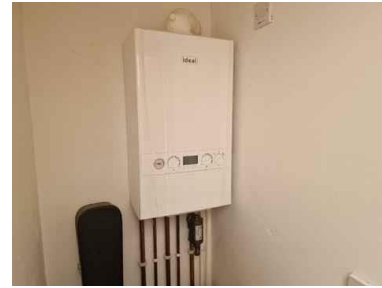
Given the age of the radiators they are likely to be inefficient compared to modern equivalents and you may wish to consider upgrading as part of the overall improvement of the property.

A significant amount of the central heating pipework is buried within the construction and whilst there were no signs of leakage, this can occur undetected beneath floor finishes, particularly if pipework is not adequately protected.
