**RICS HOME SURVEY  
LEVEL 2**

- SURVEY ONLY

Friday 18 October 2024

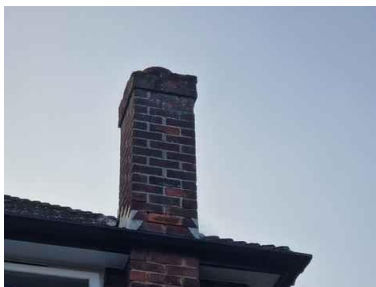
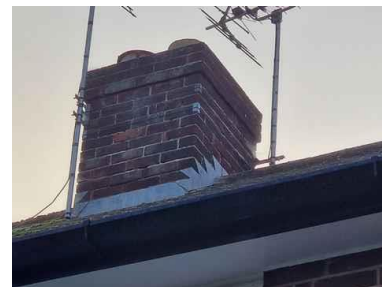
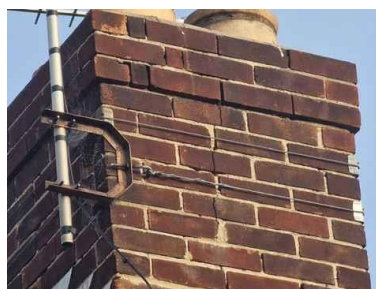
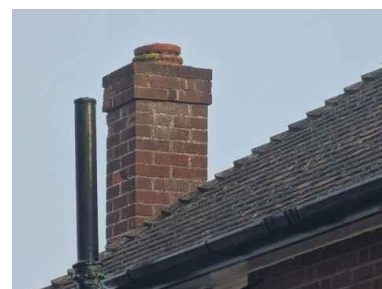
There is evidence of deteriorated mortar bedding to the front face of the front stack (for example).

A thermal movement crack was noted to be running vertically down the face of the front stack. This does not appear to be of structural significance but should be monitored for further movement and re-pointed during future maintenance in order to prevent water ingress. You may wish to have the cracked bricks cut out and replaced for aesthetic purposes. It would be prudent to obtain quotes for these works prior to purchase in order to budget accordingly.

Some masonry has deteriorated to the top of the rear stack due to freeze/thaw action commonly referred to as 'spalling'. Spalling occurs when brickwork becomes wet due to rain. If freezing conditions occur before the bricks dry out, the entrapped moisture expands and forces off the hard face of the brick, so exposing the softer inner core.

Whilst repairs are not urgently required, it is recommended that you obtain quotations for future repointing works through a reputable roofing contractor prior to purchase, to budget accordingly.

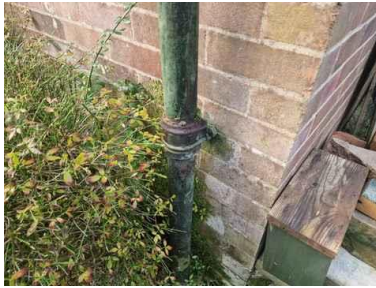
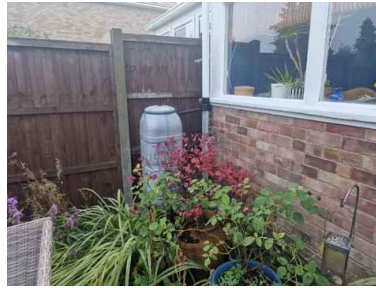
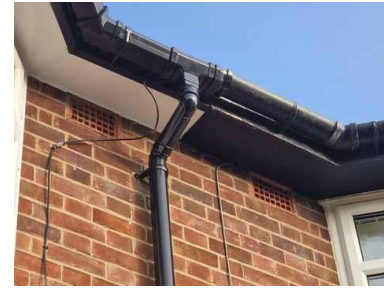
Please note it was not raining during the course of the inspection so we cannot confirm that rainwater goods are watertight at the joint sections. It is recommended that you inspect rainwater goods during a period of heavy rain in order to establish their effectiveness, with repairs addressed as found to be necessary.

You should ensure that the gutters are seasonally unblocked of moss and other debris.

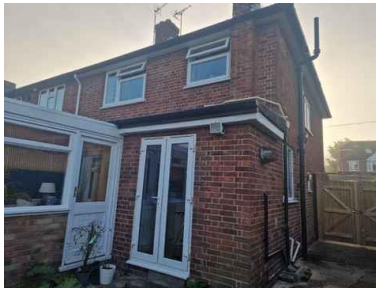
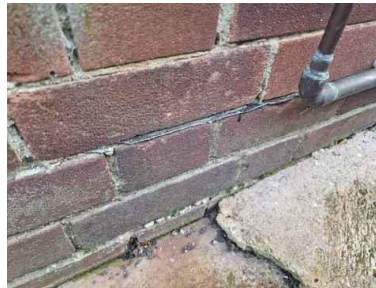
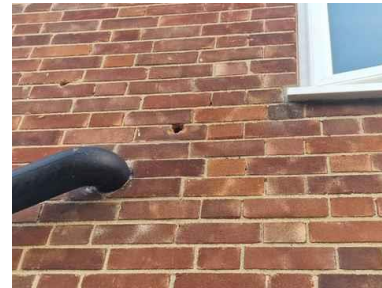
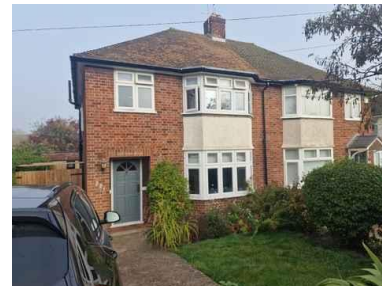
There are holes around penetrations in the side elevation wall. Any holes should be repaired and filled in the short term to prevent damp or debris entering the wall.

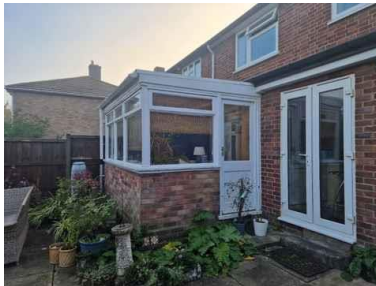
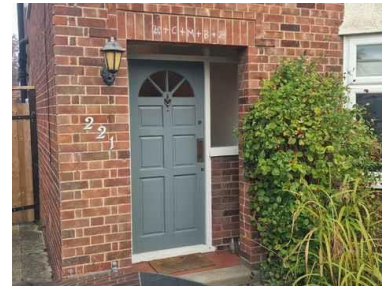
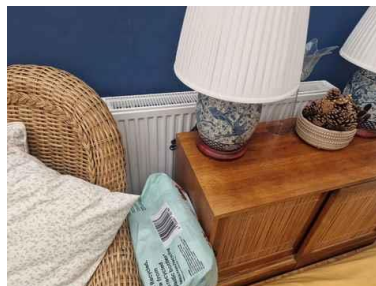
There is a small integral storm canopy to the front of the property that is set beneath the first-floor accommodation, to which no significant defects were noted.

You may wish to obtain quotes for the replacement of the timber sections of the conservatory with modern uPVC equivalents. This would bring the conservatory up to modern standards and make it a more thermally efficient area.

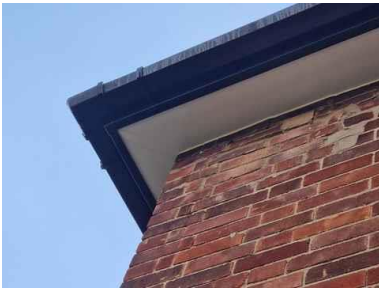
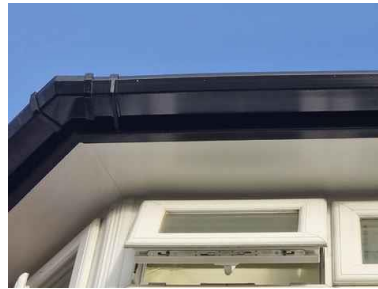
Where these uPVC replacement boards have been provided, it is not possible to determine whether they are fixed directly on top of any original decaying joinery. It is not possible to comment on any concealed section of woodwork which can only be examined by the removal of the uPVC covering.

Given the age of the property materials containing asbestos may be concealed beneath the PVC although we are unable to confirm this, and care should be taken during future maintenance.

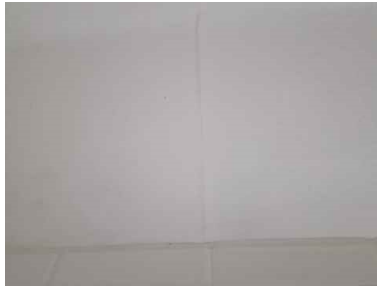
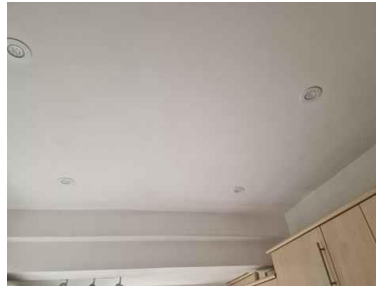
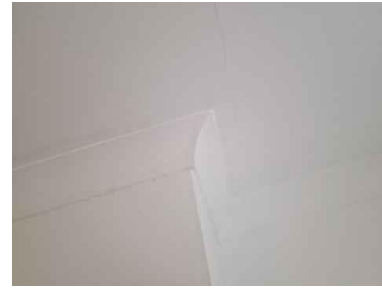
Minor irregularities and shrinkage cracks are present, but these are not unusual for this type and age of property. Cosmetic works upon redecoration will be required.

Cracks along the lines of plasterboard joints are not unusual. These cracks are not structurally significant and can be filled prior to redecoration.

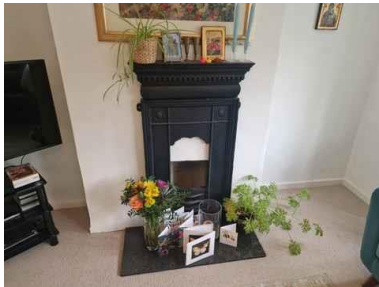
There is an open fireplace within the lounge.

The chimney breast appears sound. However, it was not possible within the limits of this report to inspect the flues in detail or to assess the internal condition of flues or flue liners and we can give no assurances as to the practicalities of using the fireplaces. Further contractor's advice will need to be sought in this regard should you wish to utilise the fireplaces.

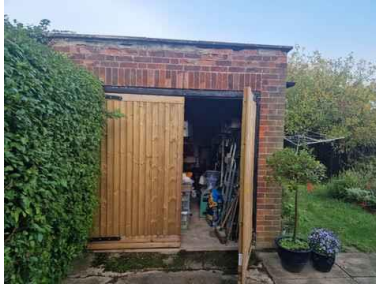
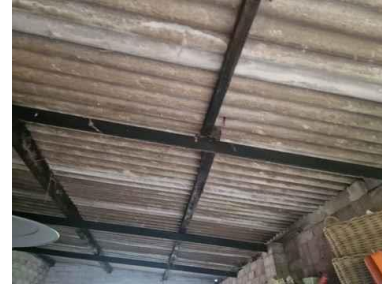
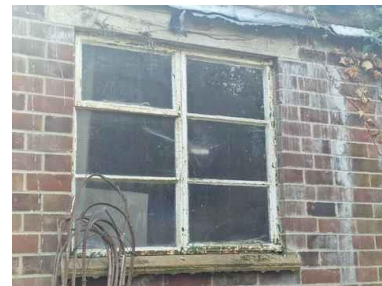
The glazing to the garage does not appear to be toughened glass and this will be hazardous for occupants. Depending on your intended use; you should have the glazing replaced with toughened glass as a safety precaution.
