**RICS HOME SURVEY
LEVEL 3**

DATE OF INSPECTION:

Thursday 10 October 2024

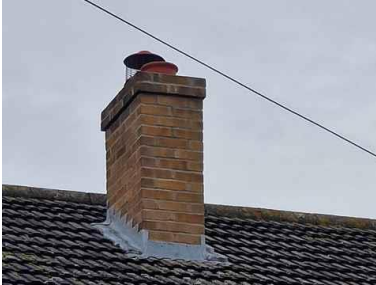
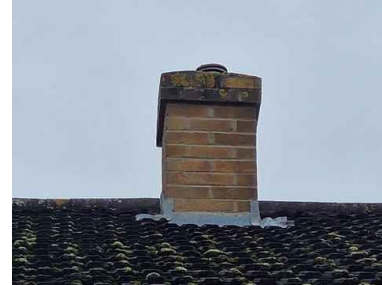
The chimney stacks appeared to be straight to the eye with no signs of any significant bulging, lean or outward movement noted.

Lichen and moss should be cleared from the top courses periodically to prevent early deterioration of brickwork pointing. The level of moss growth is not significant at this time. Please be aware, it may be necessary to repoint brickwork once moss has been cleared during future maintenance.

The soakers [under flashings] that provide watertightness between the chimney stack edge and the roof are concealed and could not be viewed. However, there is no evidence of internal leakage at these positions to suggest that they are defective.

A back gutter is formed at the rear of the stacks where the roof slopes meet the chimneys. This feature will require regular maintenance and can easily block resulting in damp penetration within

the roof void and regular maintenance should be undertaken. At the time of the inspection, we found no evidence of associated defect internally within the roof void.

Condition Rating: 1

Secure quotations to complete chimney repairs, to include the cost of any required scaffolding for access

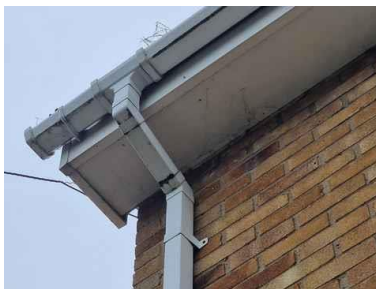
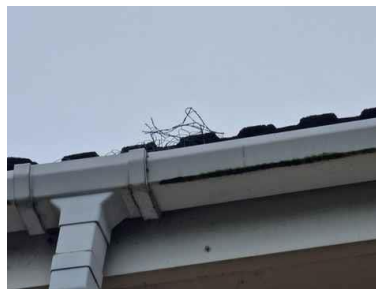
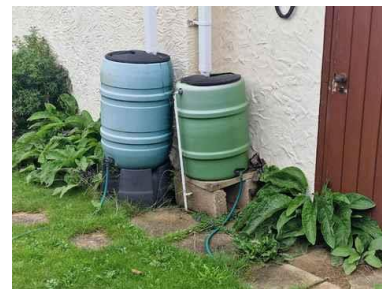
Please note it was not raining during the course of the inspection so we cannot confirm that rainwater goods are watertight at the joint sections. It is recommended that you inspect rainwater goods during a period of heavy rain in order to establish their effectiveness, with repairs addressed as found to be necessary.

Condition Rating: **3**

Secure quotations for repair or replacement of the rainwater fittings

You should ensure that the gutters are seasonally unblocked of moss and other debris.

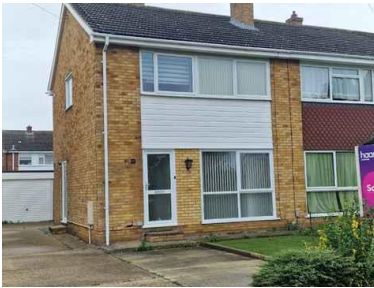
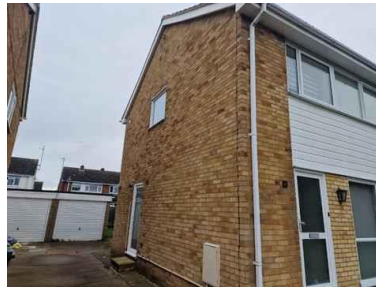
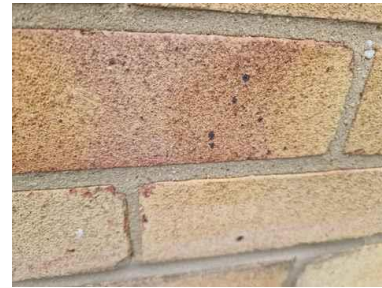
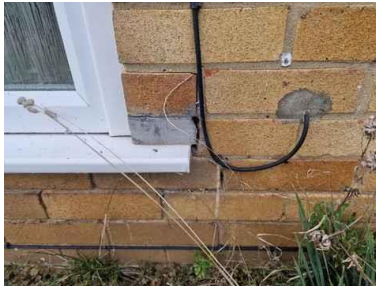
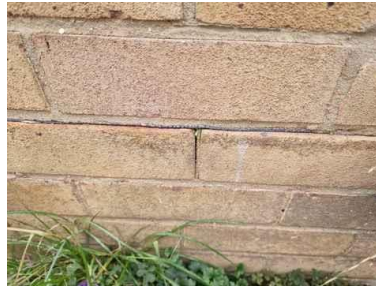
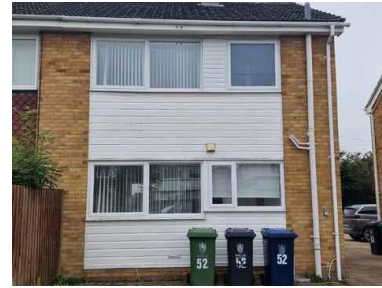
We found no evidence of any significant associated defect within the masonry at the time of the inspection; however, it must be appreciated that the risk remains, and you should regularly monitor the brickwork for changes.

Subsoils within the area may include shrinkable clay and these are subject to seasonal changes in ground conditions. You should maintain trees and shrubs close to the property in order that ground conditions remain as stable as possible.

Condition Rating: **2**

Seek quotations for repairs to the external walls

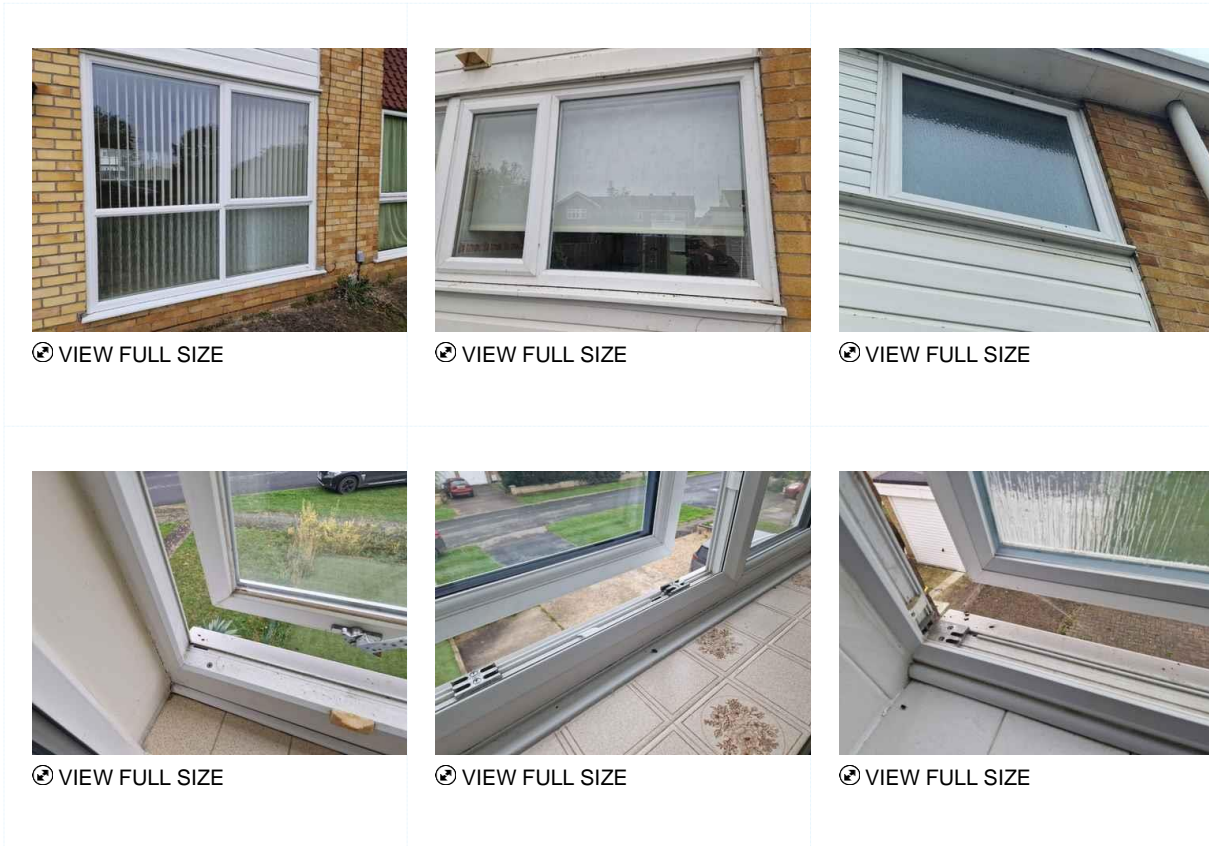
Toughened glazing appears to be present where required

Condition Rating: 2

Seek quotations for window repairs or replacement

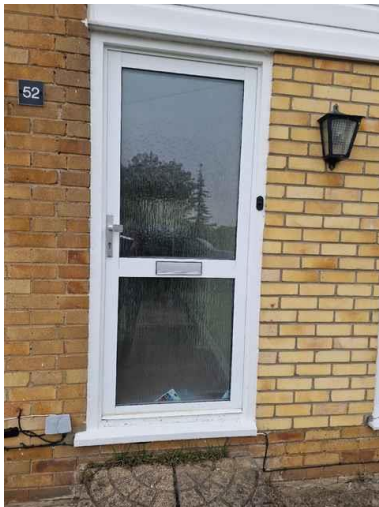
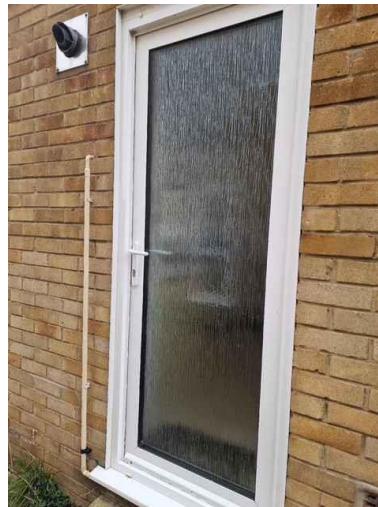
Doors open square to the eye with no signs of any significant movement or distortion noted.

Condition Rating: 3

Seek quotations for external door repairs or replacement

We recommend you change all locks upon occupation to enhance security.

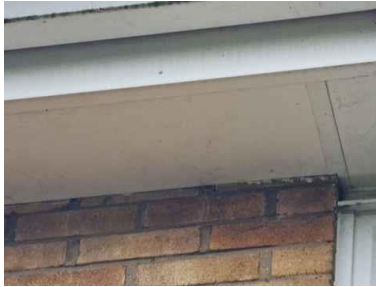
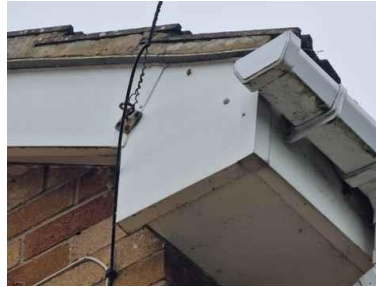
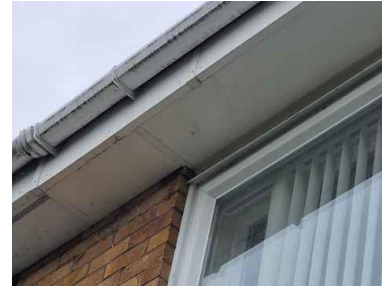
Where these uPVC replacement boards have been provided, it is not possible to determine whether they are fixed directly on top of any original decaying joinery. It is not possible to comment on any concealed section of woodwork which can only be examined by the removal of the uPVC covering.

Given the age of the property materials containing asbestos may be concealed beneath the PVC although we are unable to confirm this, and care should be taken during future maintenance.

Condition Rating: 1

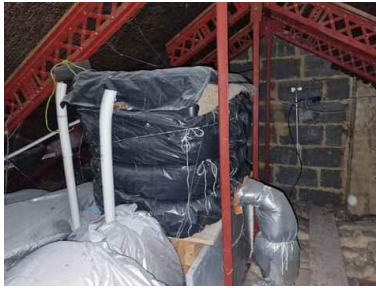
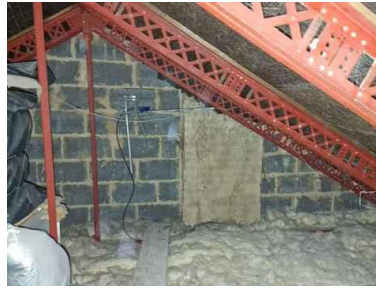
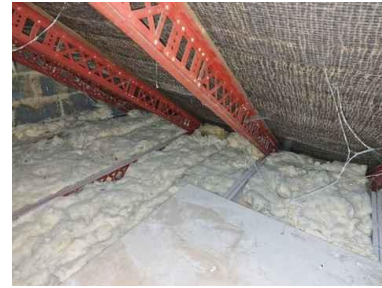
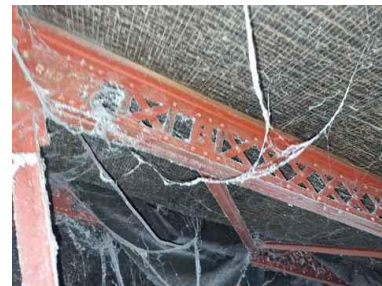
The cold-water storage tanks are of plastic construction and are adequately covered, supported and insulated, with overflow pipes extending to the exterior of the property.

A 'dry-ice' like material was present in the roof void which may indicate recent spray-foam removal and/or some kind of clean. Your legal advisor should seek confirmation of such works and any associated guarantees.

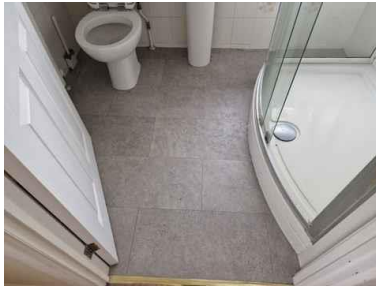
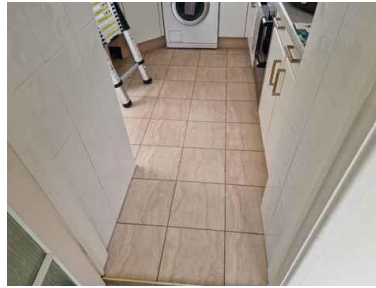
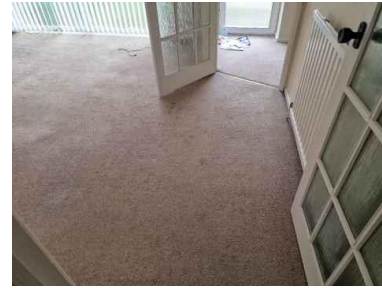
Where walked upon, suspended timber floor surfaces were found to be generally firm and even to the tread with no signs of excessive spring or distortion.

The flooring beneath the sanitary fittings could not be inspected as this would involve damaging investigations which are beyond the scope of a normal survey. If there has been leakage, such as from concealed pipework or through gaps in wall tiles, or around the shower, dampness may have caused serious rot in the floor. We found no evidence of timber decay, but further investigations would be necessary to establish whether any defects exist. If such work is to be undertaken, there will be some resultant damage and appropriate contractors should be appointed to undertake this work, with the vendor's permission, so that any replacement of panelling or flooring can be carefully undertaken.

Condition Rating: 1

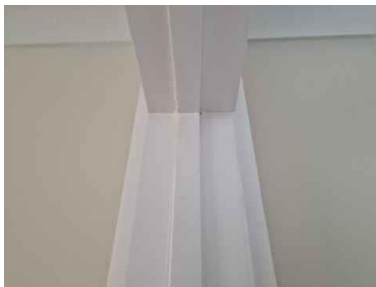
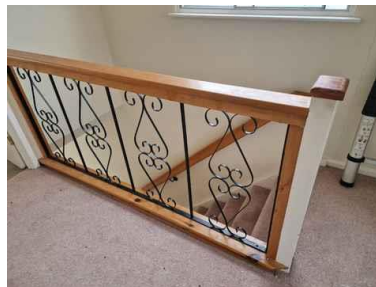
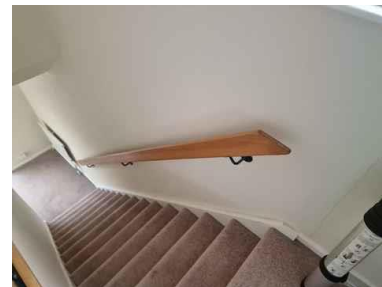
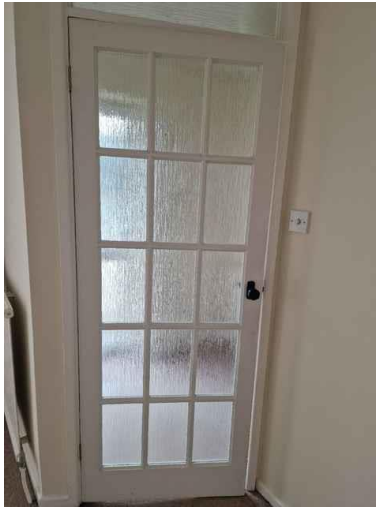
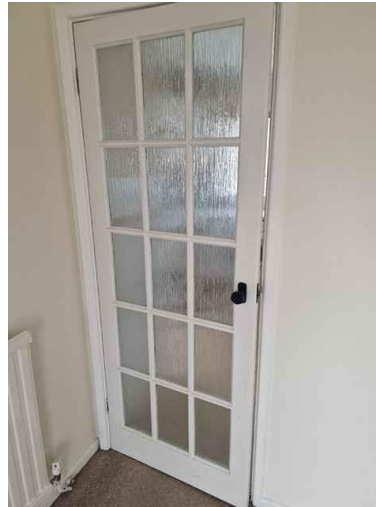
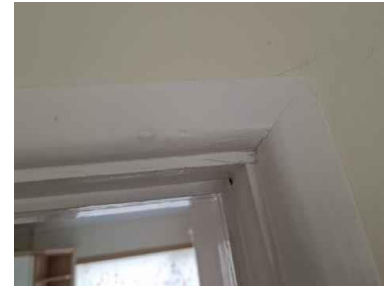
Current Building Regulation standards recommend a maximum gap of 100mm to banisters and balustrading within Part K – Protection from Falling, Collision and Impact of the current Building Regulations.

As the gaps to the banister rails are wider than the required maximum of 100mm, additional spindles or rails should be installed prior to taking occupation as the current arrangements are hazardous.

Condition Rating: **3**

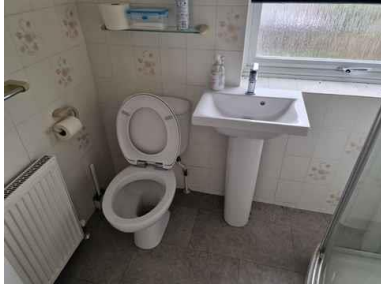
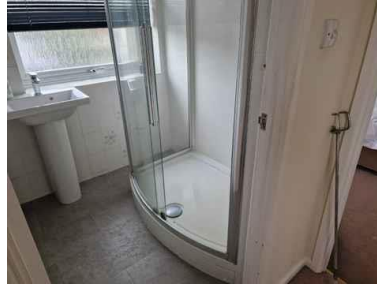
We noted the water pressure in the bathroom was rather weak. You should ask a plumbing contractor to inspect the system and advise on any necessary improvements such as installing a water pressure booster pump.

Condition Rating: **2**

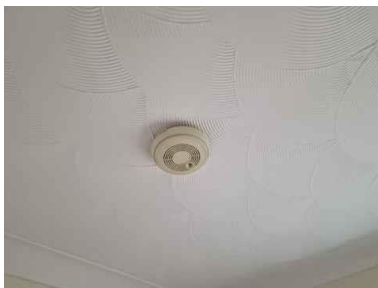
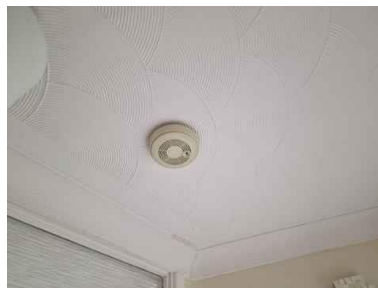
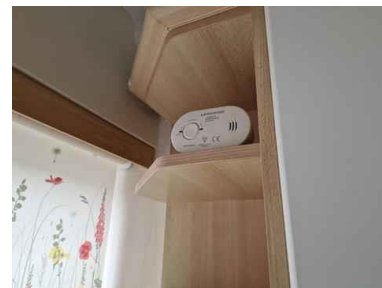
Carbon monoxide alarms should be provided in all rooms which house a fuel-burning appliance.

Where there is a gas-fired boiler, carbon monoxide alarms have been installed and should be maintained in line with the alarm manufacturer's guidelines.

Condition Rating: **3**

Seek quotations to replace the expired smoke detectors

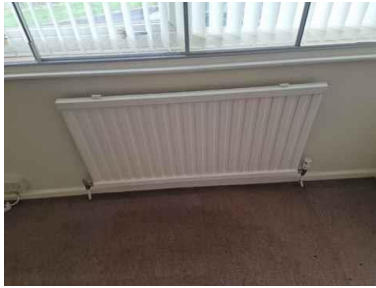
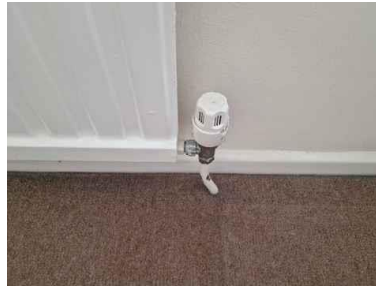
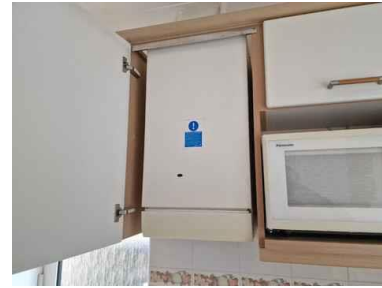
Thermostatic radiator valves (TRVs) should ideally be fitted to all radiators where absent. These can be fitted retrospectively to help improve energy efficiency as they allow for individual heat control over each unit.

A significant amount of the central heating pipework is buried within the construction and whilst there were no signs of leakage, this can occur undetected beneath floor finishes, particularly if pipework is not adequately protected.

Condition Rating: 3

Undertake a test of the dated boiler installation with quotations obtained for all required improvements, to include replacement if necessary, prior to purchase

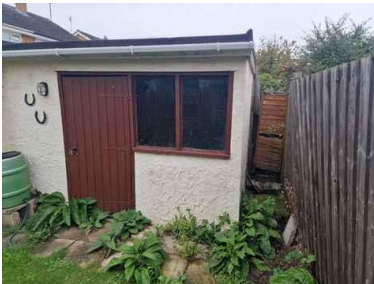
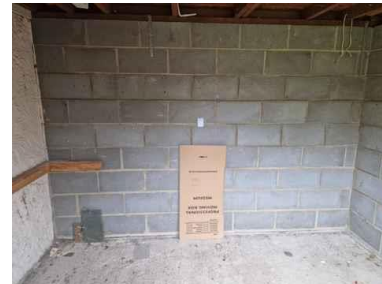
There is a block-built outbuilding to the rear which is constructed beneath a flat and felt covered roof.

There were no significant structural issues noted to the outbuilding at the time of the inspection.

Condition Rating: 2

Seek quotations for repairs/improvements to the garage
