**RICS HOME SURVEY
LEVEL 2**
- SURVEY ONLY

Wednesday 18 September 2024

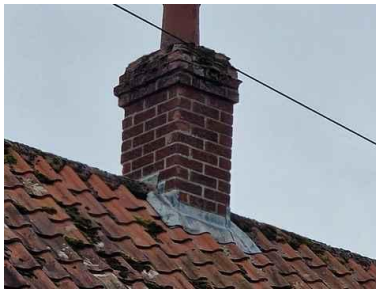
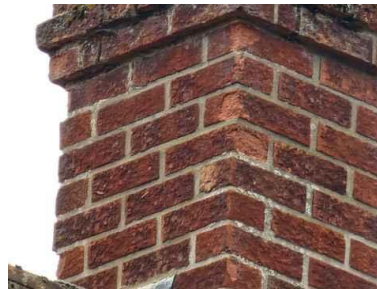
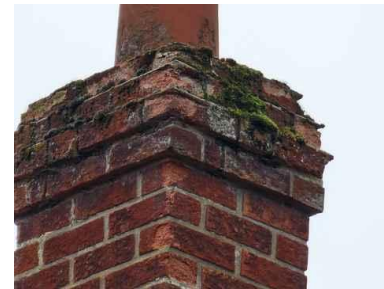
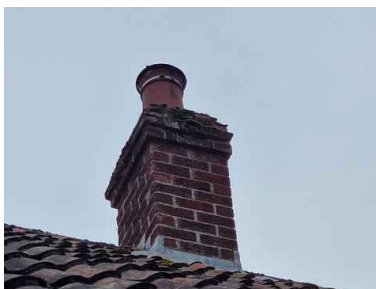
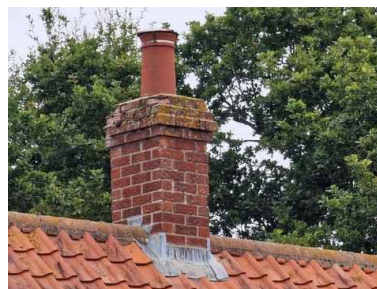
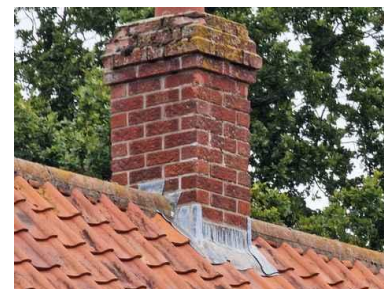
There is evidence of deteriorated mortar bedding to the top courses.

Some masonry has deteriorated to the stack due to freeze/thaw action commonly referred to as 'spalling'. Spalling occurs when brickwork becomes wet due to rain. If freezing conditions occur before the bricks dry out, the entrapped moisture expands and forces off the hard face of the brick, so exposing the softer inner core.

Whilst repairs are not urgently required, it is recommended that you obtain quotations for future repointing works through a reputable roofing contractor prior to purchase, to budget accordingly.

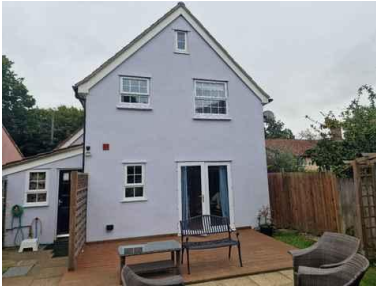
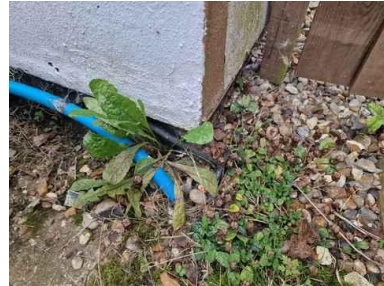
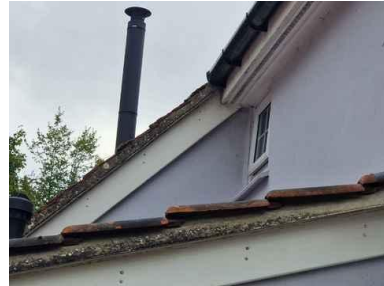
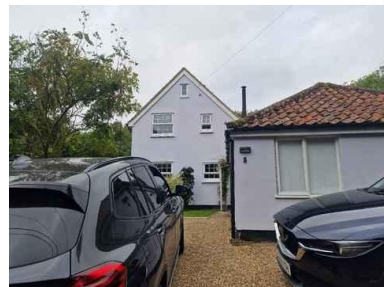
Minor thermal cracking was apparent to the left side elevation (for example). This often occurs with this type of construction where there are large expanses of masonry without a thermal break such as a window or door opening which offers some relief from thermal expansion and contraction of the structure. You should expect some minor ongoing movement may occur during your occupation and regular maintenance will need to be completed.

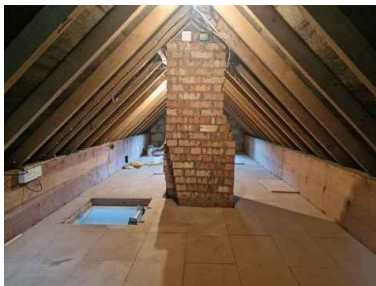
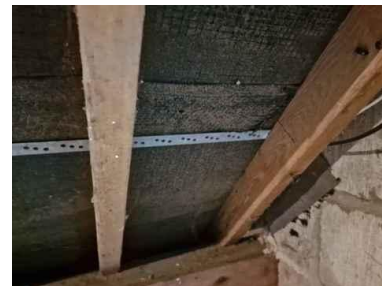
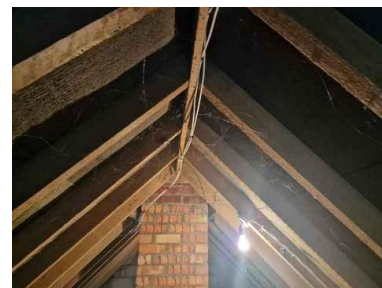
Where the insulation is concealed beneath the timber decking, given the overall thickness of the ceiling joists, the insulation is unlikely to comply with current standards within these areas and should be upgraded accordingly.

In places, electrical wiring is present beneath the loft insulation. This can cause overheating and in extreme cases lead to fires. All covered cables must be re-positioned on top of the insulation, and this should be assessed as part of a specialist Electrical test. Please see also section F1 of this report.

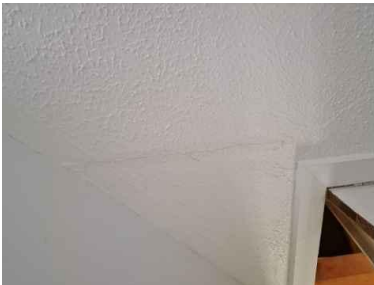
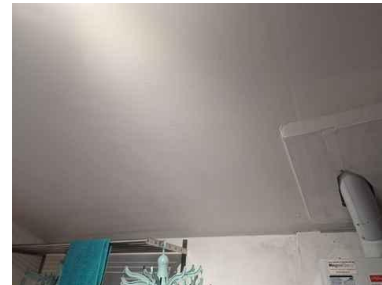
Minor irregularities and shrinkage cracks are present, but these are not unusual for this type and age of property. Cosmetic works upon redecoration will be required.

Cracks along the lines of plasterboard joints are not unusual. These cracks are not structurally significant and can be filled prior to redecoration.

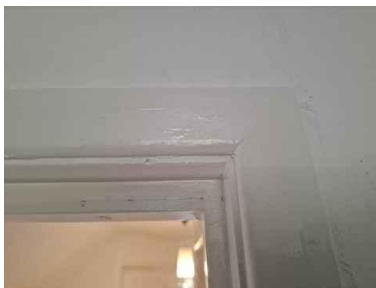
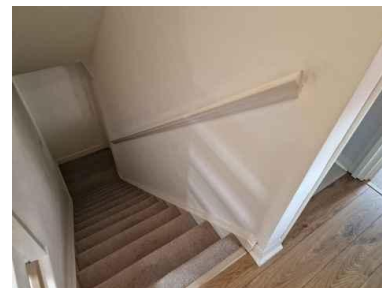
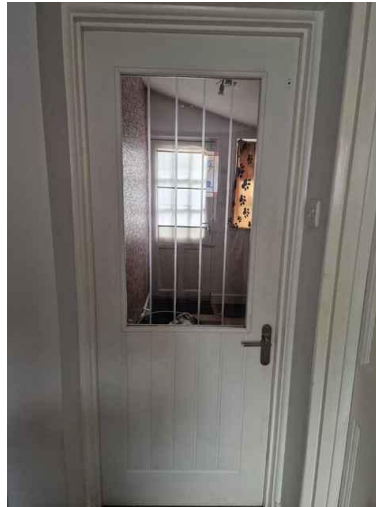
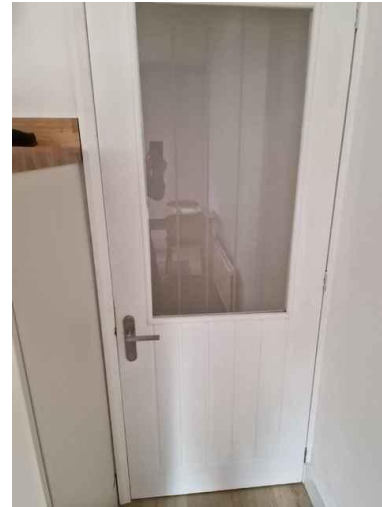
The banister rails have been constructed at horizontals which does not comply with current regulations as they are potentially climbable, and a particular hazard to young children. The banisters rails should be altered on taking occupation so that the railings are enclosed by boarding or replaced with uprights.

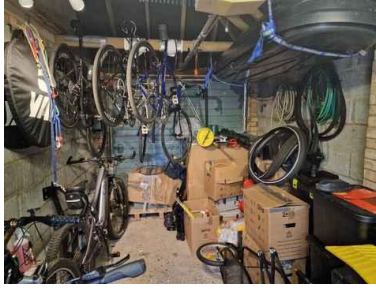
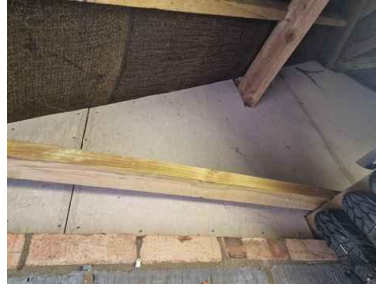
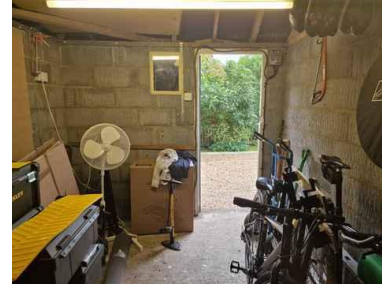
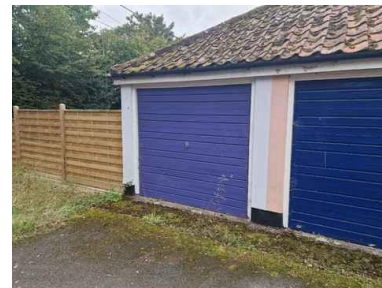
There is an up and over door that was not able to be due to the presence of stored items and you may wish to arrange for a precautionary inspection prior to purchase as replacement doors can be costly.
