RICS HOME SURVEY LEVEL 2

- SURVEY & VALUATION

DATE OF INSPECTION:

Friday 27 September 2024

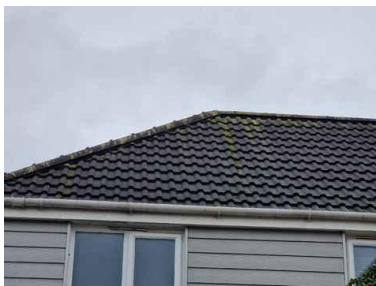
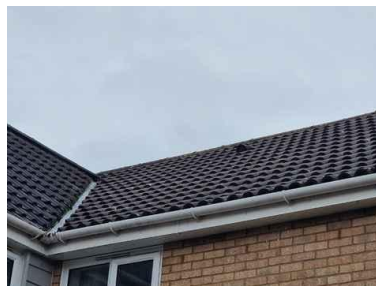
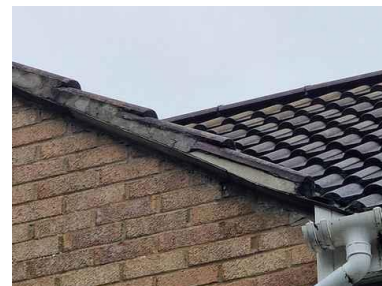
The roofline appears to be level and within normal tolerances with no signs of any significant deflection or undulation noted, indicating that the roof structure is adequate for the current roof covering. See Section E1 regarding the roof structure.

We are pleased to report the roof coverings appear to be complete with no signs of any slipped, missing or damaged covering noted.

There is moss growth present on the roof slopes. This level of moss growth is not unusual on properties of this age and type. You should monitor the roof slopes especially where they are north facing or shaded by trees. At present no action is required. However, in the future if the growth becomes excessive then the moss should be cleaned off. Moss growth impedes the run-off of rainwater and leads to gutter blockage and can cause water penetration which may lead to rot or other defects in surrounding timbers.

The valleys are formed in lead and appear to be in a satisfactory condition where viewed from ground level. Moss should be cleared from within the valleys periodically to prevent overspill. Valley gutters can fail unexpectedly, and regular maintenance is necessary. Even valley gutters that are in sound condition can quickly become blocked by leaves, snow, or ice, causing water levels to rise above the edges of the joints and so seep into the fabric of the building. It should be noted that maintenance and repair costs, when needed, tend to be expensive, and you may therefore wish to arrange for a precautionary up-close inspection prior to purchase.

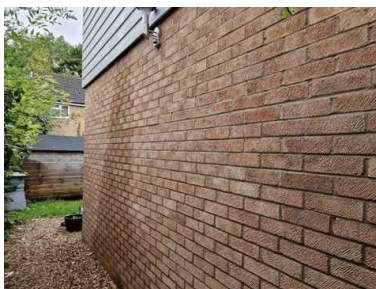
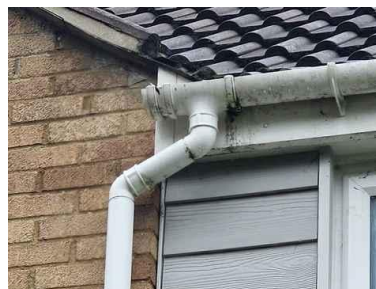
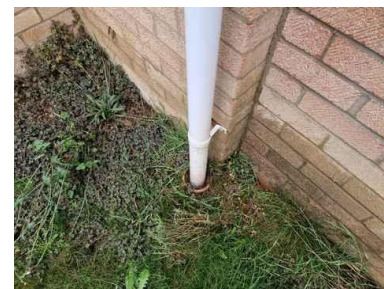
The guttering to the front and side is currently blocked and should be cleared at the earliest opportunity. This has caused splashback to the side wall for example and if allowed to continue can eventually lead to damp penetration.

You should introduce a new cover at the base of the rear rainwater pipe to prevent debris entering the underground drainage installation. The current cover has a broken seal.

You should ensure that the gutters are seasonally unblocked of moss and other debris.

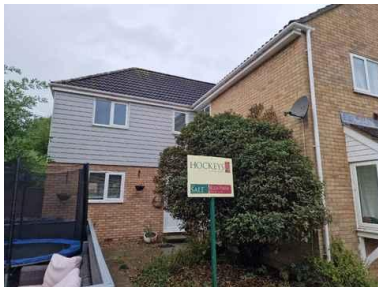
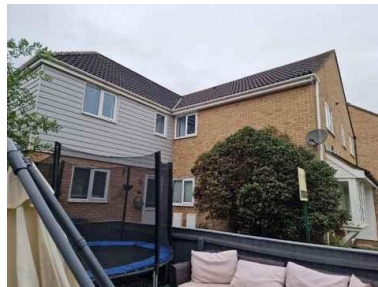
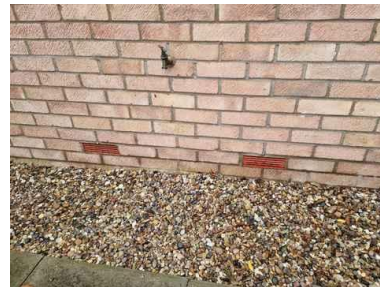
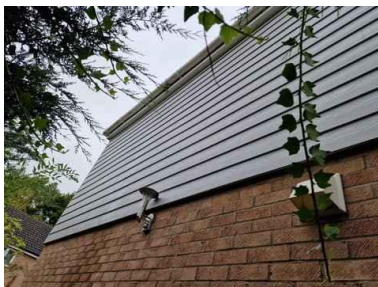
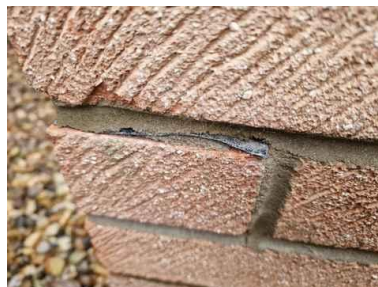
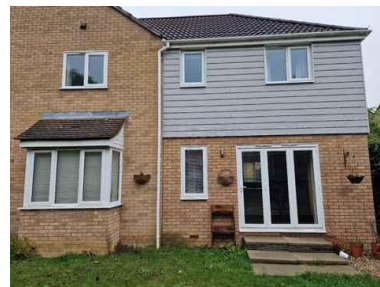
We are pleased to report we saw no evidence of any significant cracks or bulges to indicate any failure or uneven loading with the foundations or structure of the subject property at this time.

Mortar joints to the brickwork were found to be in an overall serviceable condition with no requirement for repointing attention.

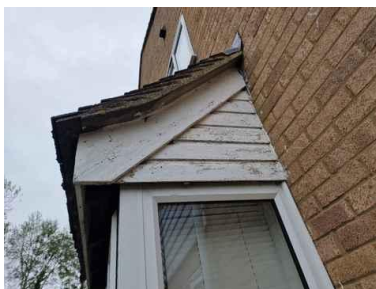
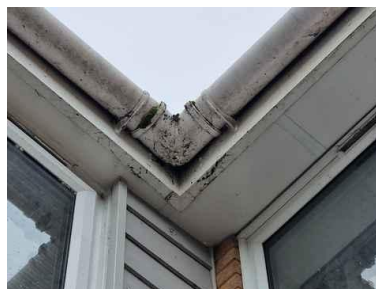
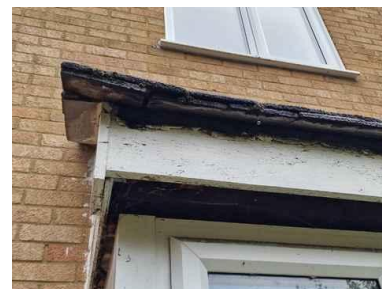
The external timber decorations are deteriorated and new decoration in reasonable course is required. This should include thorough preparation of the timber by removing all loose and flaking decorative finishes before priming the bare surfaces and re-applying appropriate decorative coatings. Much of this work will be undertaken at height and it is therefore recommended that you obtain quotations for this prior to purchase.

Please note, a closer inspection of the timber may reveal some concealed deterioration and you should expect that localised repairs may be necessary prior to redecoration.

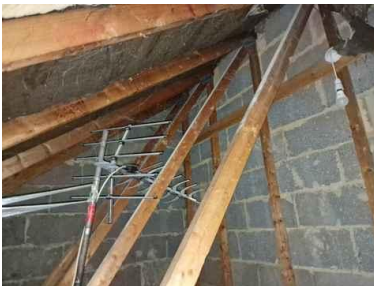
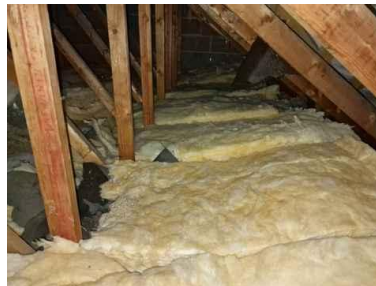
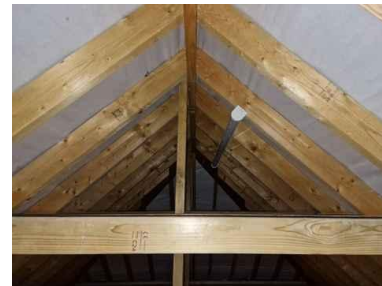
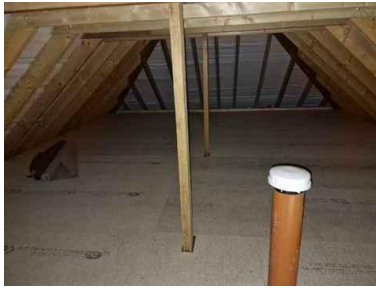
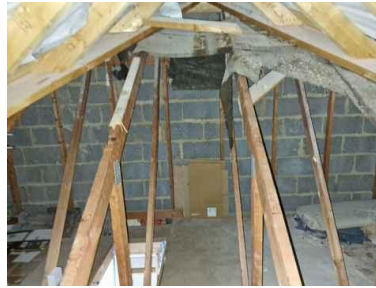
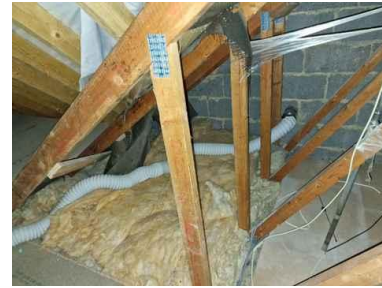
Insulation is provided to a depth of 300mm, which appears to comply with current standards.

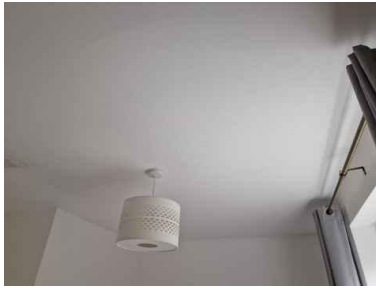
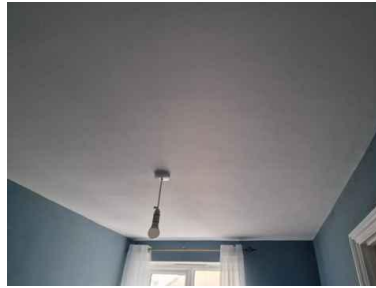
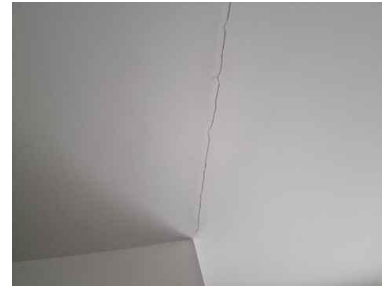
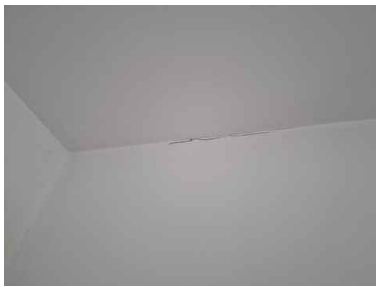
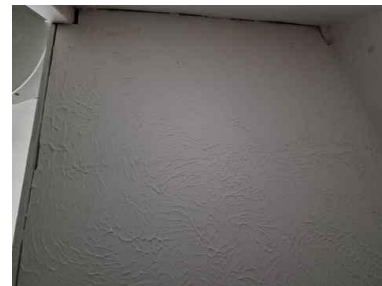
Minor irregularities and shrinkage cracks are present, but these are not unusual for this type and age of property. Cosmetic works upon redecoration will be required.

Cracks along the lines of plasterboard joints are not unusual. These cracks are not structurally significant and can be filled prior to redecoration.

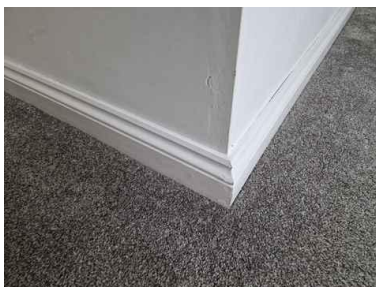
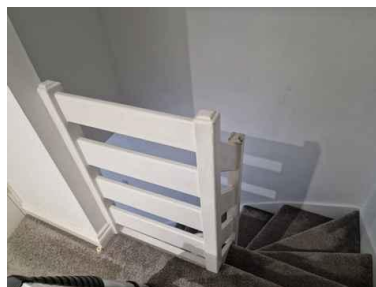
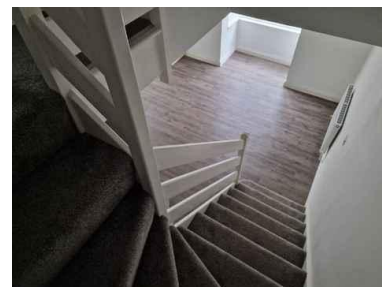
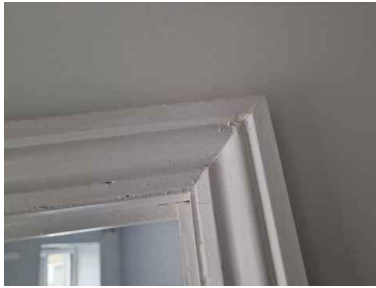
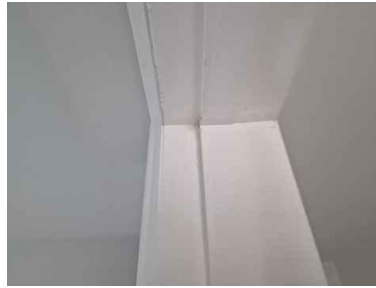
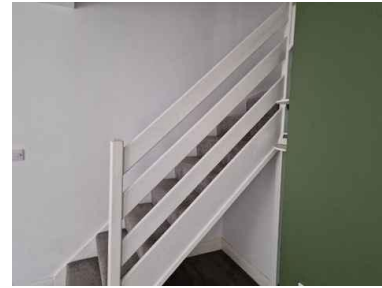
There is a satisfactory handrail to the staircase.

The banister rails have been constructed at horizontals which does not comply with current regulations as they are potentially climbable, and a particular hazard to young children. The banisters rails should be altered on taking occupation so that the railings are enclosed by boarding or replaced with uprights.

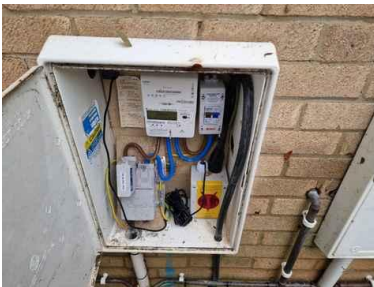
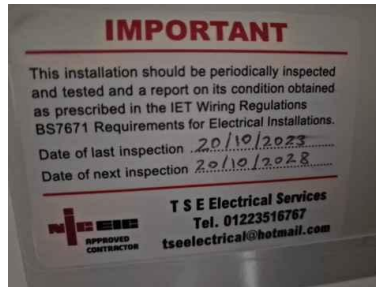
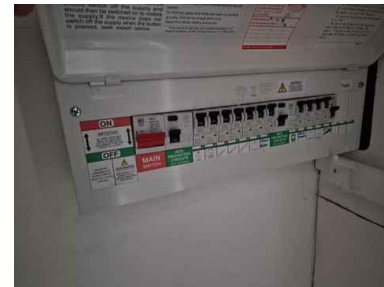
Although there were no particular areas of concern, we do endorse the Electrical Safety Council's recommendations and a precautionary electrical inspection should therefore still be undertaken, to ensure that circuitry complies with current electrical regulations, prior to a legal commitment to purchase. All recommendations should be fully costed and implemented.

The electrical installation is provided with an RCD which is designed to protect the users from electric shock. These installations are extremely sensitive and consequently occasional tripping of switches will occur, effectively shutting down the affected circuit(s). It can often result when a light bulb fails, or it may be the result of a defective appliance. When this happens, the 'trip-switch' must be reset. If this occurs with any frequency, an electrician should be instructed to investigate.

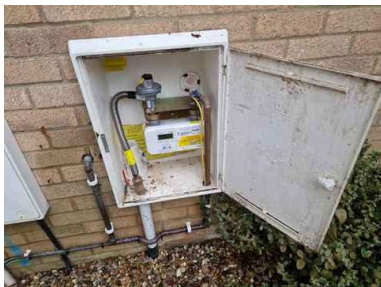
For precautionary purposes it is recommended that the gas installation be inspected by a Gas Safe registered engineer prior to legal commitment to purchase in the absence of any documentary evidence dated in the last 12 months. All recommendations for improvement to ensure compliance with current Gas Regulation standards should be implemented.

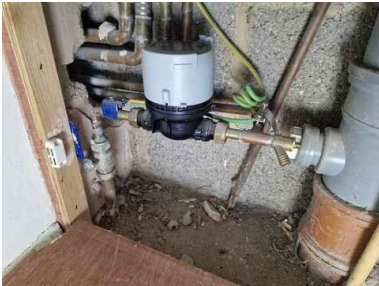
The internal rising main and stop tap are located in the utility cupboard along with the water meter.

The external stop tap could not be found and you should ask the water supplier to tell you where it is located so that you can turn off the water in an emergency.
