**RICS HOME SURVEY
LEVEL 3**

DATE OF INSPECTION:

Monday 28 October 2024

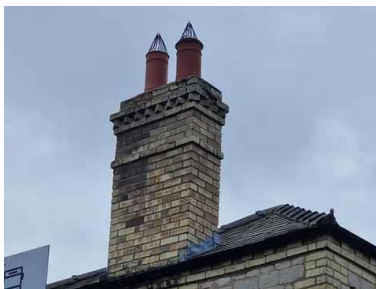
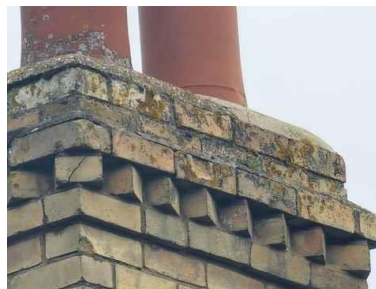
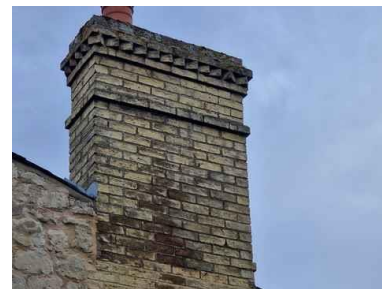
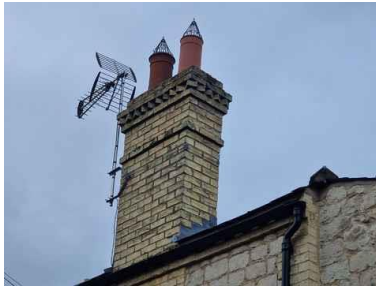
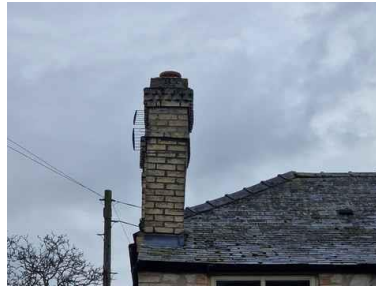
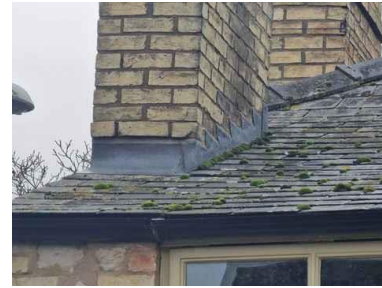
The chimney stacks appeared to be straight to the eye with no signs of any significant bulging, lean or outward movement noted. The rear stack to the right has a slight inward lean that is not of structural significance but should be monitored for further movement. If this occurs, it would be prudent to reduce the height of the stack.

There are 5 visible chimney pots that appear to be straight to the eye with no signs of visible damage. Flaunchings to the chimney pots could not be seen. These should be periodically inspected to ensure that the chimney pots or flues remain adequately bedded.

There is evidence of deteriorated mortar bedding to the right face of the left stack (for example).

Some masonry has deteriorated to the right face of the left stack due to freeze/thaw action commonly referred to as 'spalling'. Spalling occurs when brickwork becomes wet due to rain. If freezing conditions occur before the bricks dry out, the entrapped moisture expands and forces off the hard face of the brick, so exposing the softer inner core.

Whilst the level of deterioration is relatively minimal at this time with no requirement for repair, you should be aware that spalling is progressive, unsightly and if allowed to continue may ultimately result in structural failure of the stack. The affected masonry should be periodically monitored and the need to cut-out and replace individual bricks in the future cannot be ruled out.

Whilst repairs are not urgently required, it is recommended that you obtain quotations for future repointing works through a reputable roofing contractor prior to purchase, to budget accordingly.

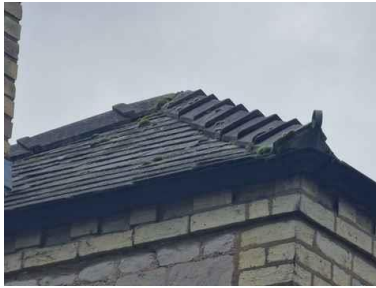
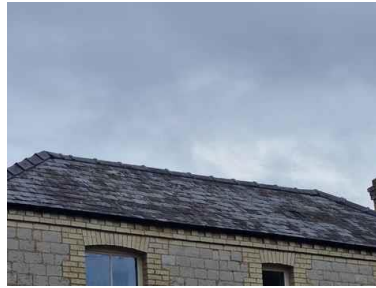
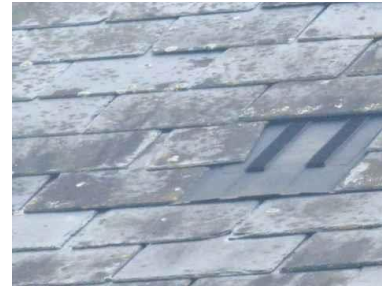
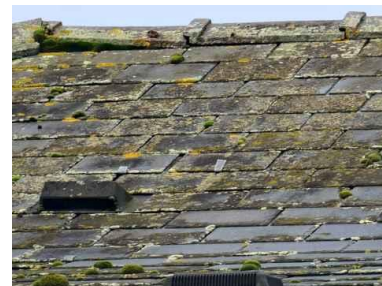
The roofline appears to be level and within normal tolerances with no signs of any significant deflection or undulation noted, indicating that the roof structure is adequate for the current roof covering. See Section E1 regarding the roof structure.

We are pleased to report the roof coverings appear to be complete with no signs of missing or damaged covering noted. A tile to the left of the front vent was noted to have slipped and you may wish to obtain quotes for repair prior to a legal commitment to purchase.

The ridge and hip tiles appear firmly fixed in position.

There is no evidence of significant cracking or loosening of the mortar to the roof edge, but this should be checked periodically and repointed as necessary.

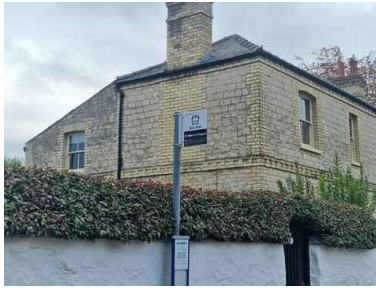
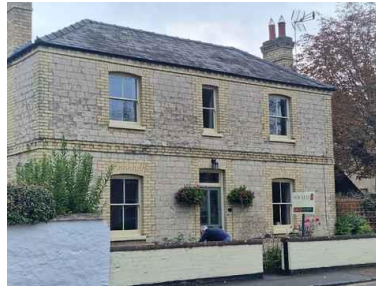
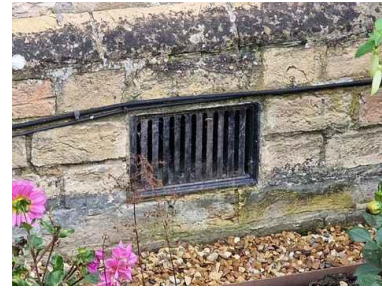
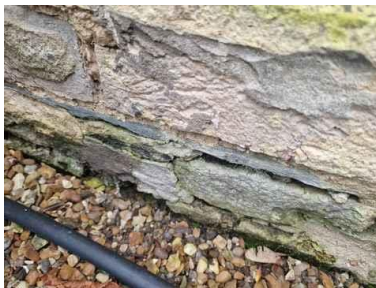
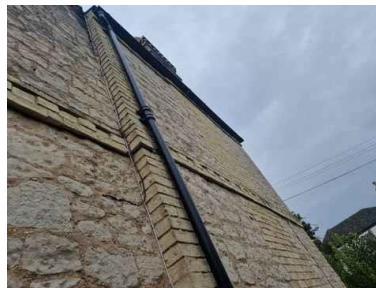
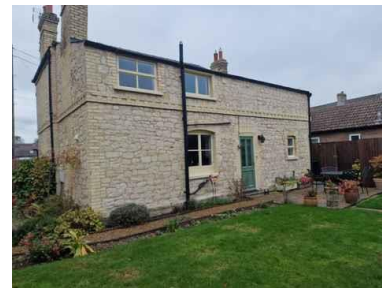
Walls and openings appear square to the eye with no signs of any significant movement or distortion noted.

We are pleased to report we saw no evidence of any significant cracks or bulges to indicate any failure or uneven loading with the foundations or structure of the subject property at this time.

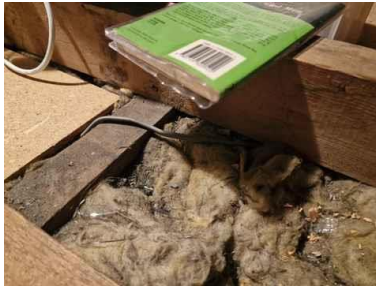
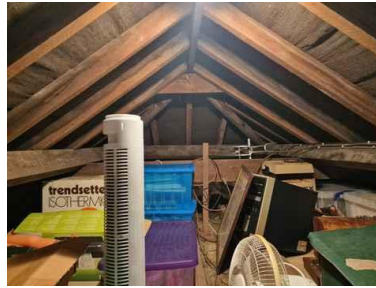
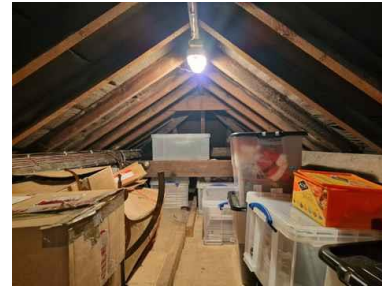
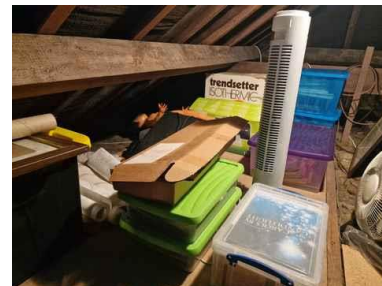
In places, electrical wiring is present beneath the loft insulation. This can cause overheating and in extreme cases lead to fires. All covered cables must be re-positioned on top of the insulation, and this should be assessed as part of a specialist Electrical test. Please see also section G1 of this report.

The roof space did contain items of storage, limiting the full extent of our inspection. Should you wish to use this area for storage it should be ensured that boarding is securely fixed, and storage limited in order to reduce possible over-loading of the roof and ceiling structure.

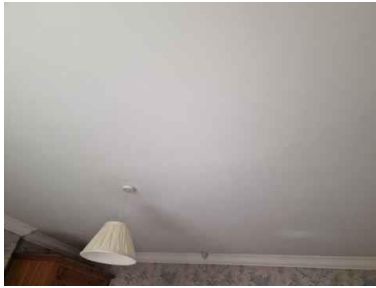
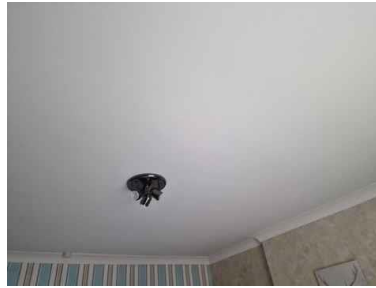
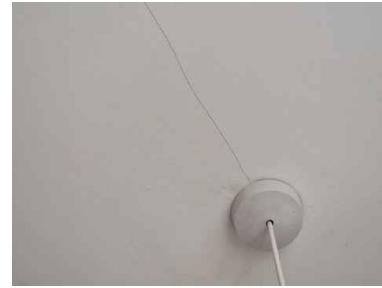
We are pleased to report the ceilings appear to be generally complete with no signs of significant cracking, undulation or distortion noted.

Minor irregularities and shrinkage cracks are present, but these are not unusual for this type and age of property. Cosmetic works upon redecoration will be required.

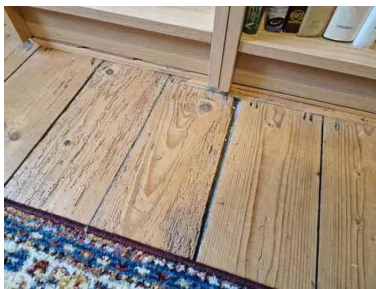
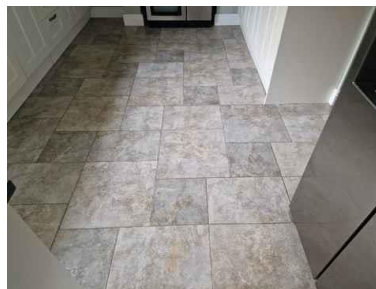
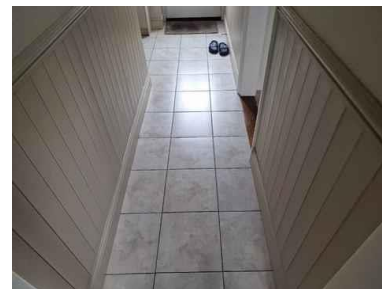
There is evidence of wood-boring insect infestation to exposed floorboards (e.g. bedroom 2) and whilst there were no signs of recent activity, you should confirm whether previous treatments have been made and if so, whether guarantees can be transferred under the sale.

The flooring beneath the sanitary fittings could not be inspected as this would involve damaging investigations which are beyond the scope of a normal survey. If there has been leakage, such as from concealed pipework or through gaps in wall tiles, or around the bath/shower, dampness may have caused serious rot in the floor. We found no evidence of timber decay, but further investigations would be necessary to establish whether any defects exist. If such work is to be undertaken, there will be some resultant damage and appropriate contractors should be appointed to undertake this work, with the vendor's permission, so that any replacement of panelling or flooring can be carefully undertaken.

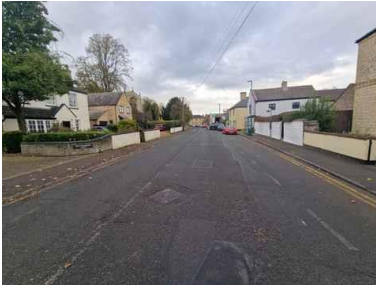
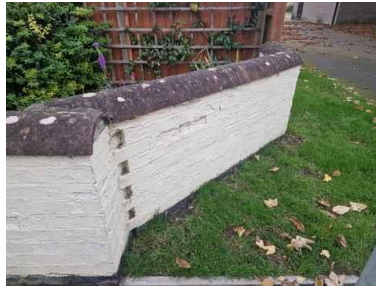
The outside areas and gardens appear to be adequately maintained.

Where there are boundary walls, these features will require high levels of maintenance and are currently suffering from deterioration, evidenced by spalled brickwork to the front wall. You should seek quotations for repairs prior to commitment to purchase in order to budget accordingly, as these works may be costly.
