SAGE
CHARTERED SURVEYORS

RICS HOME SURVEY LEVEL 2

- SURVEY & VALUATION

Thursday 26 September 2024

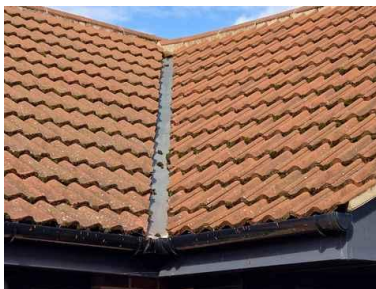
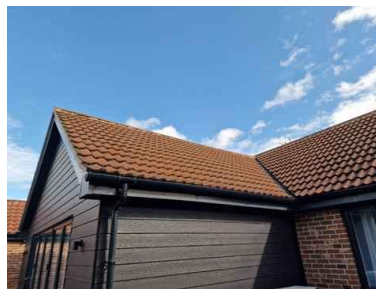
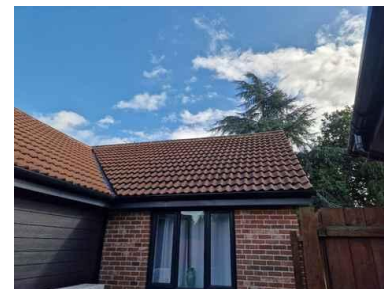
The roofline appears to be level and within normal tolerances with no signs of any significant deflection or undulation noted, indicating that the roof structure is adequate for the current roof covering. See Section E1 regarding the roof structure.

We are pleased to report the roof coverings appear to be complete with no signs of any slipped, missing or damaged covering noted.

There is moss growth present on the roof slopes. This level of moss growth is not unusual on properties of this age and type. You should monitor the roof slopes especially where they are north facing or shaded by trees. At present no action is required. However, in the future if the growth becomes excessive then the moss should be cleaned off. Moss growth impedes the run-off of rainwater and leads to gutter blockage and can cause water penetration which may lead to rot or other defects in surrounding timbers.

There is no evidence of significant cracking or loosening of the mortar to the roof edge, but this should be checked periodically and repointed as necessary.

The valleys are formed in lead and appear to be in a satisfactory condition where viewed from ground level. Moss should be cleared from within the valleys periodically to prevent overspill. Valley gutters can fail unexpectedly, and regular maintenance is necessary. Even valley gutters that are in sound condition can quickly become blocked by leaves, snow, or ice, causing water levels to rise above the edges of the joints and so seep into the fabric of the building. It should be noted that maintenance and repair costs, when needed, tend to be expensive, and you may therefore wish to arrange for a precautionary up-close inspection prior to purchase.

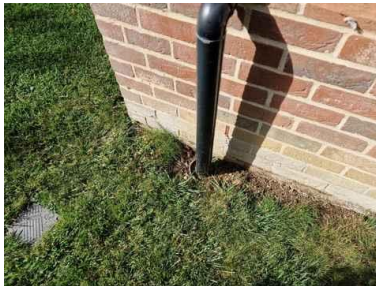
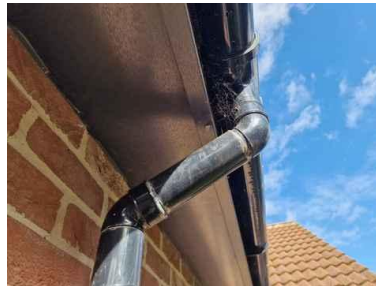
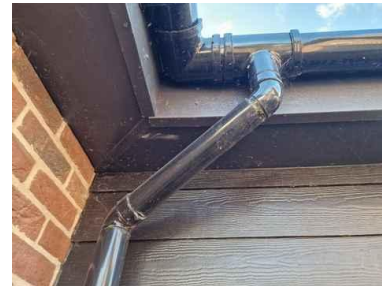
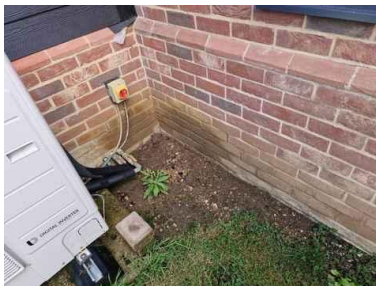
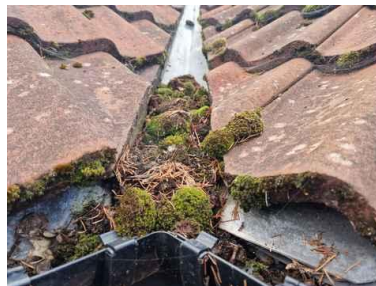
The rainwater goods are formed in uPVC and appear to be in a good condition.

We are pleased to report that rainwater goods appear to be adequately aligned with no signs of any significant twisting or distortion noted.

The valleys to the rear (and the front right valley) are currently blocked and should be cleared at the earliest opportunity. The blockage to the rear is causing splashback to the brickwork below and if allowed to progress could eventually cause damp penetration.

The water butt to the side of the garage should be checked regularly, as if allowed to overflow water butts can cause damp penetration on external walls and if unattended for prolonged period could lead to a change in ground conditions and resulting movement of the structure.

Secure quotations for repair of the rainwater fittings

You should ensure that the gutters are seasonally unblocked of moss and other debris.

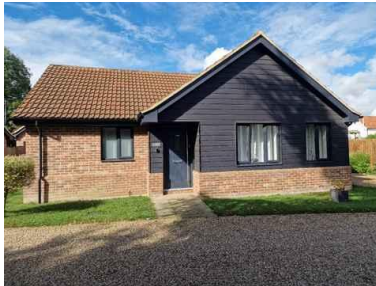
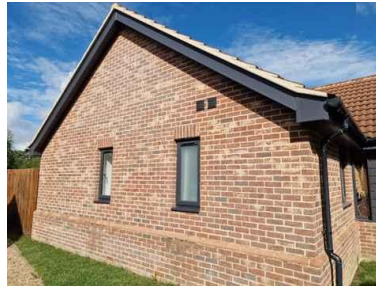
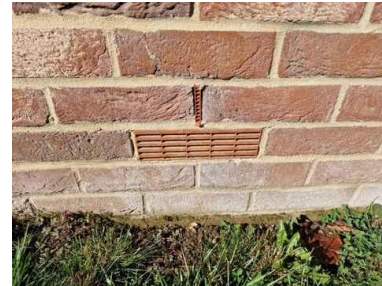
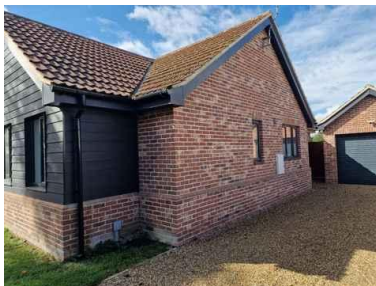
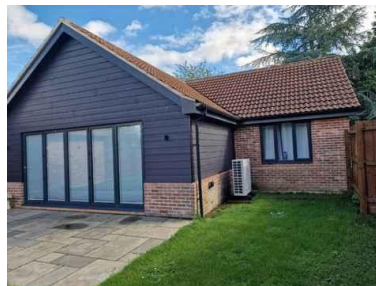
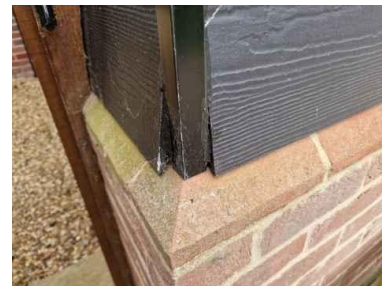
The property is of modern timber framed construction. Construction of this type has now become well established. Provided that the property has been constructed in the approved manner, in accordance with the relevant Codes of Practice, it should be structurally satisfactory. It is important that timber frame dwellings are constructed to a high standard of workmanship and that proper supervision has been undertaken. It is critical that appropriate vapour barriers are included at strategic positions within the wall structures and that these have not perforated in such a way as to allow humidity from the living accommodation to enter the wall structure and so cause the potential for damage. The stability of the external walls depends on the quality of the ties holding together the inner and outer leaves. These fittings, together with the necessary vapour barriers are now hidden and could not be examined.

There is no evidence of significant cracking surrounding the window and door openings suggesting the lintels are performing satisfactorily.

Walls to the front and rear have been clad with composite boarding. The cladding was found to be complete with no signs of any slipped, missing or damaged lengths noted.

In general, there were no signs of any significant structural defects noted to the main walls at the time of inspection.

Walls and openings appear square to the eye with no signs of any significant movement or distortion noted.

We are pleased to report we saw no evidence of any significant cracks or bulges to indicate any failure or uneven loading with the foundations or structure of the subject property at this time.

Mortar joints to the brickwork were found to be in an overall serviceable condition with no requirement for repointing attention.

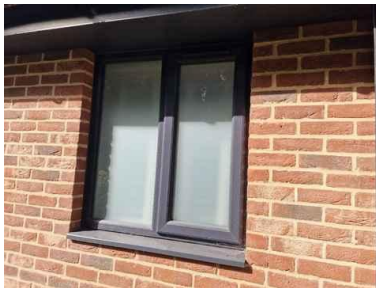
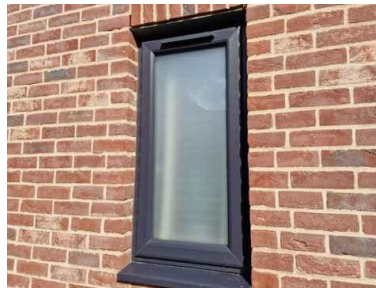
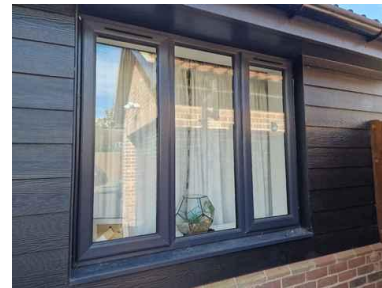
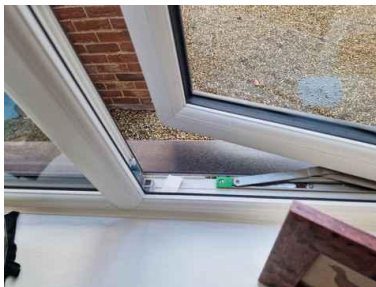
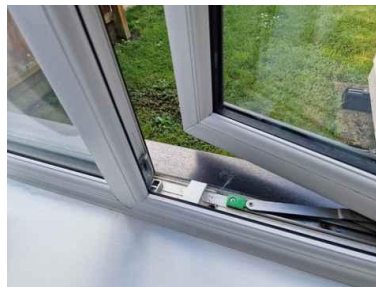
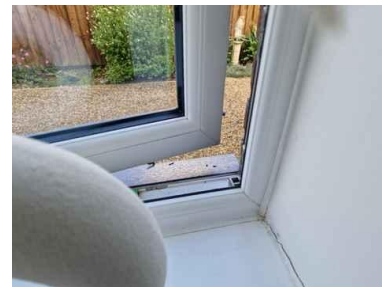
The windows are of double-glazed uPVC construction and appear to be the original installation, to which no significant defects were noted.

There were no signs of condensation between the double-glazed panes at the time of inspection. It should be noted, however, that double-glazing can be prone to this problem, which is caused by a failure of the seals at the edges of the panes of glass. Over a period of time the seals can deteriorate, causing unsightly condensation or misting between the panes. When this happens there is no remedy other than to replace the defective double-glazed panes.

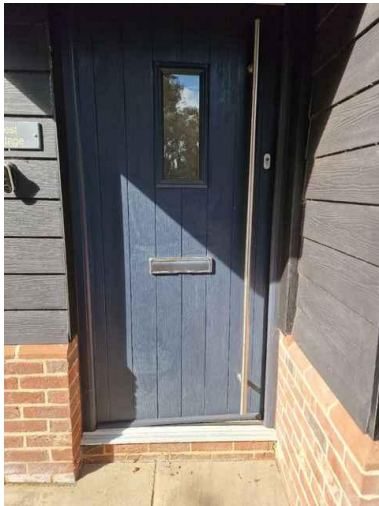
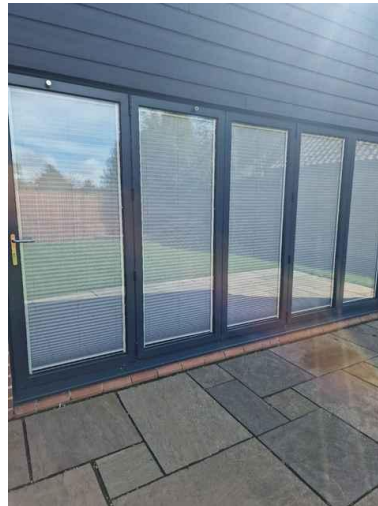
The doors are of double-glazed uPVC (front) and uPVC with external aluminium (to the rear) construction and appear to be the original installation, to which no significant defects were noted.

Doors open square to the eye with no signs of any significant movement or distortion noted.

We recommend you change all locks upon occupation to enhance security.

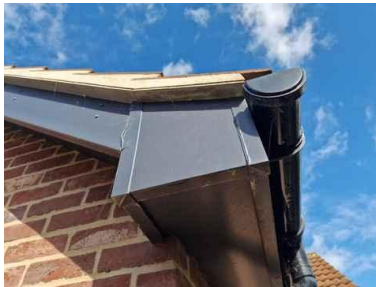
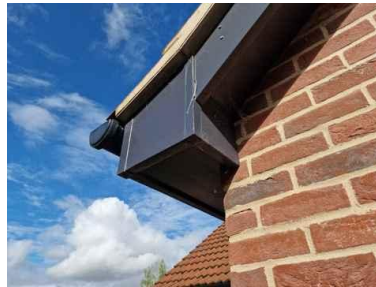
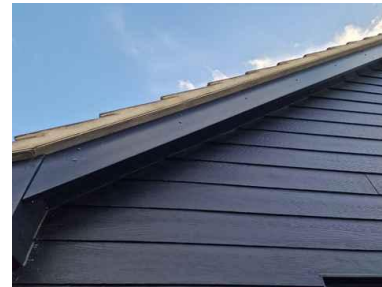
No significant defects were noted to the uPVC roof edge materials which will have a relatively limited liability for ongoing maintenance.

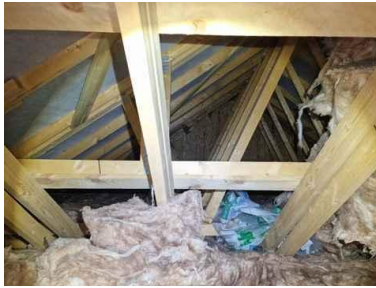
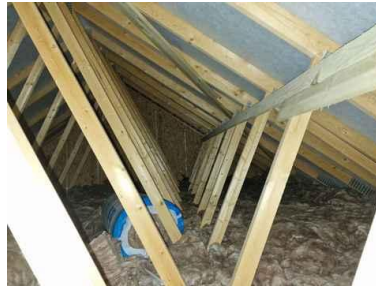
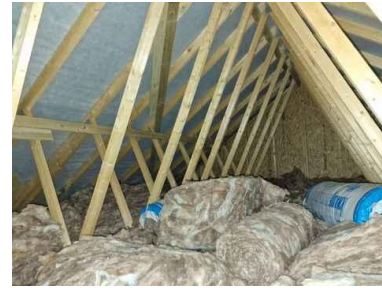
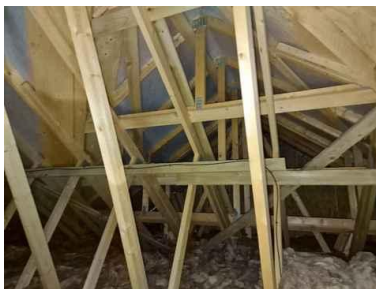
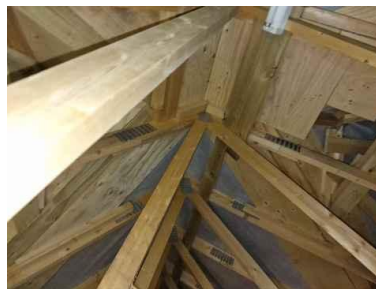
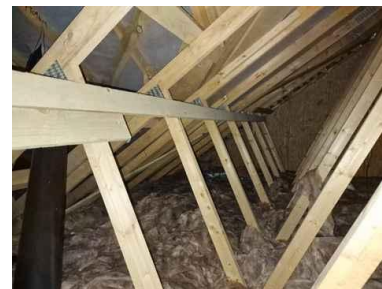
Insulation is provided to a depth of 270mm, which appears to comply with current standards.

In places, electrical wiring is present beneath the loft insulation. This can cause overheating and in extreme cases lead to fires. All covered cables must be re-positioned on top of the insulation, and this should be assessed as part of a specialist Electrical test. Please see also section F1 of this report.

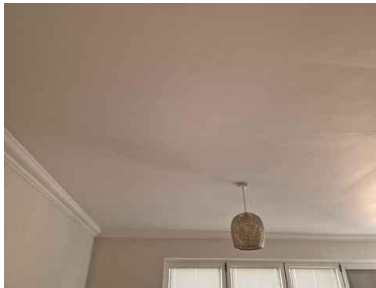
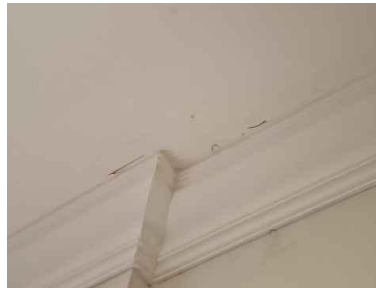
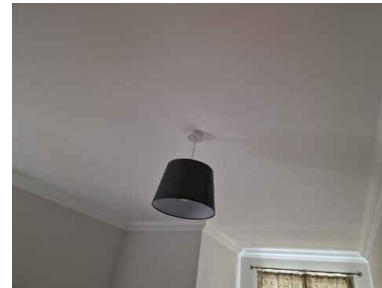
Where decorative coving is fitted within the property, this appeared to be complete with no signs of any significant defect noted. Please note that coving can conceal a degree of settlement cracking.

We are pleased to report the ceilings appear to be generally complete with no signs of significant cracking, undulation or distortion noted.

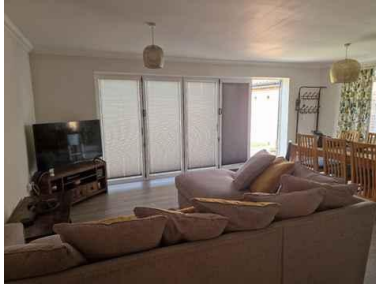
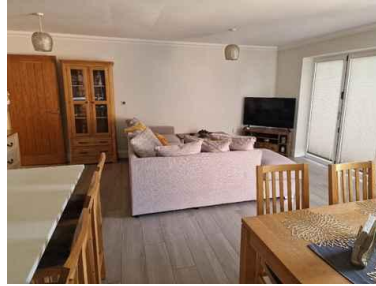
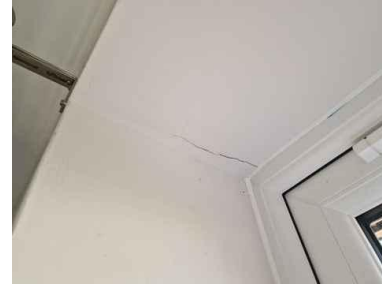
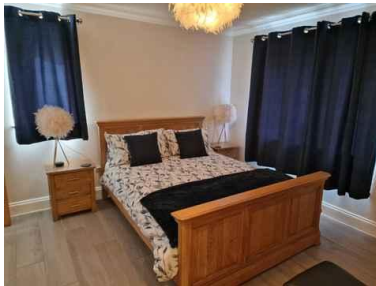
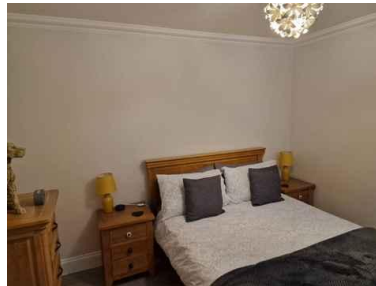
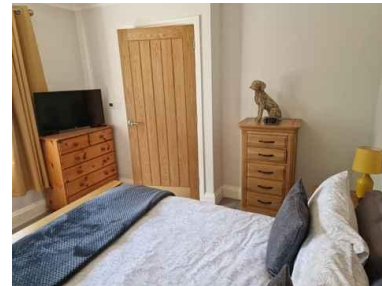
Moisture content readings were taken throughout the walls at regular intervals with an electronic damp meter and no significant dampness was recorded, suggesting the damp-proof course is operating effectively.

We also found no evidence of any significant penetrating dampness within the property.

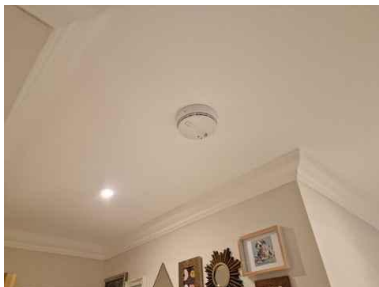
There is a mains-wired smoke detectors installed. It is recommended the smoke detectors are serviced in accordance with the manufacturer's instructions.

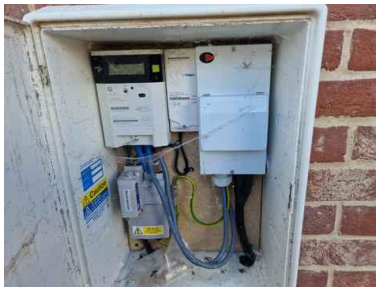
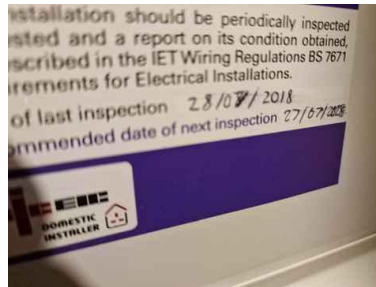
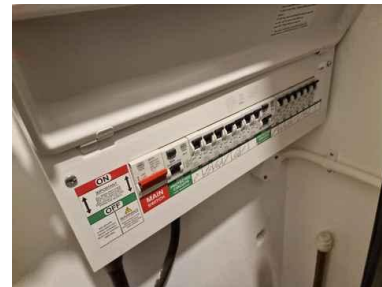
Although there were no particular areas of concern, we do endorse the Electrical Safety Council's recommendations and a precautionary electrical inspection should therefore still be undertaken, to ensure that circuitry complies with current electrical regulations, prior to a legal commitment to purchase. All recommendations should be fully costed and implemented.

The electrical installation is provided with an RCD which is designed to protect the users from electric shock. These installations are extremely sensitive and consequently occasional tripping of switches will occur, effectively shutting down the affected circuit(s). It can often result when a light bulb fails, or it may be the result of a defective appliance. When this happens, the 'trip-switch' must be reset. If this occurs with any frequency, an electrician should be instructed to investigate.

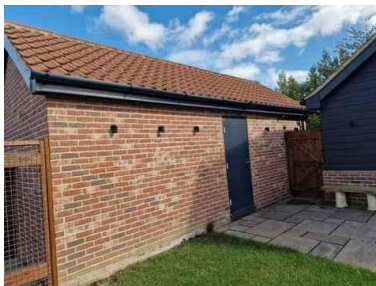
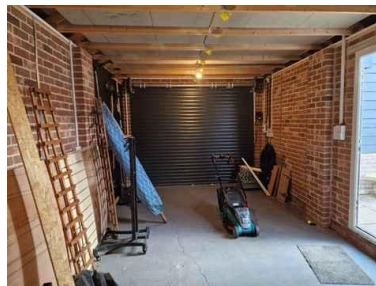
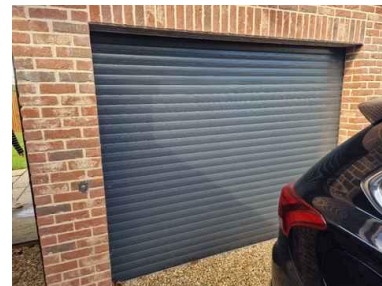
The electrical services to the garage should be tested by a qualified electrician alongside the electrics to the property. Please see also section F1 of this report.

There is an electrically operated garage door. You should confirm whether there is a service contract or guarantee which could transfer with title.
