## RICS HOME SURVEY LEVEL 2

Monday 2 June 2025

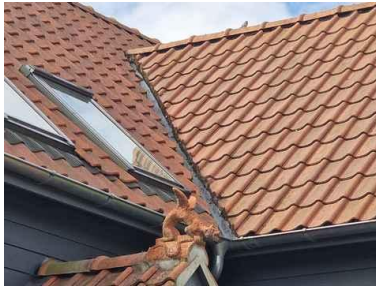
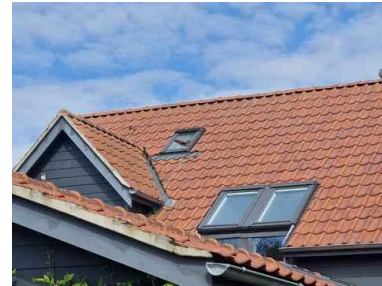
The roofline appears to be level and within normal tolerances with no signs of any significant deflection or undulation noted, indicating that the roof structure is adequate for the current roof covering. See Section E1 regarding the roof structure.

We are pleased to report the roof coverings appear to be complete with no signs of any slipped, missing or damaged covering noted.

There is no evidence of significant cracking or loosening of the mortar to the roof edge, but this should be checked periodically and repointed as necessary.

The valleys are formed in lead and appear to be in a satisfactory condition where viewed from ground level. Moss should be cleared from within the valleys periodically to prevent overspill. Valley gutters can fail unexpectedly, and regular maintenance is necessary. Even valley gutters that are in sound condition can quickly become blocked by leaves, snow, or ice, causing water levels to rise above the edges of the joints and so seep into the fabric of the building. It should be noted that maintenance and repair costs, when needed, tend to be expensive, and you may therefore wish to arrange for a precautionary up-close inspection prior to purchase.

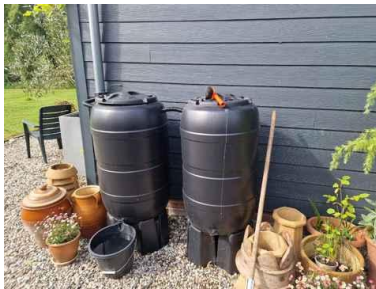
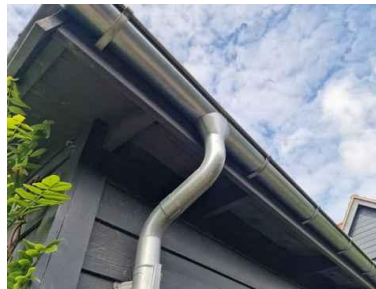
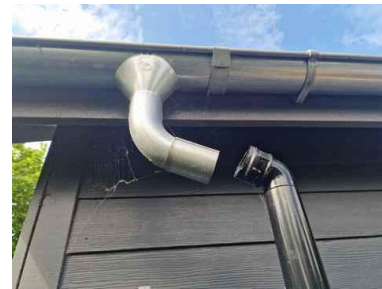
The rainwater goods are of Lindab galvanised steel construction which generally has a lower maintenance liability than other metals and jointed uPVC guttering. No significant defects were noted at the time of the inspection. There may be guarantees for the installation which can be transferred under the sale, Legal Advisors to confirm.

We are pleased to report that rainwater goods appear to be adequately aligned with no signs of any significant twisting or distortion noted.

Please note it was not raining during the course of the inspection so we cannot confirm that rainwater goods are watertight at the joint sections. It is recommended that you inspect rainwater goods during a period of heavy rain in order to establish their effectiveness, with repairs addressed as found to be necessary.

You should ensure that the gutters are seasonally unblocked of moss and other debris.

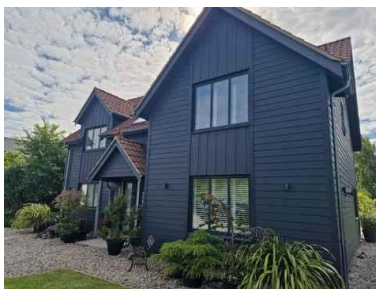
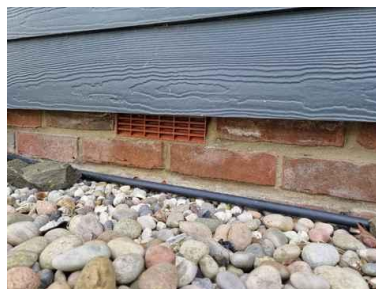
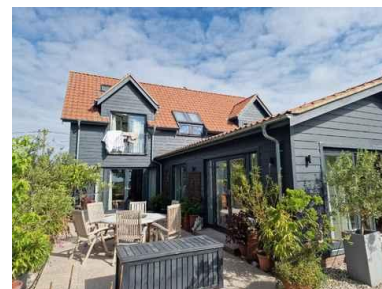
Walls have been clad with composite boarding. The cladding was found to be complete with no signs of any slipped, missing or damaged lengths noted.

In general, there were no signs of any significant structural defects noted to the main walls at the time of inspection.

We are pleased to report we saw no evidence of any significant cracks or bulges to indicate any failure or uneven loading with the foundations or structure of the subject property at this time.

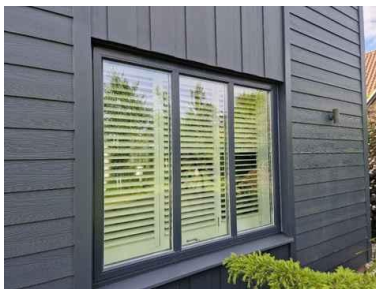
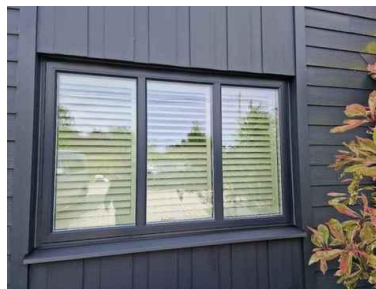
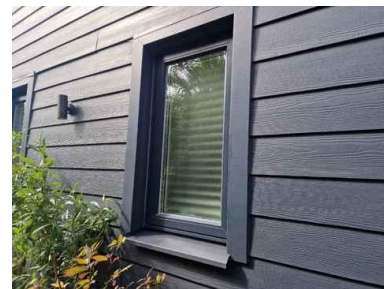
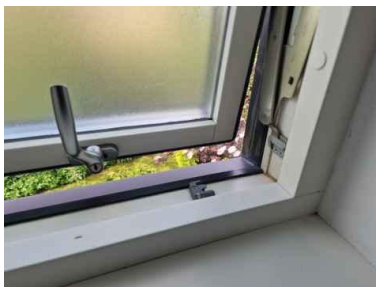
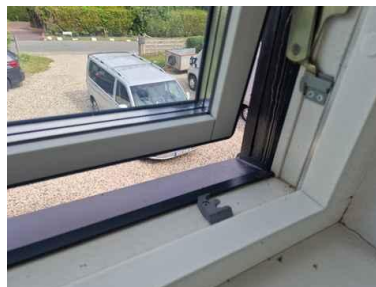
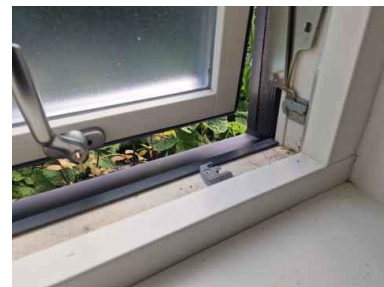
Where trickle ventilation has been provided to windows, this should allow a degree of natural ventilation when windows are closed.

You should ensure that you are provided with a full set of window keys on occupation.

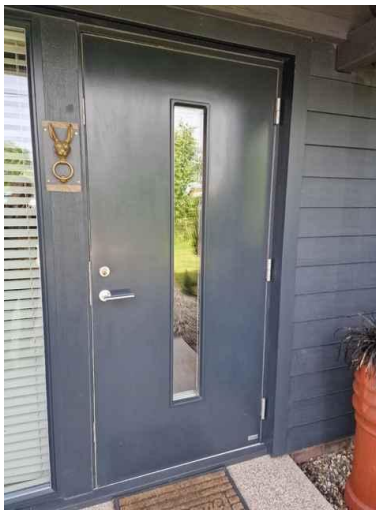
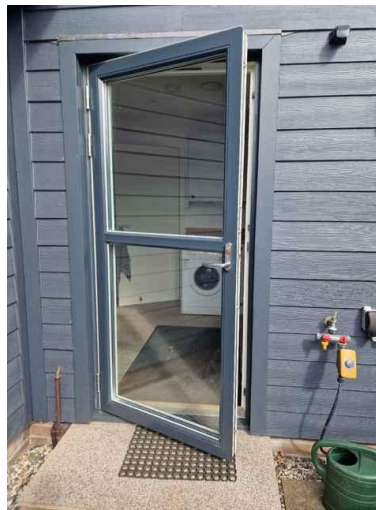
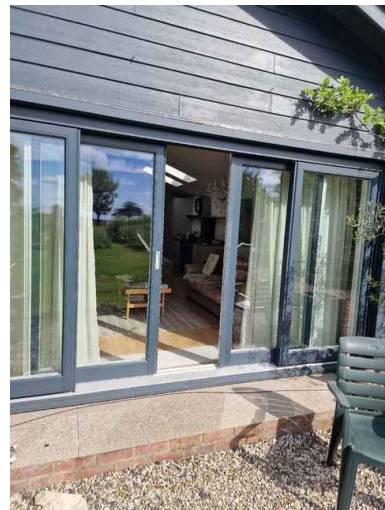
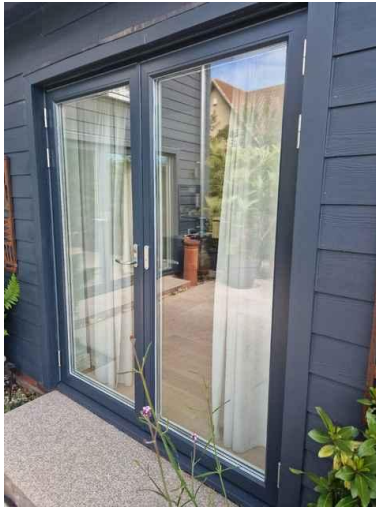
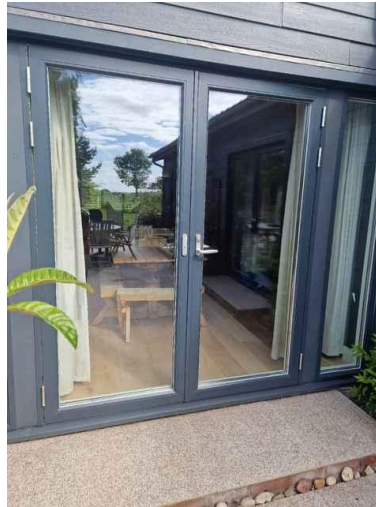
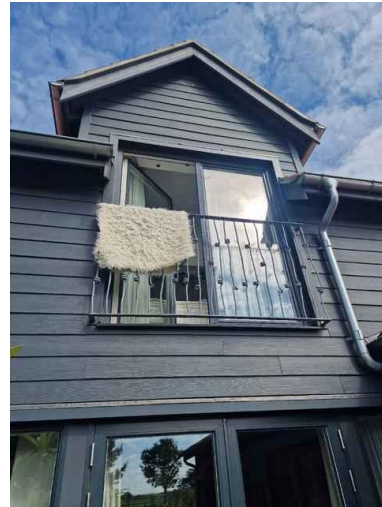
Doors open square to the eye with no signs of any significant movement or distortion noted.

We recommend you change all locks upon occupation to enhance security.

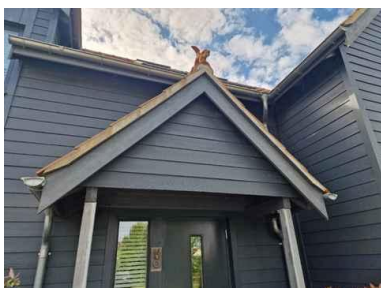
There is a timber-built porch constructed beneath a tiled roof structure, which was in good condition and appears to be original to the construction of the property.

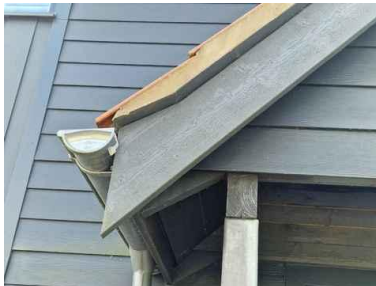
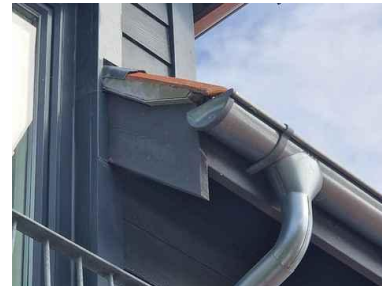
The roof edges are provided with timber fascia and soffit boards which are in a good condition. External decorations will need regular redecoration, typically on a three-to-five-year cycle dependent upon the quality of paint or stain coating.

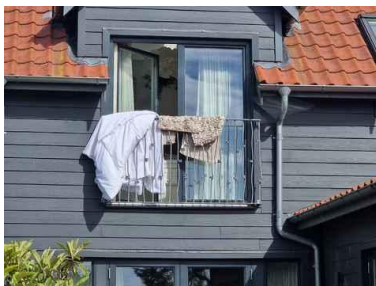
There is a Juliet-style balcony accessed via the rear bedroom.

The railings were in a good condition. The height of the banister and the gaps between the spindles will comply with Building Regulations.

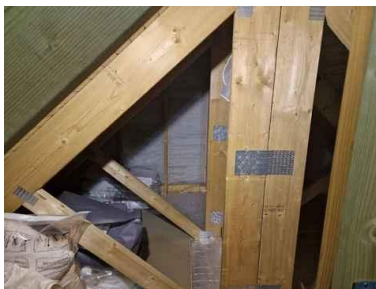
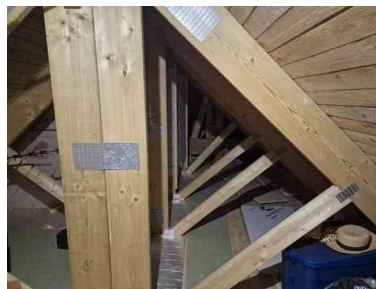
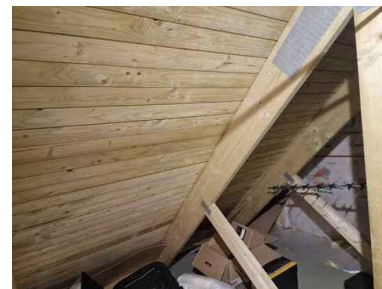
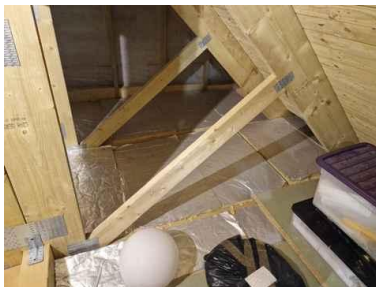
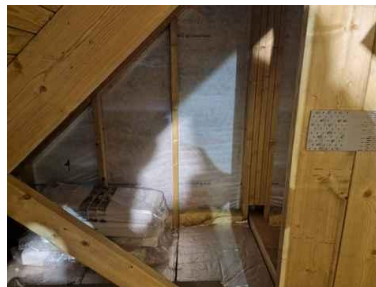
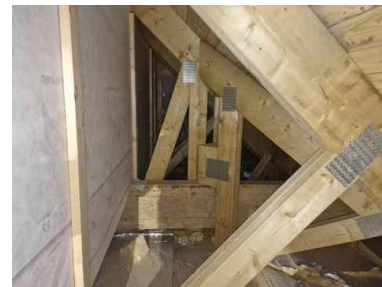
Insulation is provided to a depth of 270mm, which appears to comply with current standards.

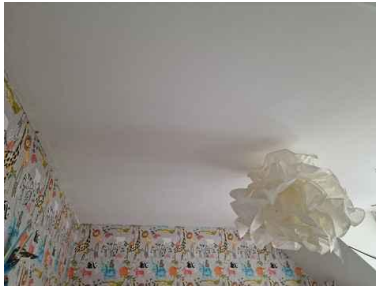
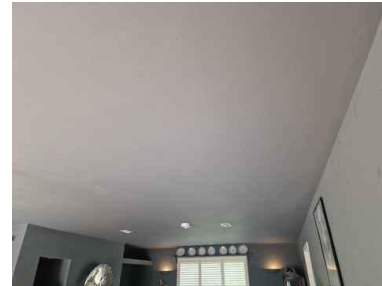
We are pleased to report the ceilings appear to be generally complete with no signs of significant cracking, undulation or distortion noted.

Minor irregularities and shrinkage cracks are present (picture 2), but these are not unusual for this type and age of property. Cosmetic works upon redecoration will be required.

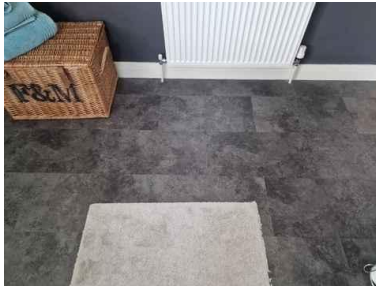
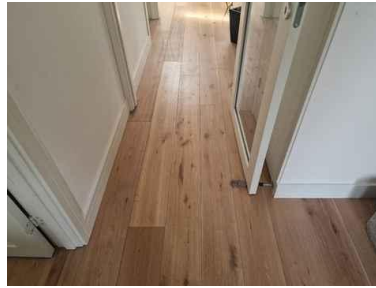
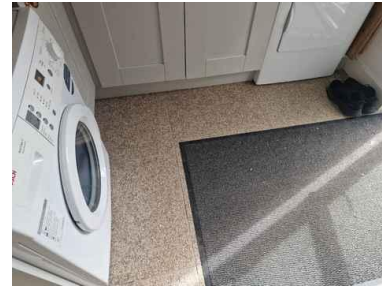
Suspended concrete floors appear to be firm and level with no signs of any significant hollowness noted.

The flooring beneath the sanitary fittings could not be inspected as this would involve damaging investigations which are beyond the scope of a normal survey. If there has been leakage, such as from concealed pipework or through gaps in wall tiles, or around the bath/shower dampness may have caused serious rot in the floor. We found no evidence of timber decay, but further investigations would be necessary to establish whether any defects exist. If such work is to be undertaken, there will be some resultant damage and appropriate contractors should be appointed to undertake this work, with the vendor's permission, so that any replacement of panelling or flooring can be carefully undertaken.

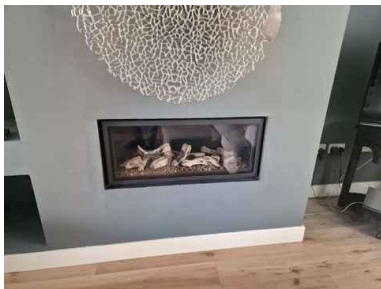
There is a gas fire within the lounge.

There is no evidence that the gas fire has been tested recently, and a Gas Safe registered engineer should be employed to check the flues are clean and function satisfactorily before use. Because of the provision of the gas appliance, it was not possible to inspect the flues during our inspection.

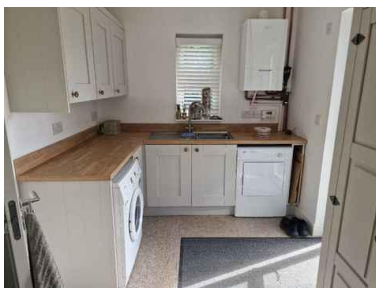
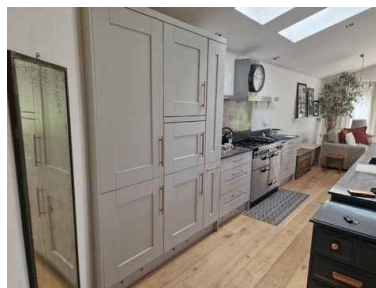
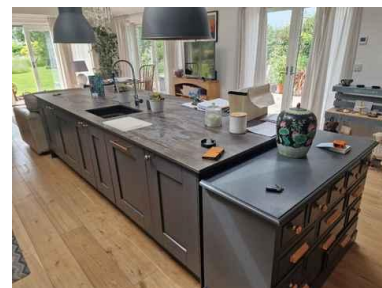
There is a gas hob fitted, and you should confirm with your Legal Advisor whether this has any Gas Safety Certification. See Section F2 of this report.

Most of the distribution and waste pipework is concealed behind the units and leaking pipework or other defects may not be readily apparent.

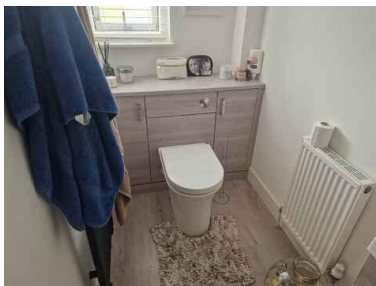
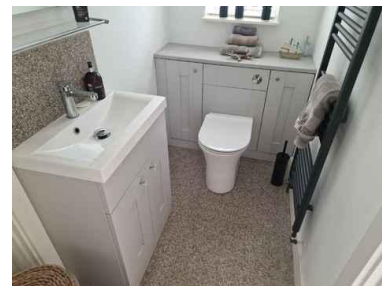
The water pressure was checked to several draw-off points and found to be adequate. Water pressure can vary seasonally and during times of high demand, both within the property and in the locality. It is recommended that should you wish to install water pressure sensitive items, such as a power shower, that further enquiries are made initially.

Most of the distribution and waste pipework is concealed beneath or behind sanitary ware items and whilst there were no obvious signs of leaks, the risk of hidden defects exists.

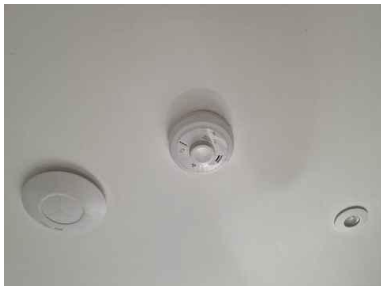
Where there is a gas-fired boiler, a gas hob and gas fire, carbon monoxide alarms have been installed and should be maintained in line with the alarm manufacturer's guidelines.

There are 2 mains-wired smoke detectors installed.

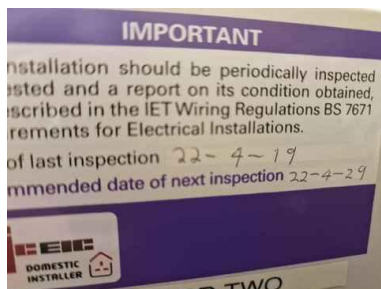
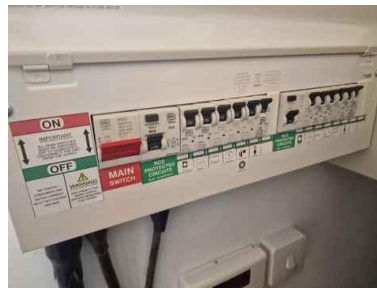
The consumer unit displayed evidence of the last testing date on 22.4.19. As a benchmark for a new test and inspection, a copy of the last electrical examination should be obtained prior to legal commitment to purchase.

The electrical installation is provided with an RCD which is designed to protect the users from electric shock. These installations are extremely sensitive and consequently occasional tripping of switches will occur, effectively shutting down the affected circuit(s). It can often result when a light bulb fails, or it may be the result of a defective appliance. When this happens, the 'trip-switch' must be reset. If this occurs with any frequency, an electrician should be instructed to investigate.

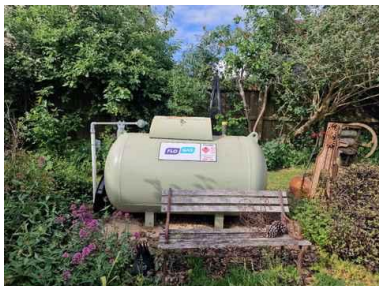
For precautionary purposes it is recommended that the gas installation be inspected by a Gas Safe registered engineer prior to legal commitment to purchase in the absence of any documentary evidence dated in the last 12 months. All recommendations for improvement to ensure compliance with current Gas Regulation standards should be implemented.

You should confirm ownership or supply arrangements, as some tanks may be rented from the supplier. Further advice and testing of the installation by a suitably qualified heating engineer is recommended.

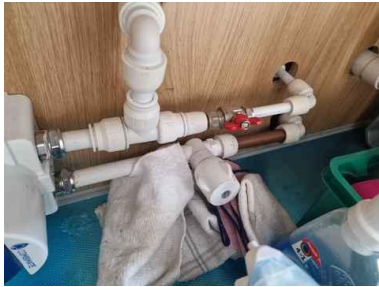
The internal rising main and stop tap are located in the utility room.

The external stop tap is located in the front verge (as stated by the vendor). You should confirm whether a water meter is provided.

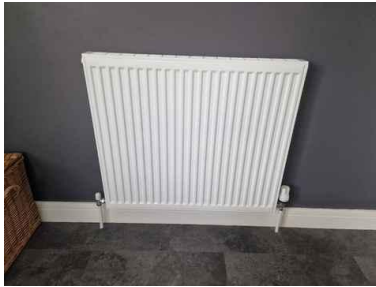
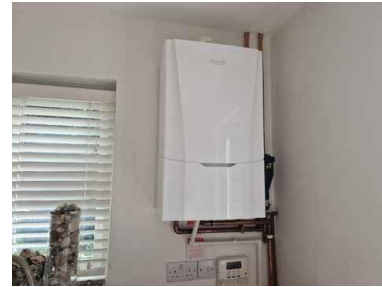
Where heating pipes are built within the floor structure, there is a risk that they are not adequately protected, and this can lead to leaks that can be hard to trace and disruptive to rectify. There were however no signs of leakages at the time of inspection.

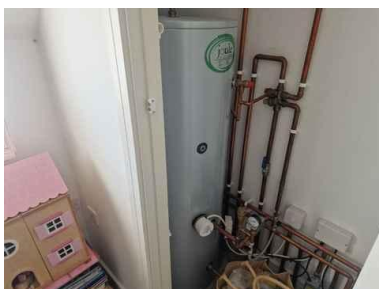
We are not suitably qualified to comment on the state and condition of the hot water installation and a test on the installation is outside the scope of this report.

You should be aware that hot water systems require regular maintenance, and it is recommended that they are serviced annually alongside the central heating boiler installation. You should request a copy of any recent service history through your Legal Advisor. In the absence of such documentation dated within the last 12 months, you should arrange for a precautionary inspection through a reputable plumber or heating engineer.

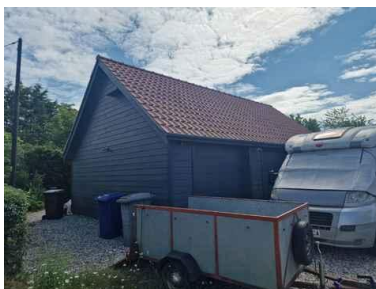
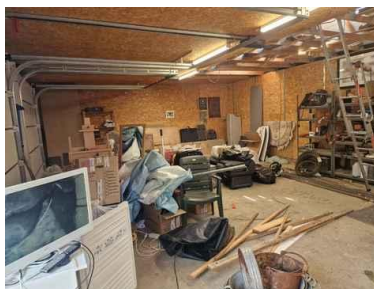
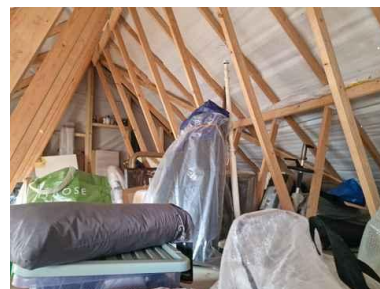
There are electrically operated garage doors. You should confirm whether there is a service contract or guarantee which could transfer with title.

The electrical services to the garage should be tested by a qualified electrician alongside the electrics to the property. Please see also section F1 of this report.

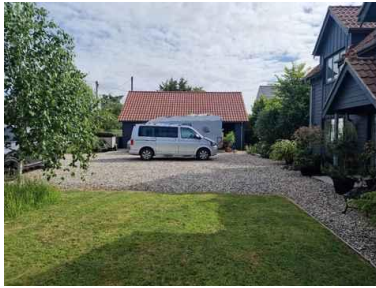
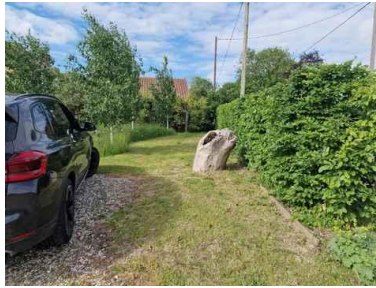
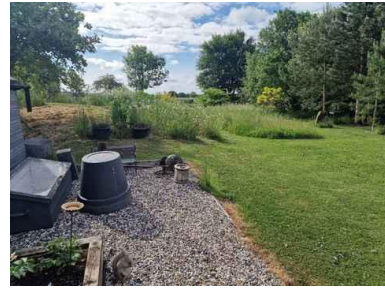
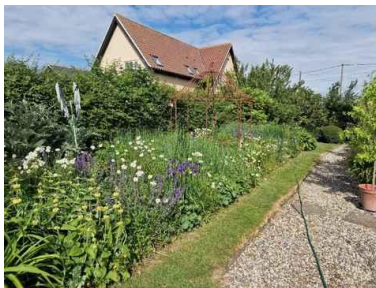
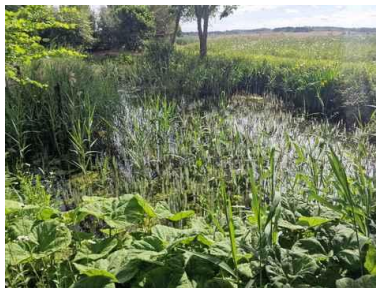
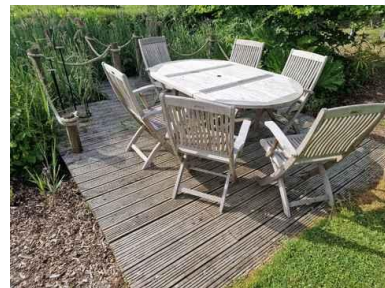
The outside areas and gardens appear to be adequately maintained.
