**RICS HOME SURVEY
LEVEL 2**
- SURVEY ONLY

Monday, 4 March 2024

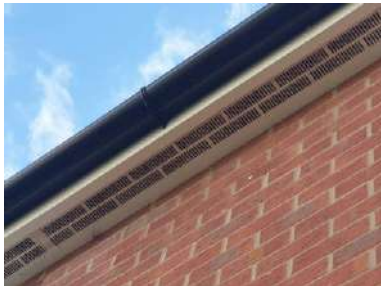
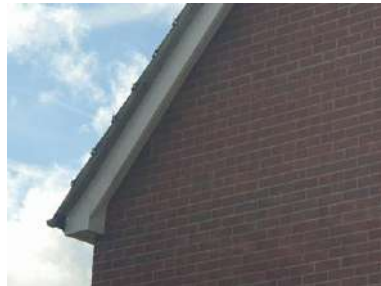
No significant defects were noted to the uPVC roof edge materials which will have a relatively limited liability for ongoing maintenance.

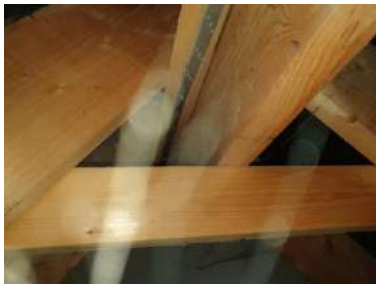
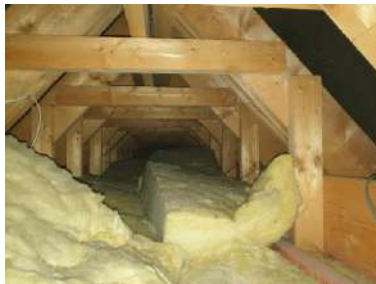
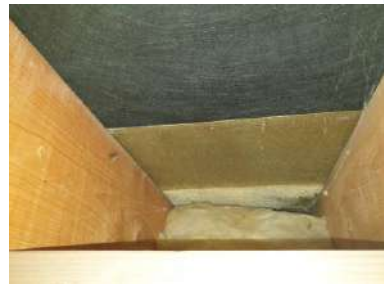
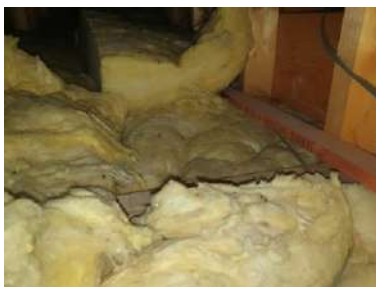
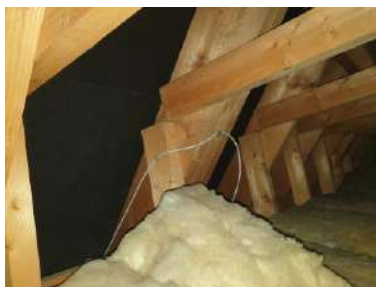
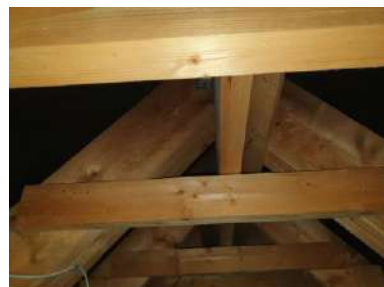
Insulation is provided to a depth of 270mm, which appears to comply with current standards.

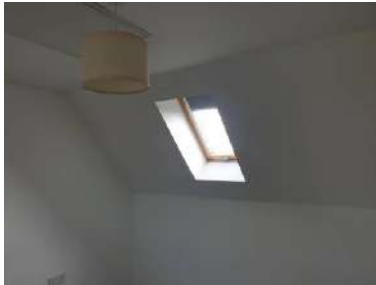
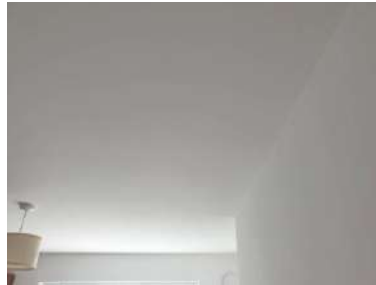
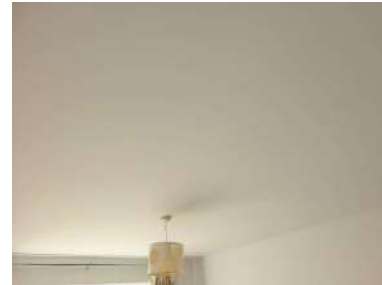
We are pleased to report the ceilings appear to be generally complete with no signs of significant cracking, undulation or distortion noted.

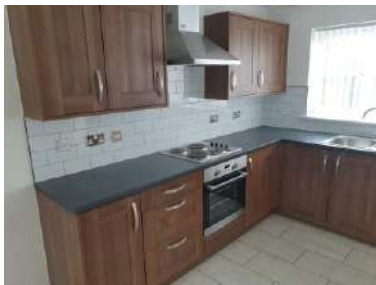
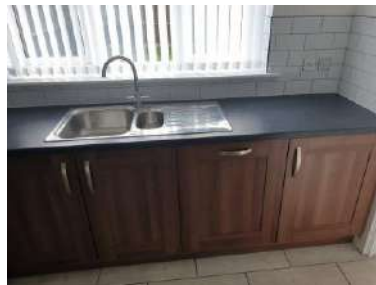
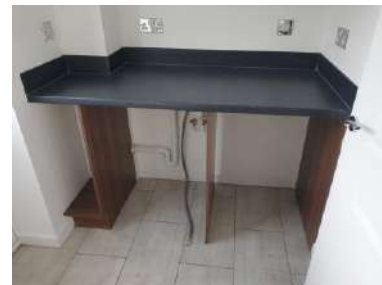
There is an electric hob fitted and you should confirm with your legal adviser whether this has any electrical safety certification. Please refer to section F1 of this report.

Most of the distribution and waste pipework is concealed behind the units and leaking pipework or other defects may not be readily apparent.

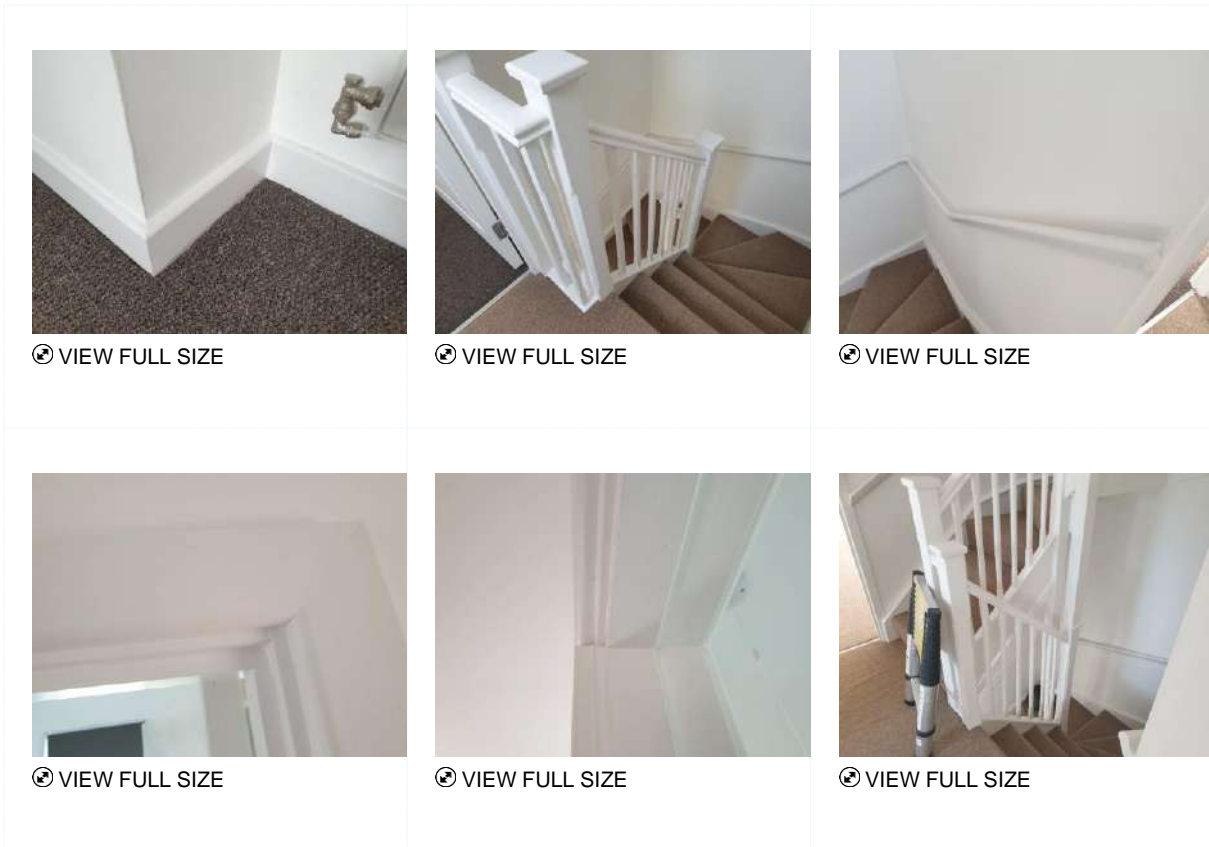
There is a satisfactory handrail to the staircase.

Banisters and balustrading appear to be complete with no signs of any defect noted. The gaps between spindles are 100mm or less which will comply with current Building Regulation standards.

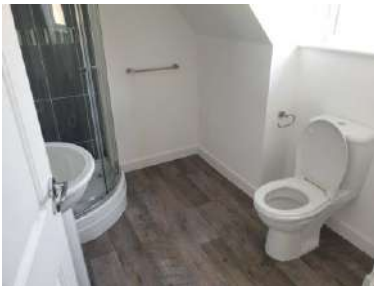
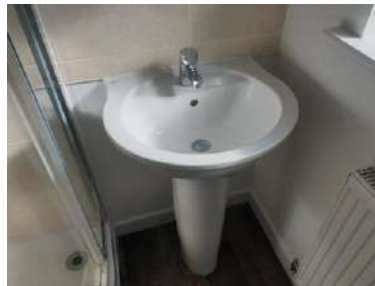
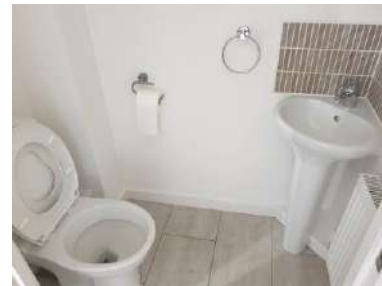
The water pressure was checked to several draw-off points and found to be adequate. Water pressure can vary seasonally and during times of high demand, both within the property and in the locality. It is recommended that should you wish to install water pressure sensitive items, such as a power shower, that further enquiries are made initially.

Most of the distribution and waste pipework is concealed beneath or behind sanitary ware items and whilst there were no obvious signs of leaks, the risk of hidden defects exists.

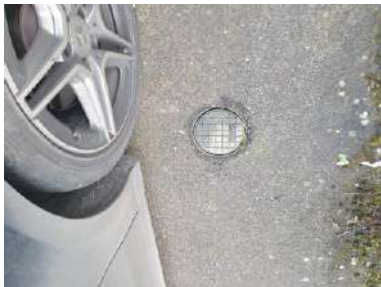
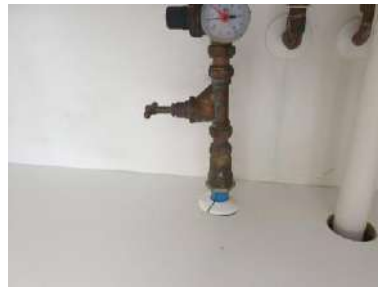
The internal rising main and stop tap are located under the kitchen sink.

The external stop tap is located in the front path. You should confirm whether a water meter is provided.

Condition Rating: 2

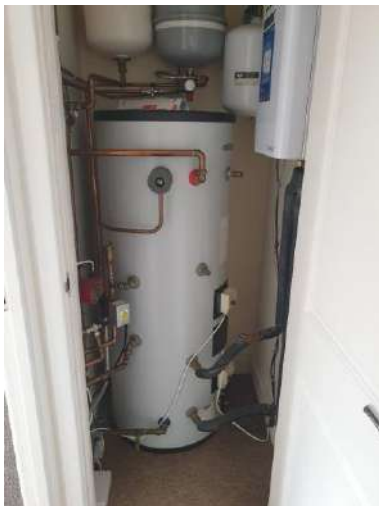
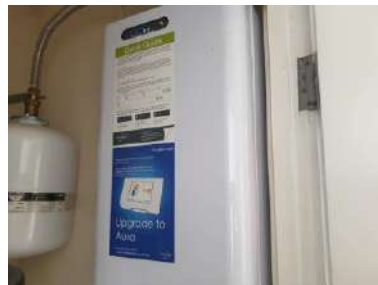
The tank appears to be suitably supported and associated pipework appears to be complete with no signs of any significant furring, corrosion or active leaks noted.

Condition Rating: 2

You should be aware that hot water systems require regular maintenance, and it is recommended that they are serviced annually alongside the central heating boiler installation. You should request a copy of any recent service history through your legal adviser. In the absence of such documentation dated within the last 12 months, you should arrange for a precautionary inspection through a reputable plumber or heating engineer.

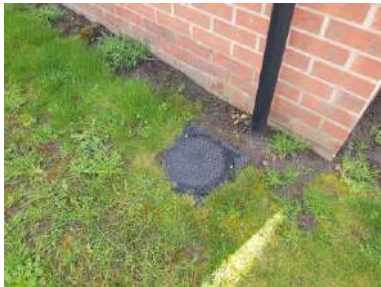
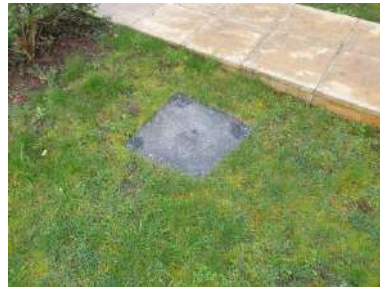
There were no above ground signs of blockage or damage or other significant defect at the time of our inspection however without a full inspection by a drainage specialist, you must accept the risk of such defects existing.

The soil and vent pipe is ducted internally and therefore hidden from view.

Condition Rating: 2

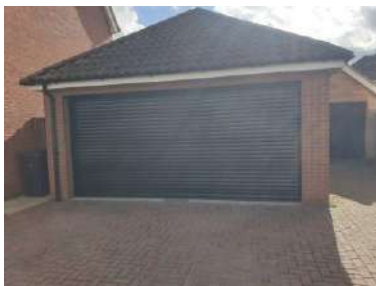
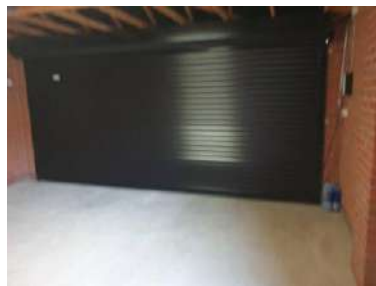
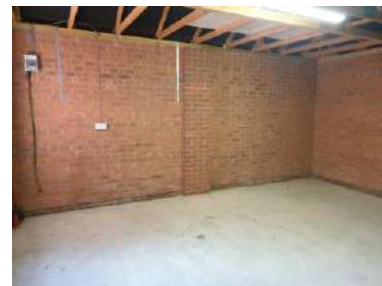
There is an electrically operated garage door. You should confirm whether there is a service contract or guarantee which could transfer with title.

Condition Rating: 1

The electrical services to the garage should be tested by a qualified electrician alongside the electrics to the property. Please see also section F1 of this report.
