RICS HOME SURVEY LEVEL 3

██████████
Bury St Edmunds
Suffolk
IP33 1JH

Tuesday, 6 February 2024

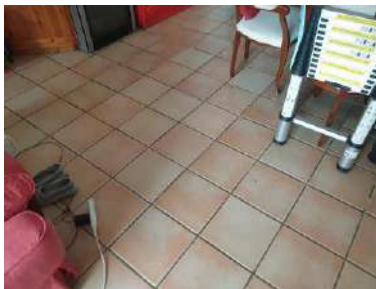
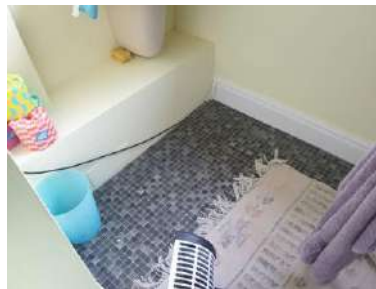
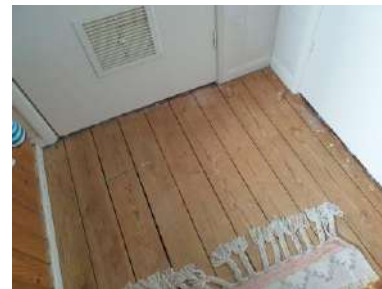
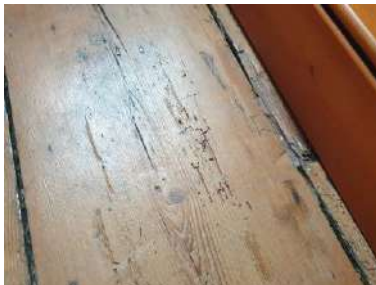
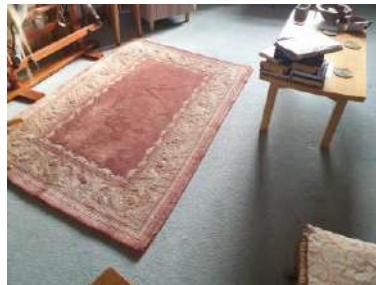
Where walked upon, suspended timber floor surfaces were subject to minor spring and unevenness, but this is within acceptable limits for domestic construction and not considered to be of structural significance. Indeed, it is quite common in older properties, particularly above ground floor level.

There is evidence of wood-boring insect infestation to exposed floorboards and whilst there were no signs of recent activity, you should confirm whether previous treatments have been made and if so, whether guarantees can be transferred under the sale.

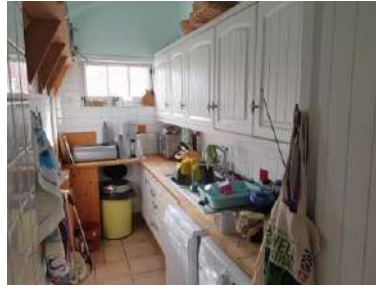
Water should not be allowed to sit on such surfaces as this can cause discoloration, staining and decay, where the oil sealant will become worn over time. Staining and wear and tear were apparent across the wooden worktops, whilst it should be possible to refurbish the woodwork with maintenance, the level of wear and tear is thought to be deeply ingrained within the timber, and it will likely be difficult to return them to their original condition.

The carcassing to these units is made of chipboard, which can deteriorate if it becomes wet. It is therefore necessary to protect the chipboard by maintaining the seals and laminating coverings in good condition. Some deterioration of the seals was observed and improvement to the mastic seal should be applied along the back edges of the kitchen worktops to prevent water penetration behind the units.

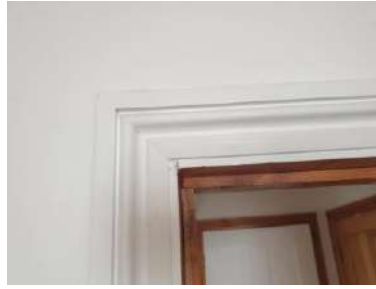
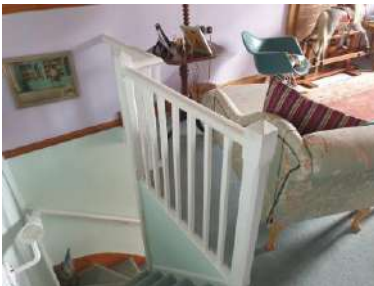
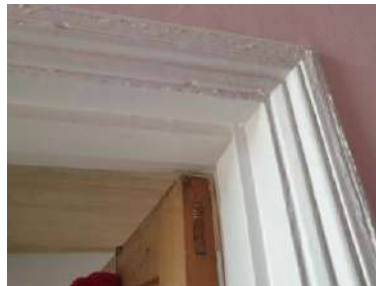
Banisters and balustrading appear to be complete with no signs of any defect noted. The gaps between spindles are 100mm or less which will comply with current Building Regulation standards.

Current Building Regulation standards recommend a height of between 900-1000mm to banisters and balustrading within Part K – Protection from Falling, Collision and Impact of the current Building Regulations.

As the height of the banister rails does not fall within 900-1000mm, the banisters should be replaced on taking occupation as the current arrangements are hazardous. The new railings should be designed in a way to prevent climbing, i.e. avoid horizontal rails.

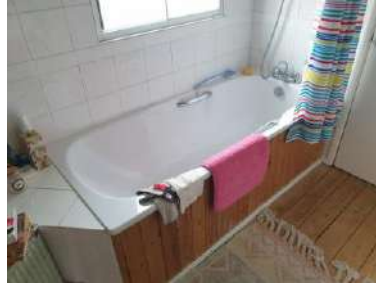
Sanitary fittings are dated and worn although apparently serviceable. As part of the general upgrading of the premises you may wish to consider replacing them.
