## RICS HOME SURVEY LEVEL 2

- SURVEY & VALUATION

**PROPERTY ADDRESS:**

Address

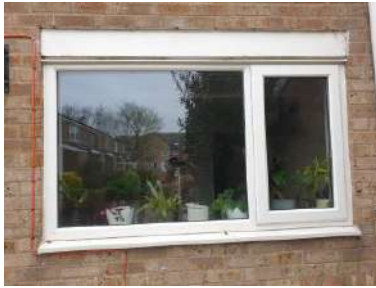
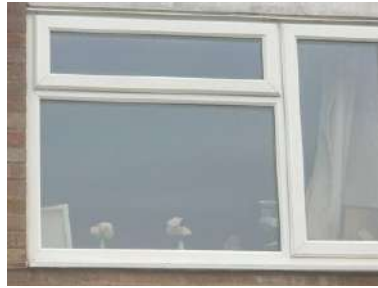
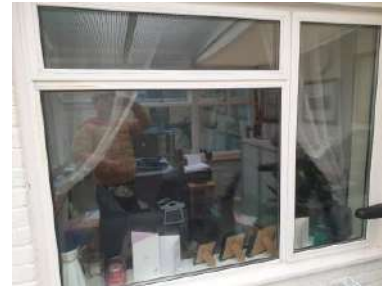
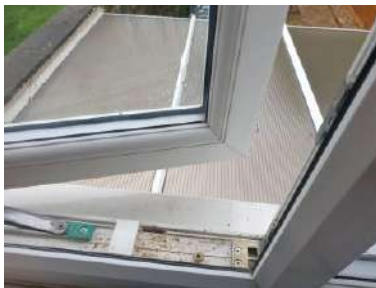
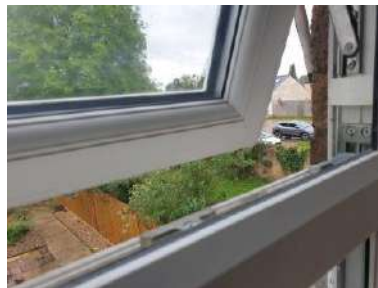
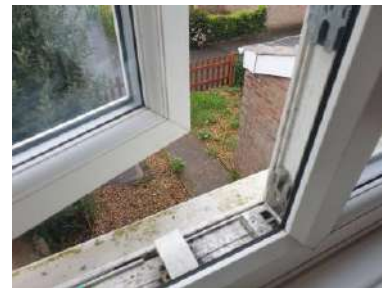
Where trickle ventilation has been provided to windows, this should allow a degree of natural ventilation when windows are closed.

Condition Rating: 2

You should ensure that you are provided with a full set of window keys on occupation.

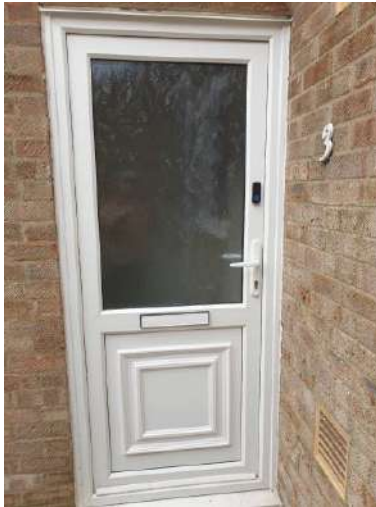
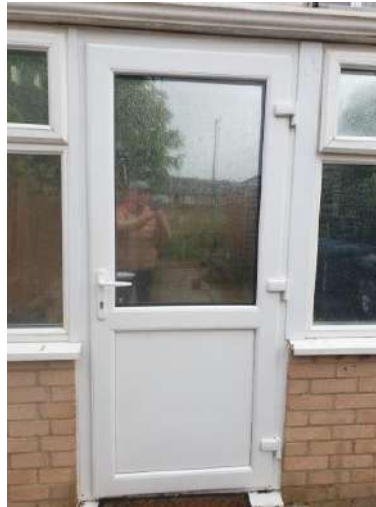
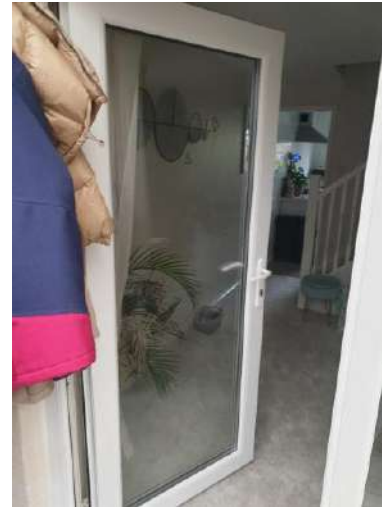
Doors open square to the eye with no signs of any significant movement or distortion noted.

Condition Rating: 1

We recommend you change all locks upon occupation to enhance security.

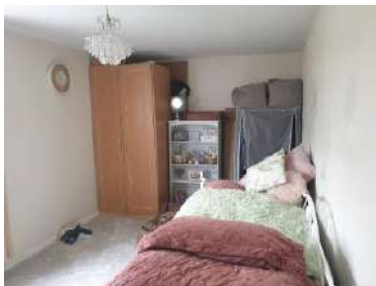
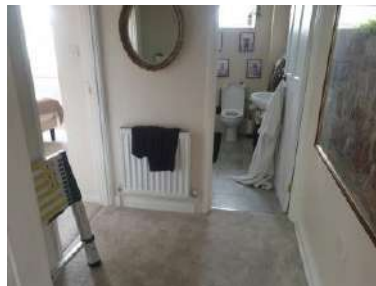
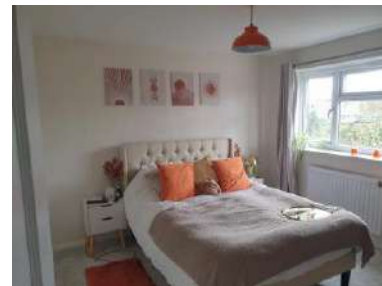
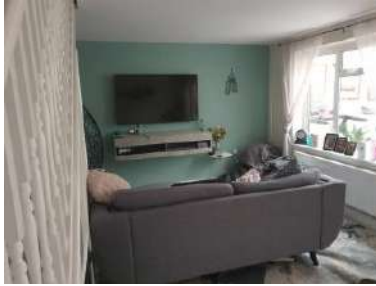
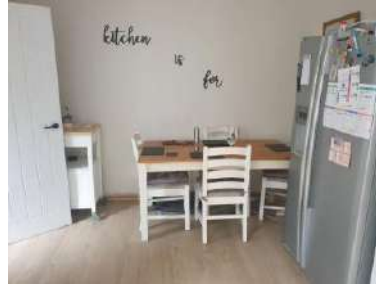
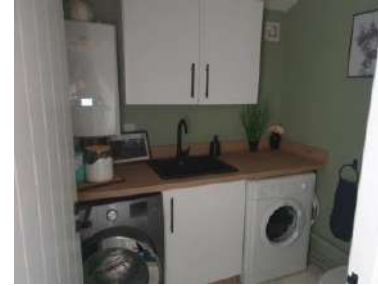
Moisture content readings were taken throughout the walls at regular intervals with an electronic damp meter and no significant dampness was recorded, suggesting the damp-proof course is operating effectively.

We also found no evidence of any significant penetrating dampness within the property.

Condition Rating: **1**

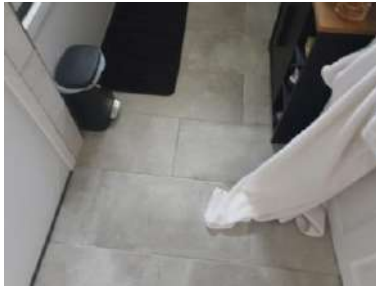
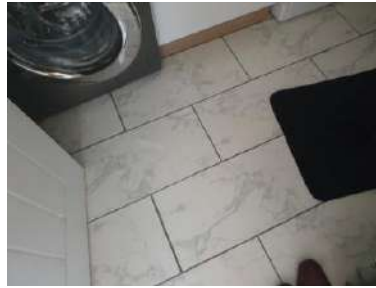
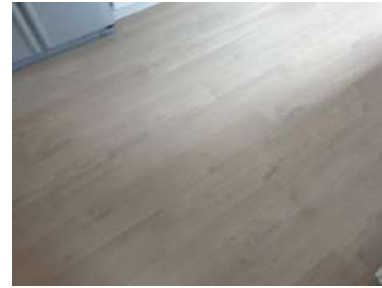
Ceramic tiles have been laid in the bathroom. These tiles are currently in a sound condition, but it must be recognised that they are inherently brittle and can become cracked when laid on timber flooring due to the natural springiness of the floor construction. Future defects may occur, and you may wish to replace these coverings with a more suitable finish in the long-term.

The flooring beneath the sanitary fittings could not be inspected as this would involve damaging investigations which are beyond the scope of a normal survey. If there has been leakage, such as from concealed pipework or through gaps in wall tiles, or around the bath, dampness may have caused serious rot in the floor. We found no evidence of timber decay, but further investigations would be necessary to establish whether any defects exist. If such work is to be undertaken, there will be some resultant damage and appropriate contractors should be appointed to undertake this work, with the vendor's permission, so that any replacement of panelling or flooring can be carefully undertaken.

Condition Rating: **1**

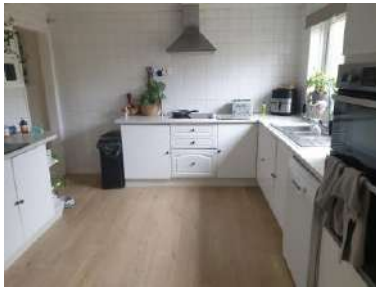
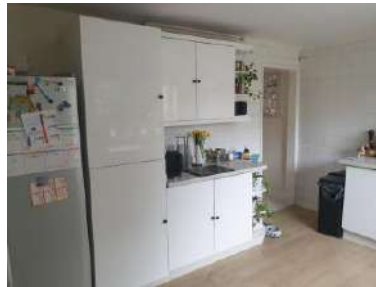
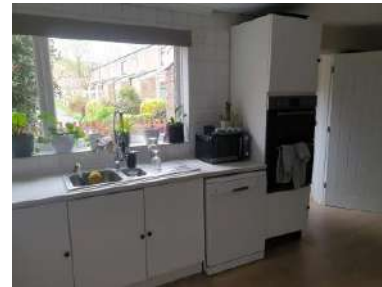
There is an electric hob fitted and you should confirm with your legal adviser whether this has any electrical safety certification. Please refer to section F1 of this report.

Most of the distribution and waste pipework is concealed behind the units and leaking pipework or other defects may not be readily apparent.

Condition Rating: **2**

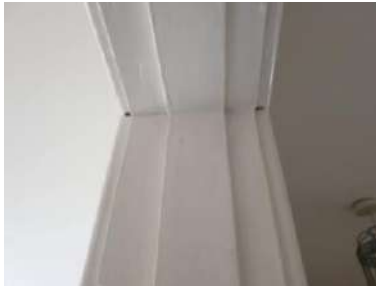
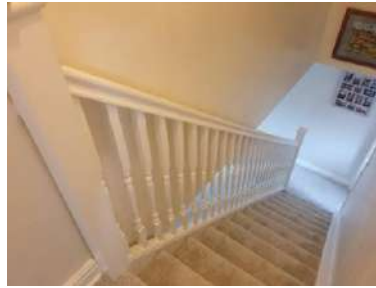
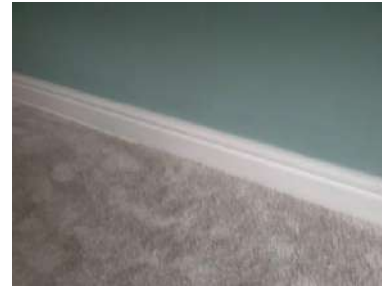
There is a satisfactory handrail to the staircase.

Banisters and balustrading appear to be complete with no signs of any defect noted. The gaps between spindles are 100mm or less which will comply with current Building Regulation standards.

Condition Rating: **2**

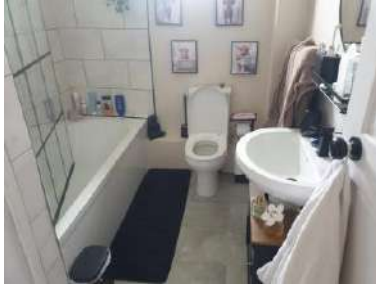
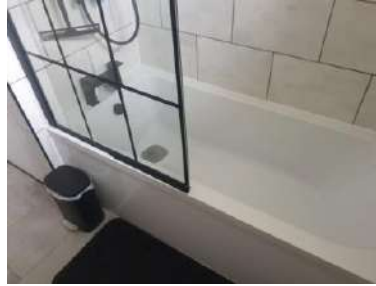
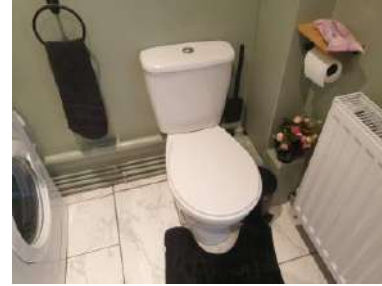
The water pressure was checked to several draw-off points and found to be adequate. Water pressure can vary seasonally and during times of high demand, both within the property and in the locality. It is recommended that should you wish to install water pressure sensitive items, such as a power shower, that further enquiries are made initially.

Most of the distribution and waste pipework is concealed beneath or behind sanitary ware items and whilst there were no obvious signs of leaks, the risk of hidden defects exists.

Condition Rating: 2
