RICS HOME SURVEY
LEVEL 3

PROPERTY ADDRESS:

CLIENT NAME(S):

DATE OF INSPECTION:

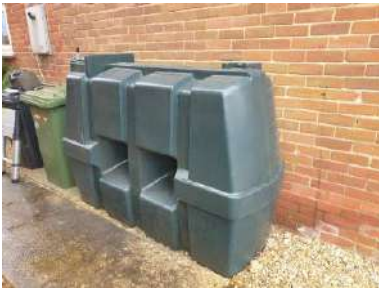
<https://www.oftec.org/>
As previously advised, a full inspection of the tank, including its location, should still be undertaken by an OFTEC registered engineer in the absence of documentary evidence dated within the last 12 months.

In order to plan and budget accordingly it is recommended that you obtain all necessary information through the vendor as to their current oil supplier, alongside the most recent costs to fill the tank and the frequency in which refills have been required throughout their occupancy.

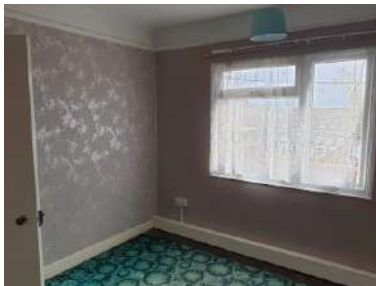
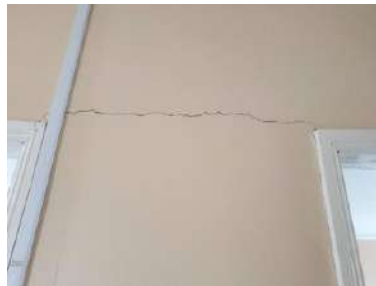
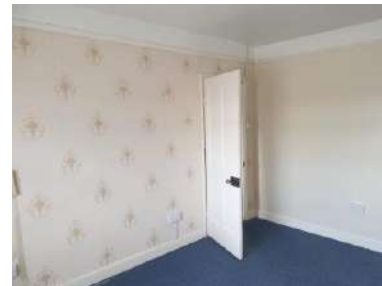
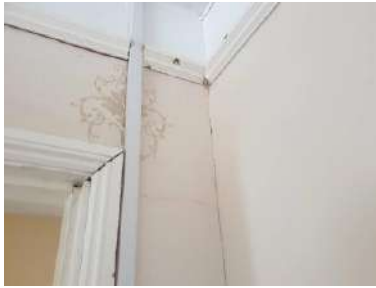
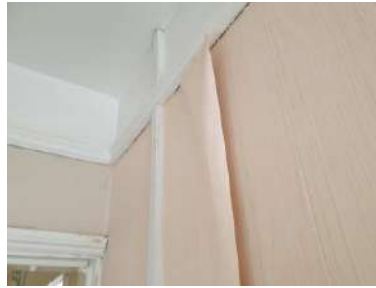
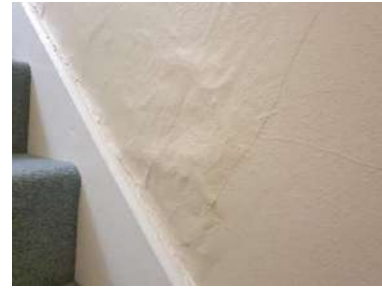
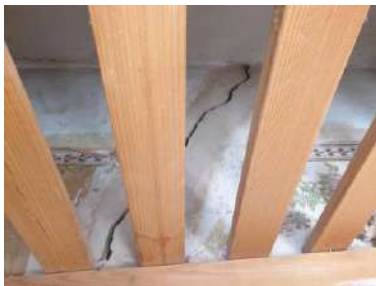
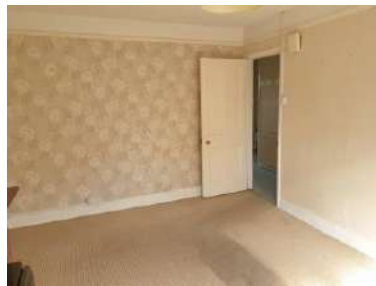
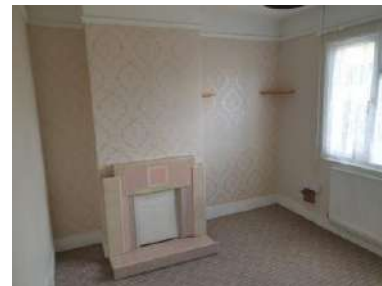
Please be aware that older properties are likely to suffer a degree of dampness and you will have to decide on what level of dampness you are prepared to accept before proceeding.

It should also be noted that remedial treatments, such as chemical injection, are not always sympathetic a period property. There are often a number of remedial measures which can be undertaken in order to alleviate the burden of moisture and possible dampness without the need for any chemical or other forms of treatment, and a specialist contractor will be able to advise accordingly in this regard.

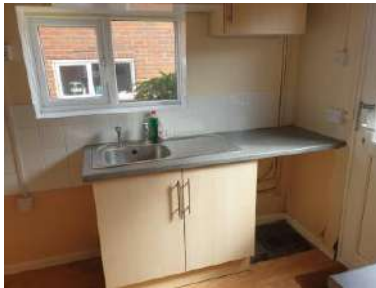
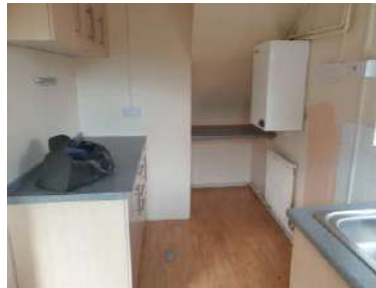
Most of the distribution and waste pipework is concealed behind the units and leaking pipework or other defects may not be readily apparent.

It would be prudent to provide mechanical extract ventilation within the to reduce the possibility of condensation problems occurring.

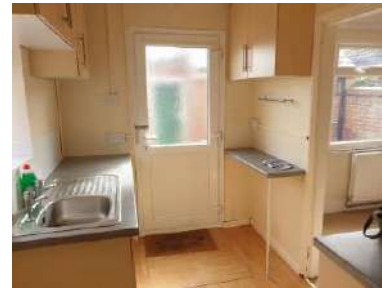
Condition Rating: 2

Some general marking and bruising are apparent consistent with normal wear and tear and some minor repairs will need to be carried out prior to redecoration.

Accessible doors were checked in accordance with RICS guidance to establish the ease with which they may be opened and shut. Doors and openings open square to the eye with no signs of any significant movement or distortion noted.

The property has a timber staircase which is carpeted on the upper surface and enclosed beneath. Treads and risers appear to be firm and level and within normal tolerances, with no signs of any significant spring or undulation noted.

Banisters and balustrading appear to be complete with no signs of any defect noted. The gaps between spindles are 100mm or less which will comply with current Building Regulation standards.
