**RICS HOME SURVEY
LEVEL 2**
- SURVEY ONLY

Friday 18 October 2024

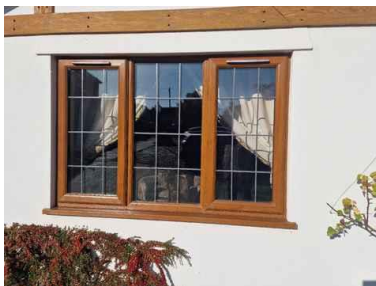
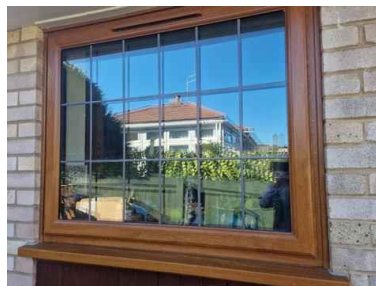
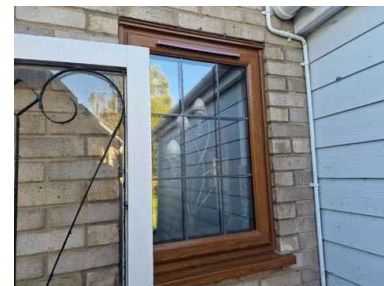
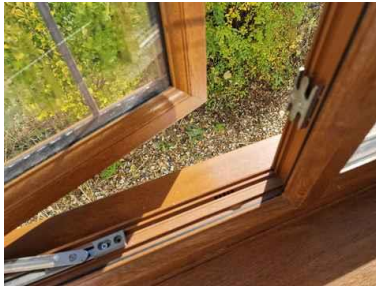
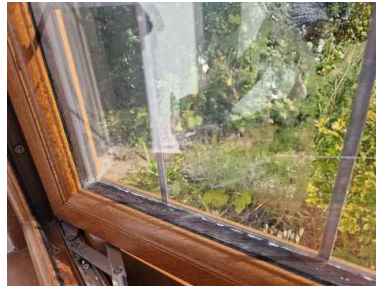
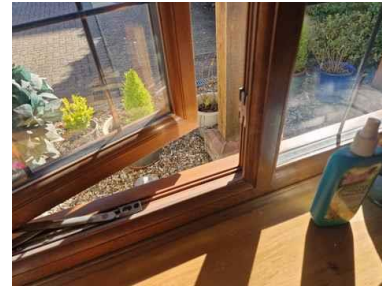
Where trickle ventilation has been provided to windows, this should allow a degree of natural ventilation when windows are closed.

Condition Rating: 2

You should ensure that you are provided with a full set of window keys on occupation.

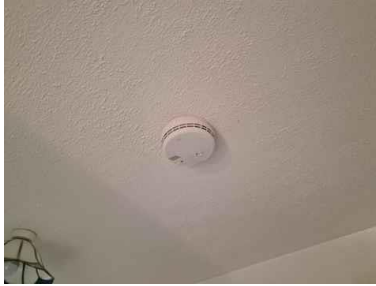
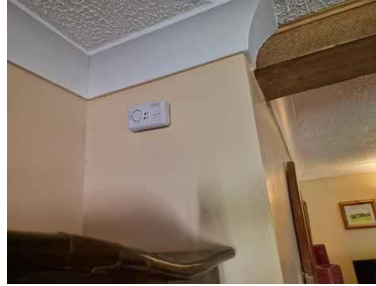
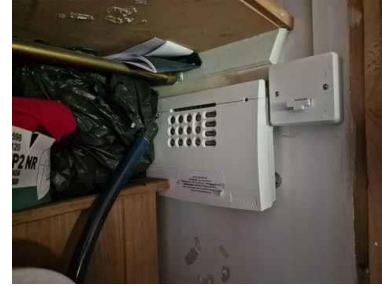
Where there is an active fireplace appliance, carbon monoxide alarms have been installed and should be maintained in line with the alarm manufacturer's guidelines.

There appears to be an intruder alarm fitted for which there may be guarantees and a service contract. Legal Advisors to confirm.

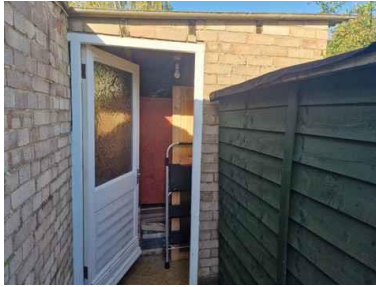
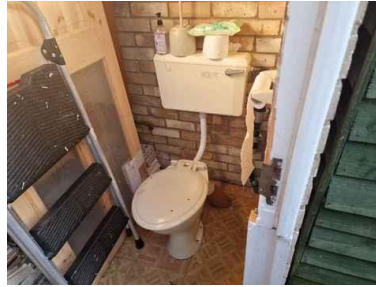
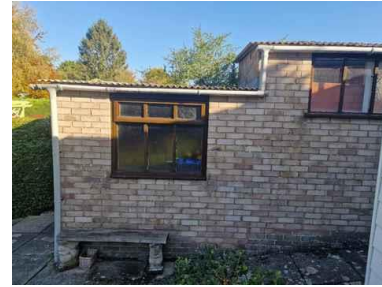
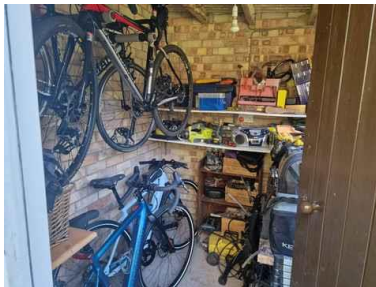
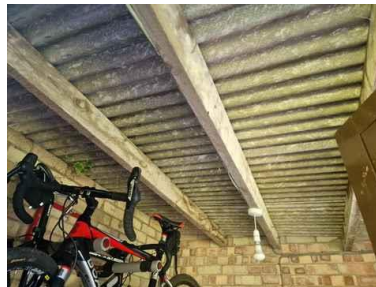
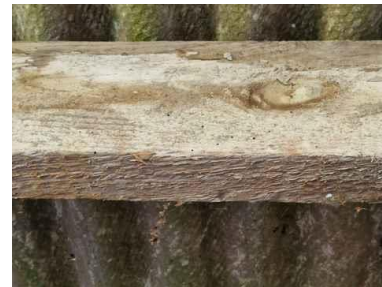
There is evidence of wood-boring insect infestation to the roof timbers within the rear outbuilding (for example) and whilst there were no signs of recent activity, you should confirm whether previous treatments have been made and if so, whether guarantees can be transferred under the sale.

Condition Rating: **2**
