**RICS HOME SURVEY  
LEVEL 3**

Wednesday 2 October 2024

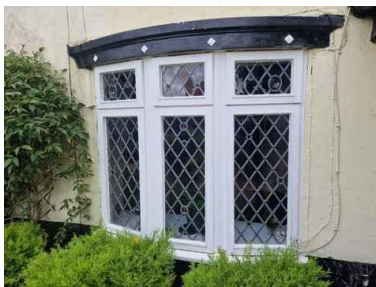
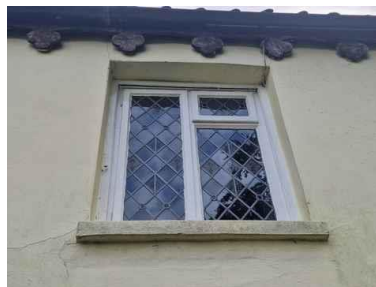
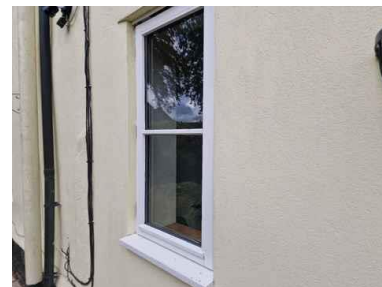
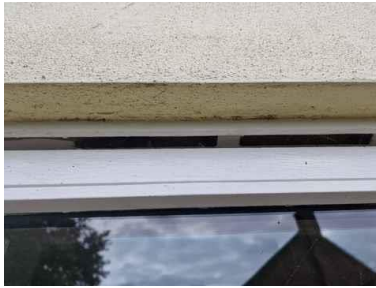
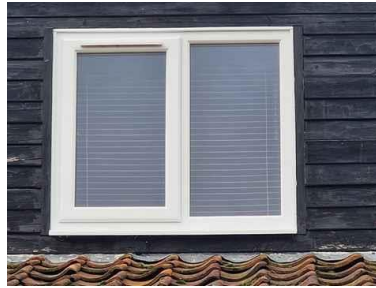
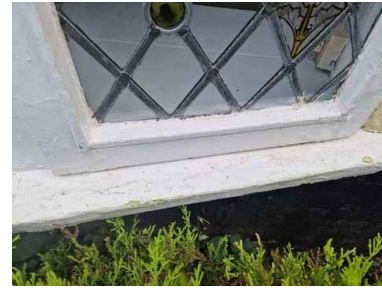
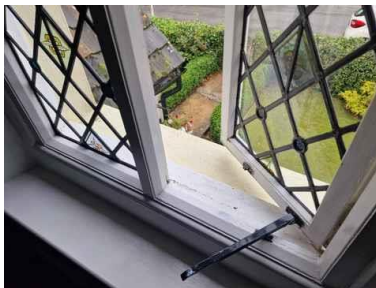
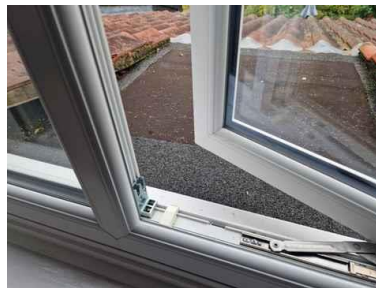
Where trickle ventilation has been provided to windows, this should allow a degree of natural ventilation when windows are closed.

You should ensure that you are provided with a full set of window keys on occupation.

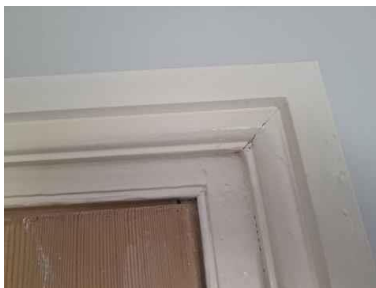
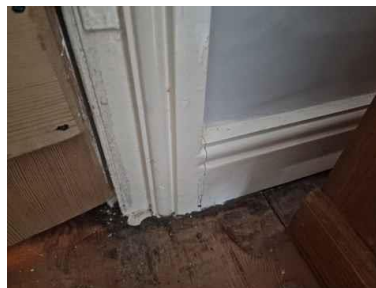
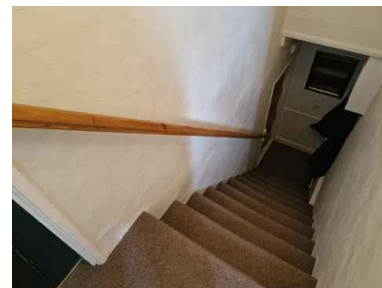
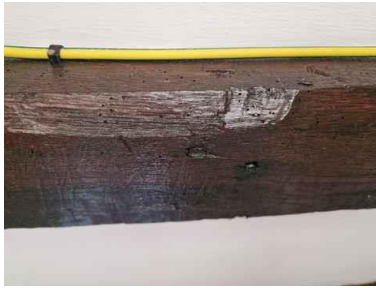
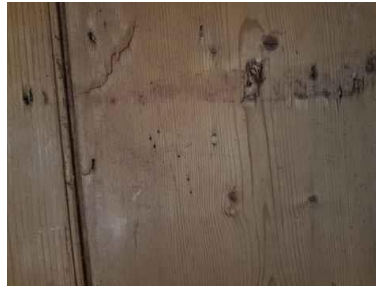
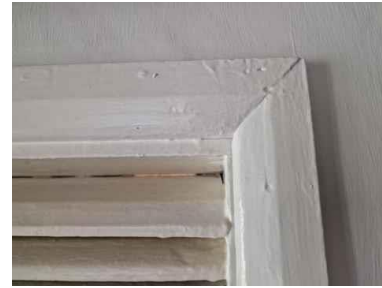
There is evidence of wood-boring insect infestation to the sitting room door and internal beams and whilst there were no signs of recent activity, you should confirm whether previous treatments have been carried out and if so, whether guarantees can be transferred under the sale.

Please note in a property of this age there may be evidence of wood-boring insect activity (historic or active) in concealed areas, although we did not find any during the inspection. You may wish to arrange for a precautionary inspection as part of your due diligence prior to purchase. Your legal advisor should also seek evidence of any previous treatments and associated guarantees.

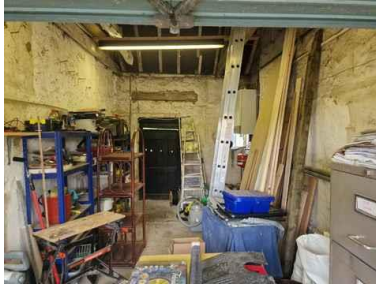
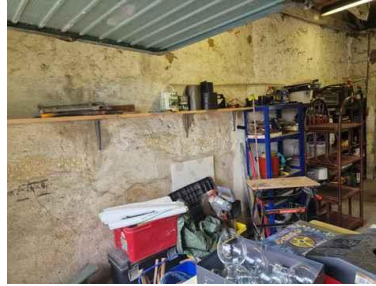
There is evidence of wood-boring insect infestation to the roof timbers within the garage and whilst there were no signs of recent activity, you should confirm whether previous treatments have been made and if so, whether guarantees can be transferred under the sale.

The electrical services to the garage should be tested by a qualified electrician alongside the electrics to the property. Please see also section F1 of this report.

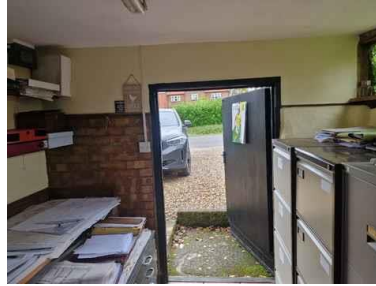
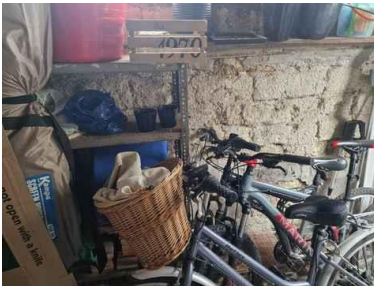
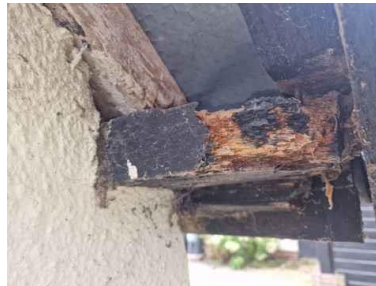
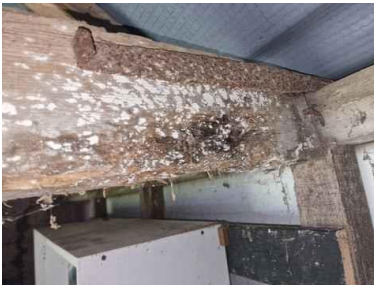
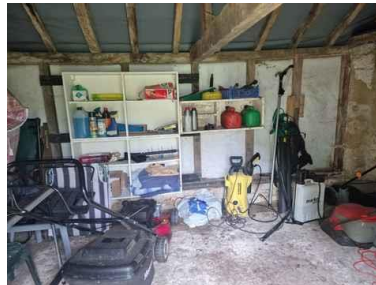
There is a clay lump outbuilding to the rear which is constructed beneath a pitched and tiled roof. There were no significant structural issues noted to the outbuilding at the time of the inspection. There is evidence of wood-boring insect infestation to the roof timbers within the outbuilding and whilst there were no signs of recent activity, you should confirm whether previous treatments have been made and if so, whether guarantees can be transferred under the sale. The render to the rear is in poor condition as is the outbuilding generally. Depending on your intended usage you may wish to obtain quotes for repair and upgrading works prior to a legal commitment to purchase. The electrical services to the outbuilding should be tested by a qualified electrician alongside the electrics to the property. Please see also section F1 of this report. Timber outhouses such as sheds and summerhouses are considered to be temporary and beyond the scope of the report and have not been inspected.

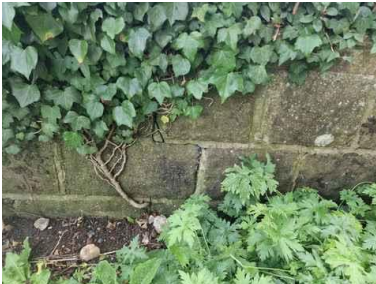
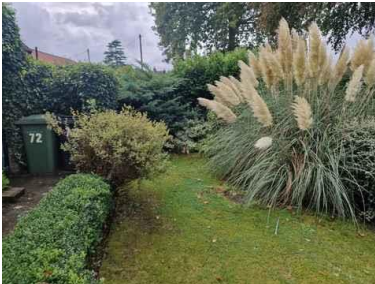
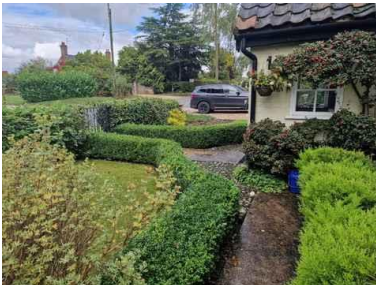
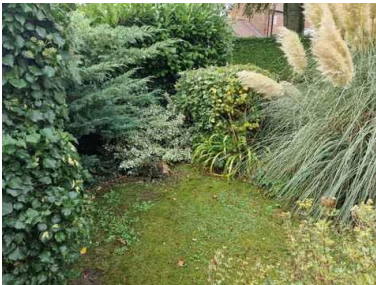
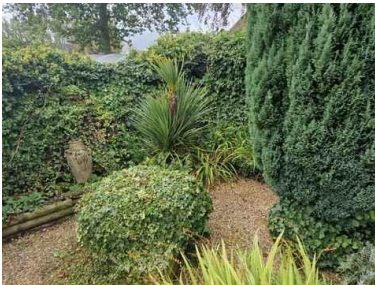
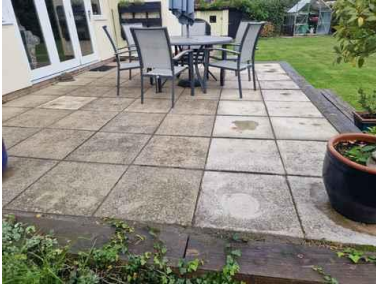
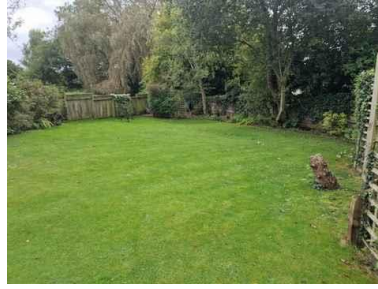
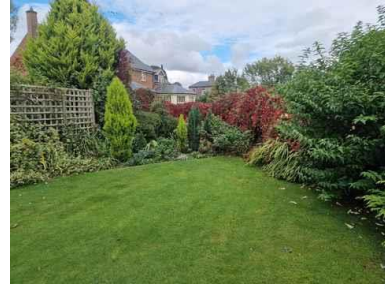
The driveway, paths and patio may be slippery in wet or icy conditions.

Where there are boundary walls, these features will require high levels of maintenance and are currently suffering from deterioration, evidenced by the front wall. You should seek quotations for repairs prior to commitment to purchase in order to budget accordingly

It is recommended that a certified copy of the Deed Plans be obtained, and boundaries checked on site, with any discrepancies investigated further, to assist in reducing the possibility of boundary disputes with adjoining owners.

Responsibilities for boundaries are unknown and repair liabilities should be investigated further.
