**RICS HOME SURVEY
LEVEL 3**

DATE OF INSPECTION:

Monday, 19 August 2024

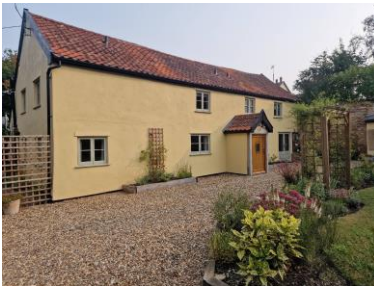
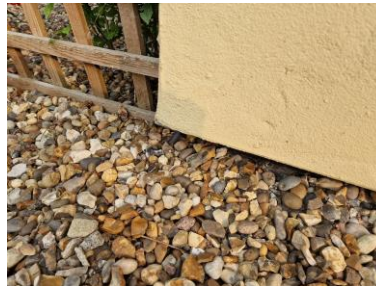
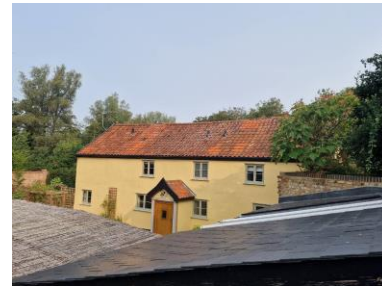
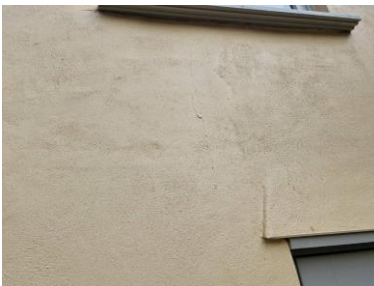
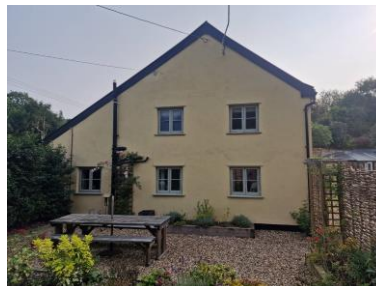
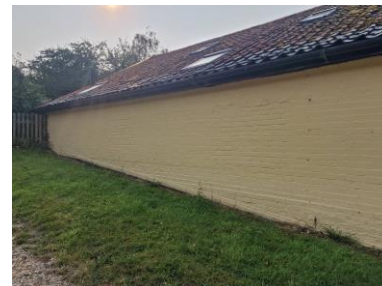
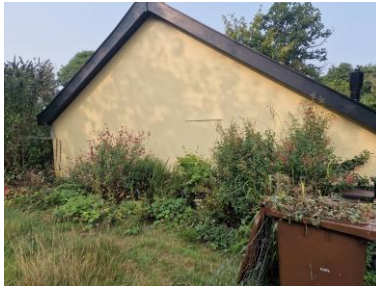
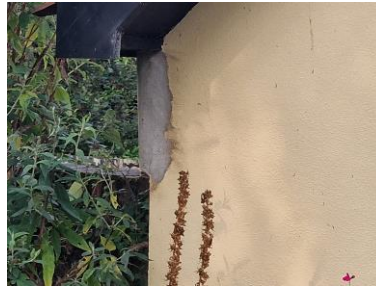
Subsoils within the area may include shrinkable clay and these are subject to seasonal changes in ground conditions. You should maintain trees and shrubs close to the property in order that ground conditions remain as stable as possible.

Where walls which form part of the external wall (right elevation) of the property are retaining walls, you should be aware that moisture is generally kept at bay by tanking, for example with bitumen or similar material. This type of tanking can fail especially when penetrated. This may not be readily visible, and dampness could be affecting the internal wall or may do so in the future, which may not have been apparent at inspection. The vendor stated the walls have been tanked as part of the recent refurbishment and your Legal Adviser should request any guarantees available.

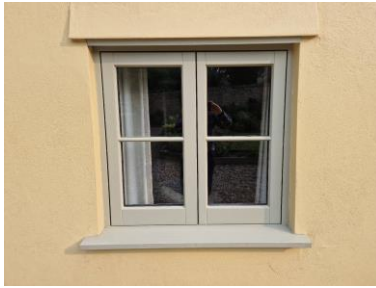
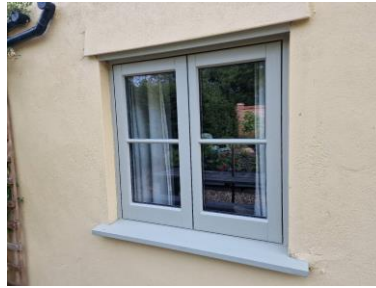
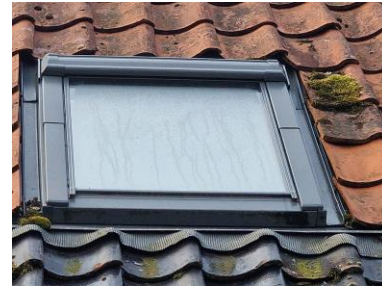
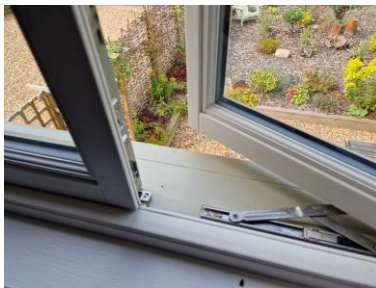
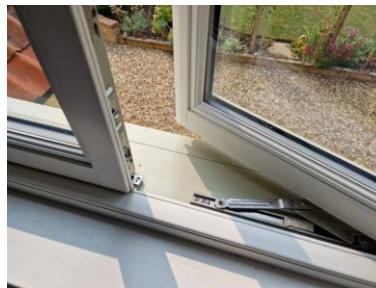
Toughened glazing appears to be present where required.

You should ensure that you are provided with a full set of window keys on occupation.

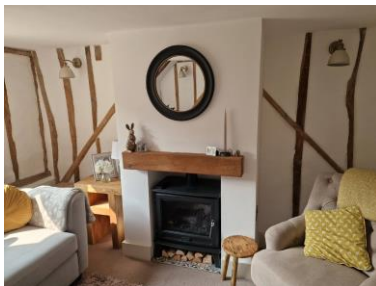
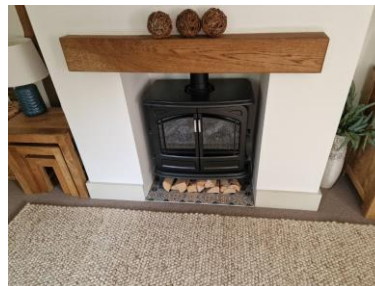
There are electric fires within the living rooms.

The electrical fire appliances were not inspected, and this should be tested in conjunction with the electrical circuitry prior to use.

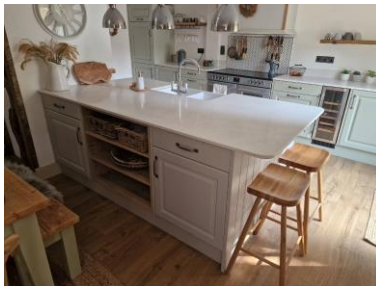
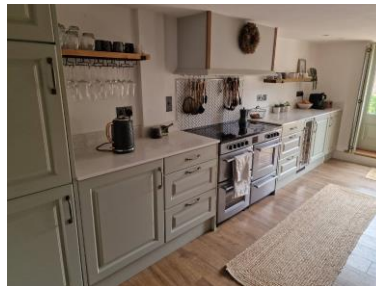
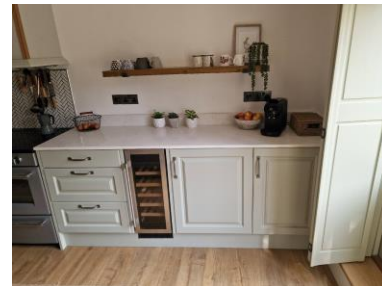
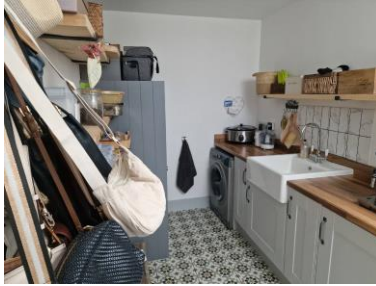
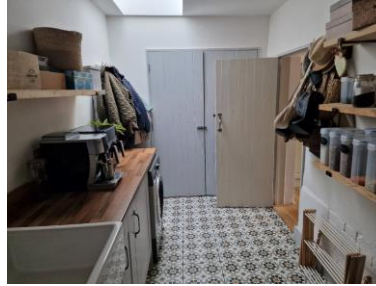
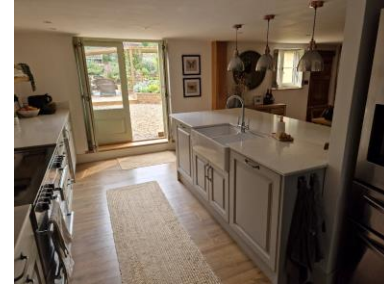
Ventilation appears adequate and should be regularly maintained.

Most of the distribution and waste pipework is concealed behind the units and leaking pipework or other defects may not be readily apparent.

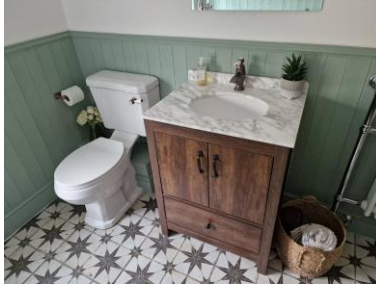
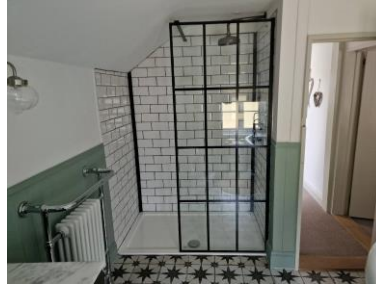
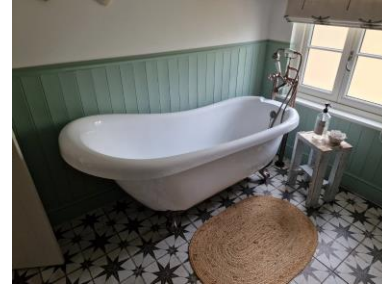
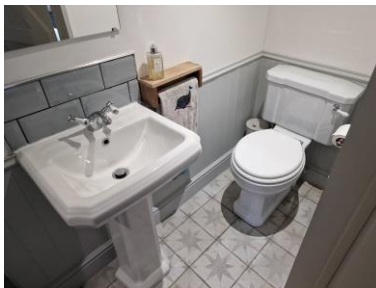
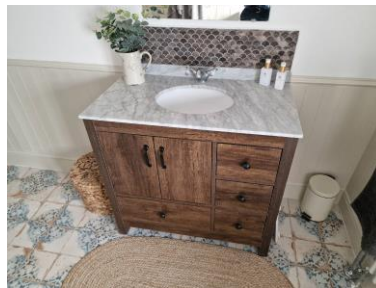
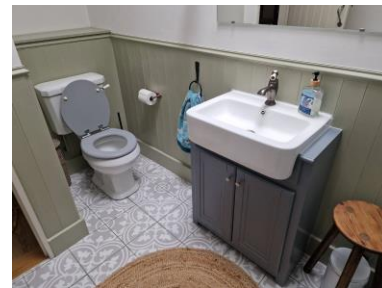
The seals around the sanitaryware were found to be in a serviceable condition and should be maintained.

Most of the distribution and waste pipework is concealed beneath or behind sanitary ware items and whilst there were no obvious signs of leaks, the risk of hidden defects exists.

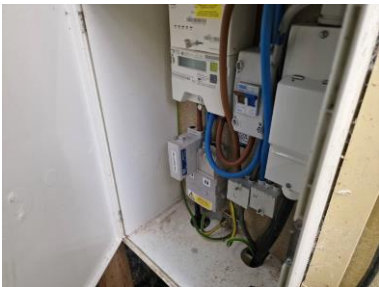
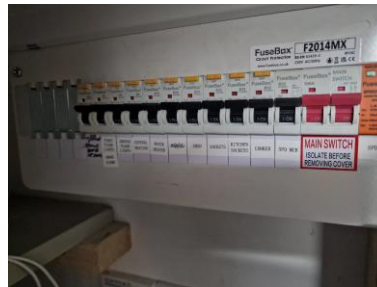
The electrical installation is provided with an RCD which is designed to protect the users from electric shock. These installations are extremely sensitive and consequently occasional tripping of switches will occur, effectively shutting down the affected circuit(s). It can often result when a light bulb fails, or it may be the result of a defective appliance. When this happens, the 'trip-switch' must be reset. If this occurs with any frequency, an electrician should be instructed to investigate.

Although there were no particular areas of concern, we do endorse the Electrical Safety Council's recommendations and a precautionary electrical inspection should therefore still be undertaken, to ensure that circuitry complies with current electrical regulations, prior to a legal commitment to purchase. All recommendations should be fully costed and implemented.

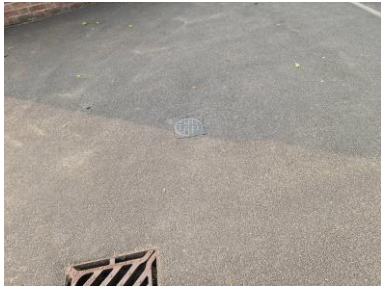
The internal stop tap was hidden from view, and you should confirm its location prior to taking occupation.

The external stop tap is located in the Path just outside the main gates. You should confirm whether a water meter is provided.

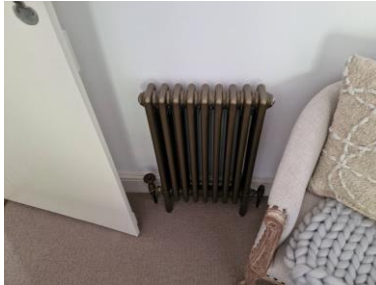
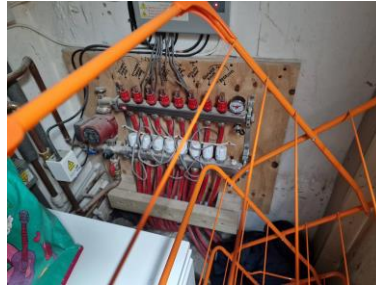
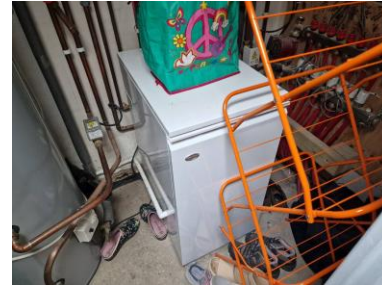
Electrical underfloor heating is provided to the 1st floor bathrooms. It should be noted that electrical underfloor heating is generally more costly when compared to plumbed underfloor heating due to the higher energy cost. This installation should be tested alongside the general electrical installation as described in Section G1 of this report.

We have not carried out any calculations and cannot confirm the heating is adequate to achieve satisfactory temperatures. We recommend that the system be assessed and if found to be inadequate, upgrading may be required.

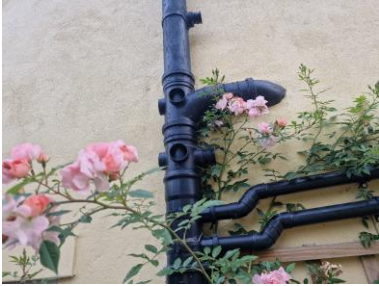
There were no above ground signs of blockage or damage or other significant defect at the time of our inspection however without a full inspection by a drainage specialist, you must accept the risk of such defects existing.

The soil and vent pipe is of uPVC construction and is in serviceable condition at present
