**RICS HOME SURVEY
LEVEL 3**

DATE OF INSPECTION:

Thursday 17 October 2024

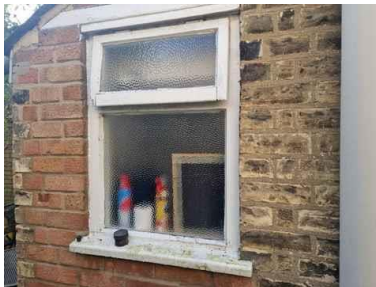
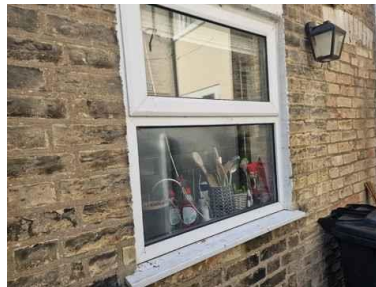
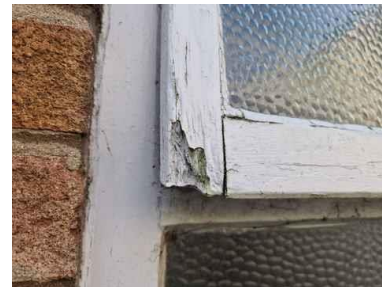
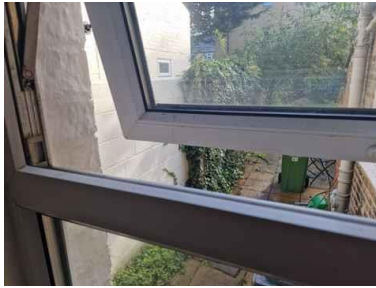
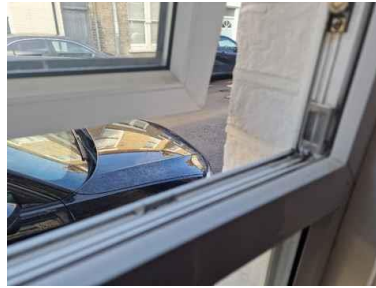
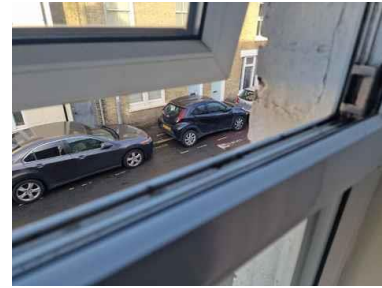
You should ensure that you are provided with a full set of window keys on occupation.

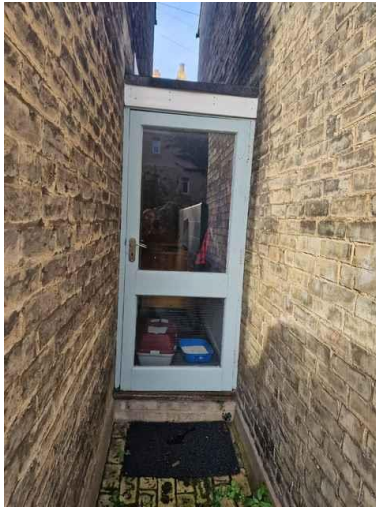
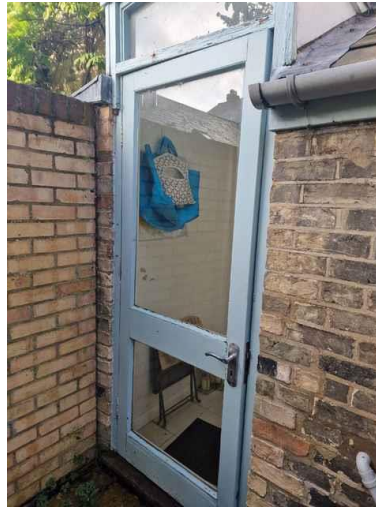
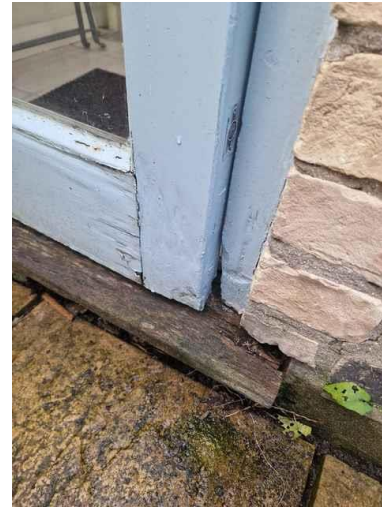
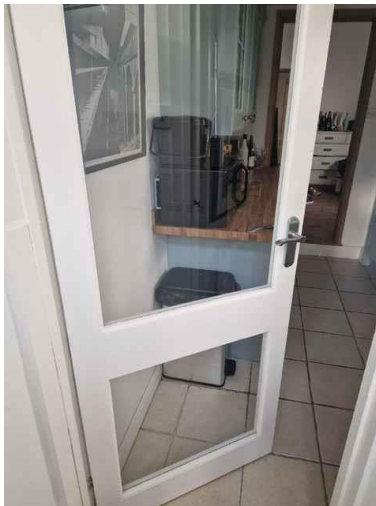
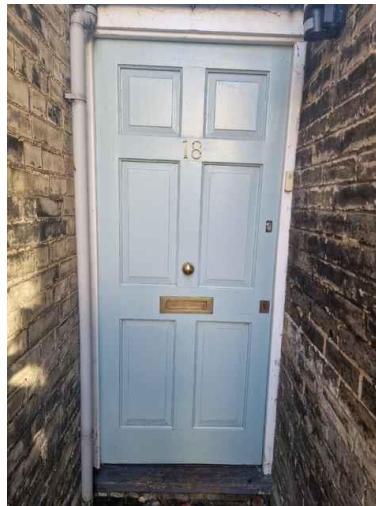
Doors open square to the eye with no signs of any significant movement or distortion noted.

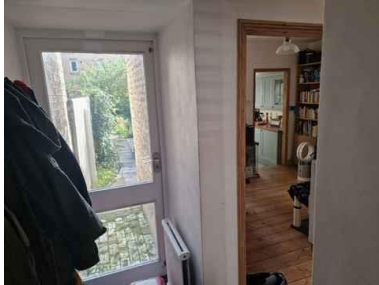
The porch is a later addition to the property and given the absence of a fixed doorway to the main dwelling, Local Authority consents and Building Regulations approval are believed to have

been required for the construction. Legal advisors to confirm that all required consents and regulations have been sought and complied with.

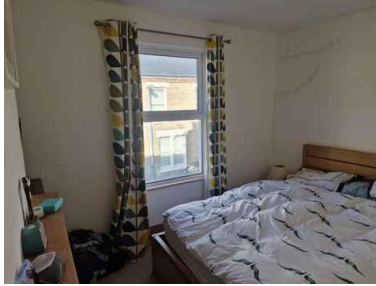
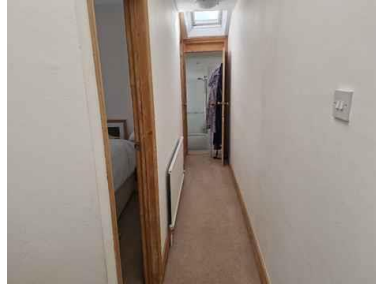
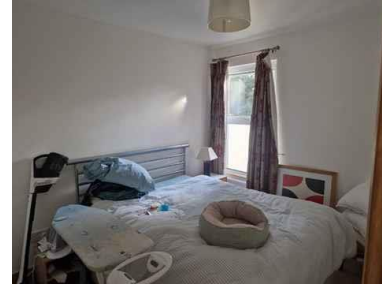
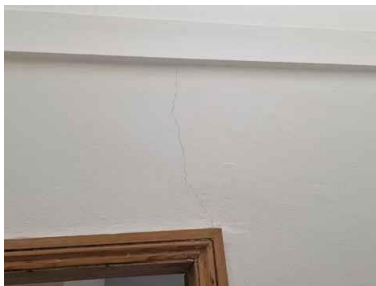
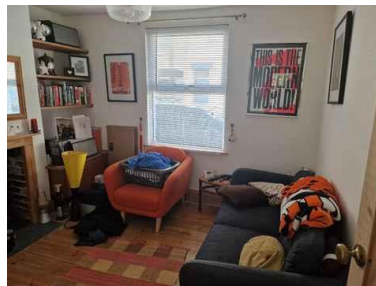
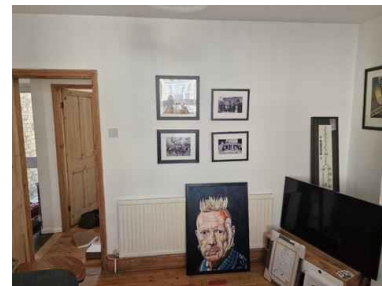
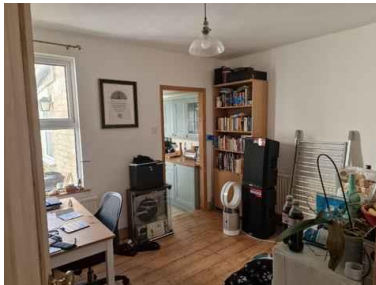
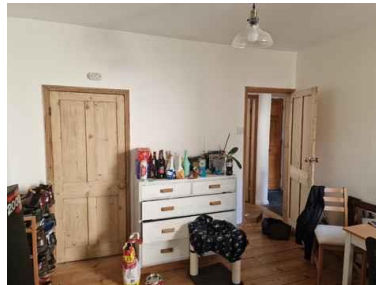
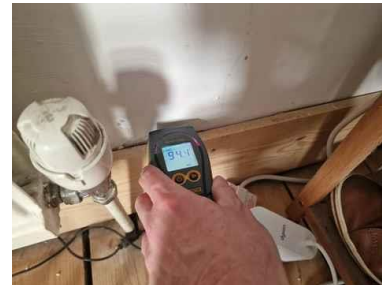
Please be aware that older properties are likely to suffer a degree of dampness, and you will have to decide on what level of dampness you are prepared to accept before proceeding.

It should also be noted that remedial treatments, such as chemical injection, are not always sympathetic a period property. There are often a number of remedial measures which can be undertaken in order to alleviate the burden of moisture and possible dampness without the need for any chemical or other forms of treatment, and a specialist contractor will be able to advise accordingly in this regard.

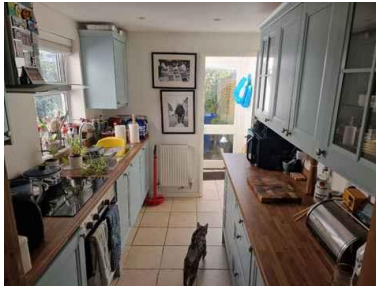
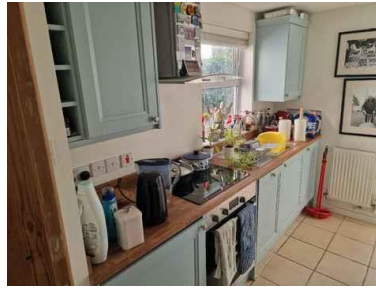
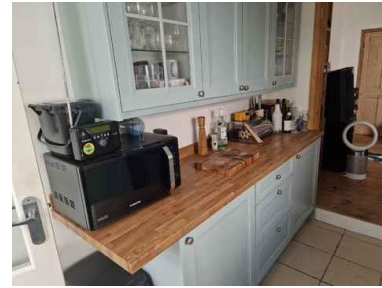
There is an electric hob fitted and you should confirm with your legal adviser whether this has any electrical safety certification. Please refer to section F1 of this report.

Most of the distribution and waste pipework is concealed behind the units and leaking pipework or other defects may not be readily apparent.

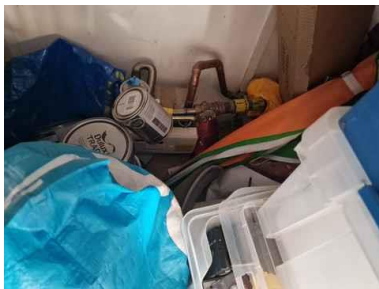
Condition Rating: **3**

Most of the internal distribution pipework is concealed within the structure or behind fittings and whilst there were no obvious signs of significant leaks, the possibility of concealed defects exists.

The external stop tap could not be found and you should ask the water supplier to tell you where it is located so that you can turn off the water in an emergency.

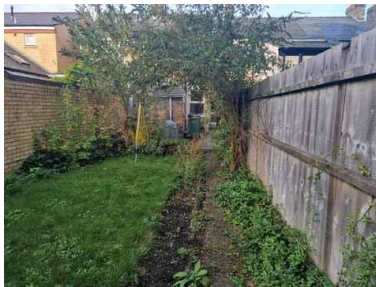
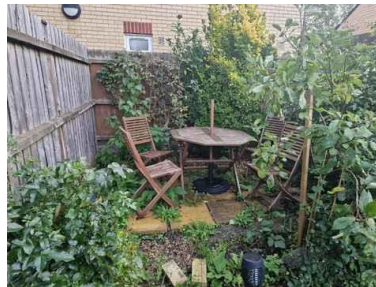
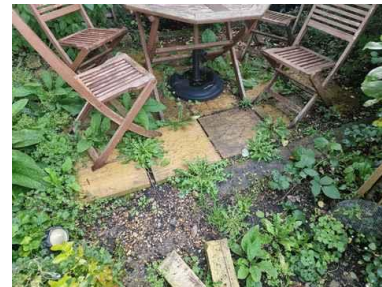
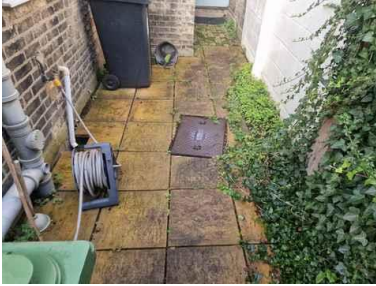
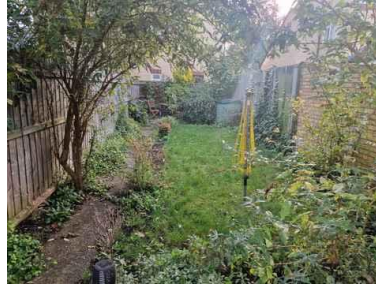
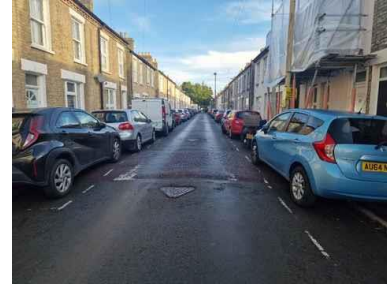
The outside areas and gardens appear to be adequately maintained.

Where there are boundary walls, these features will require high levels of maintenance and are currently in a reasonable condition.
