**RICS HOME SURVEY  
LEVEL 2**

- SURVEY ONLY

Friday 18 October 2024

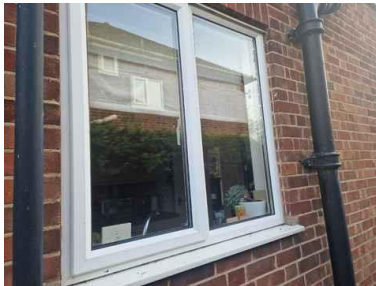
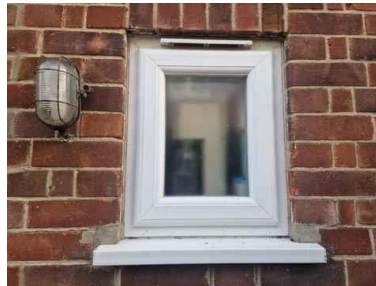
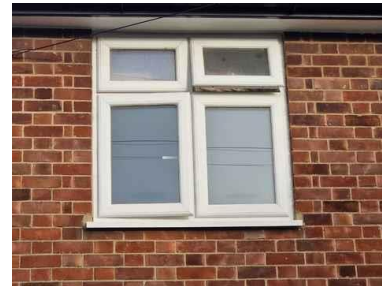
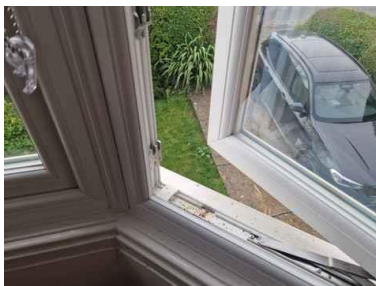
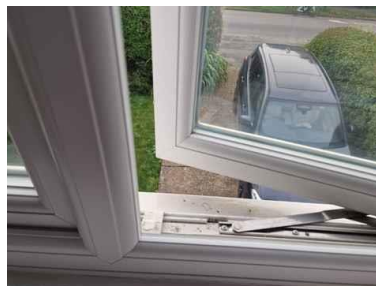
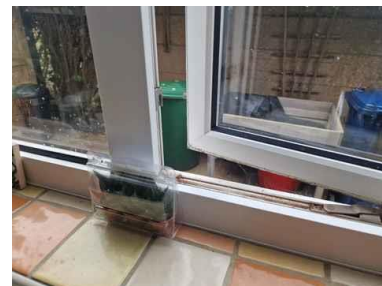
Where trickle ventilation has been provided to windows, this should allow a degree of natural ventilation when windows are closed.

Condition Rating: 2

You should ensure that you are provided with a full set of window keys on occupation.

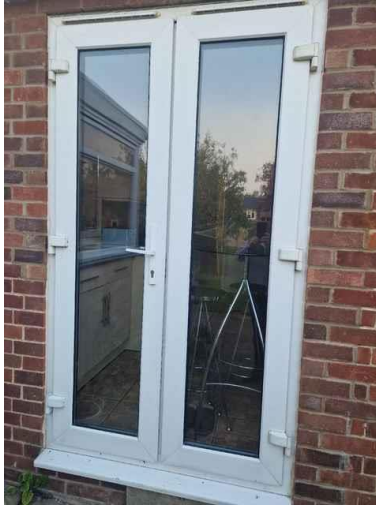
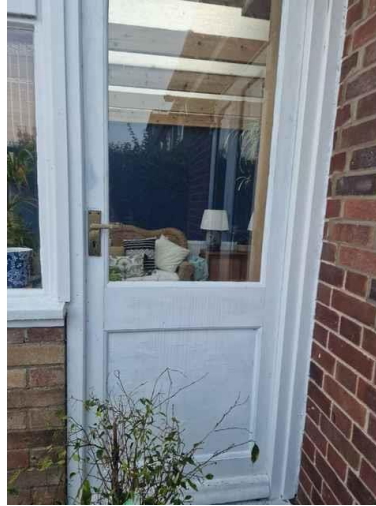
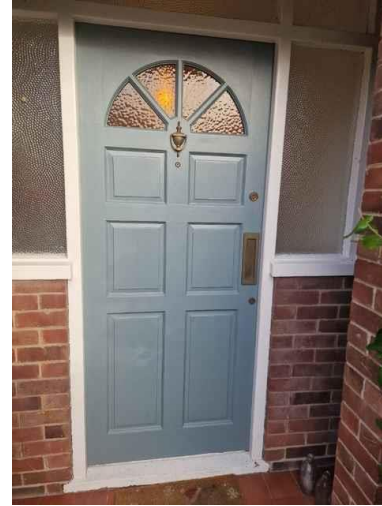
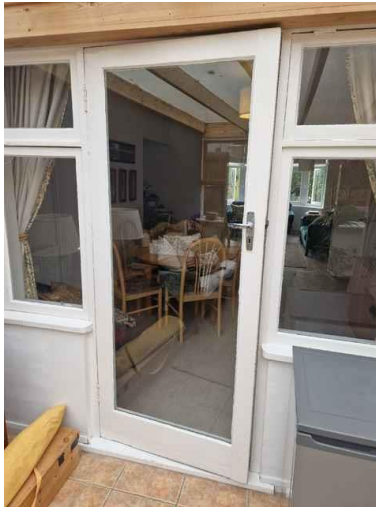
Doors open square to the eye with no signs of any significant movement or distortion noted.

Condition Rating: **2**

We recommend you change all locks upon occupation to enhance security.

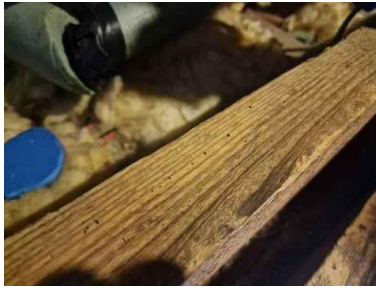
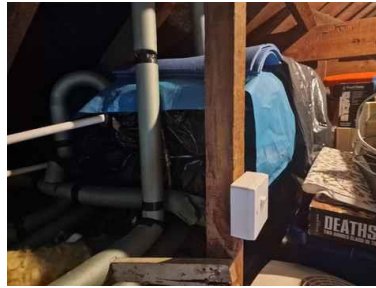
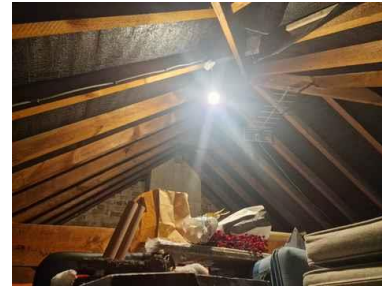
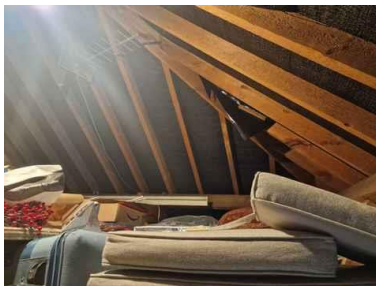
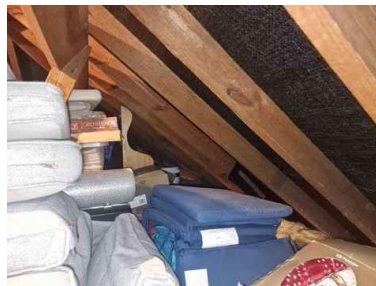
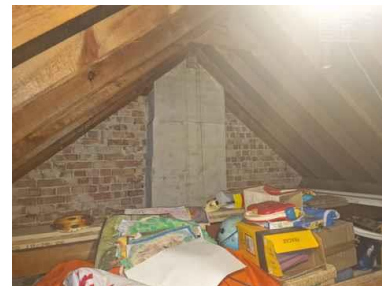
The cold-water storage tanks are of plastic construction and are adequately covered, supported and insulated, with overflow pipes extending to the exterior of the property.

The roof space did contain items of storage, limiting the full extent of our inspection. Should you wish to use this area for storage it should be ensured that boarding is securely fixed, and storage limited in order to reduce possible over-loading of the roof and ceiling structure.

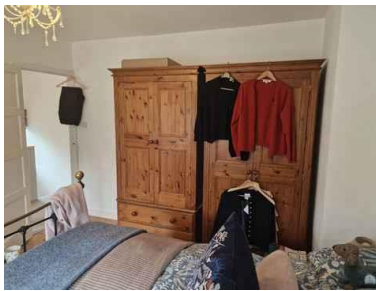
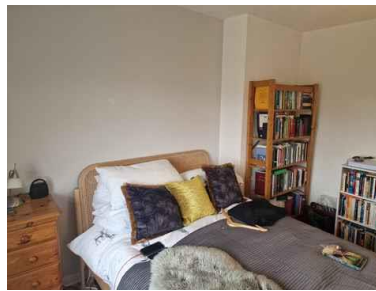
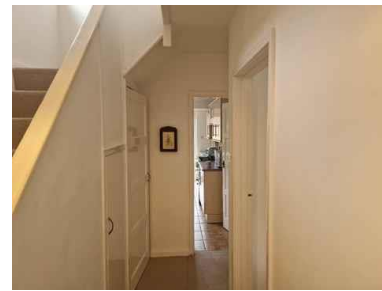
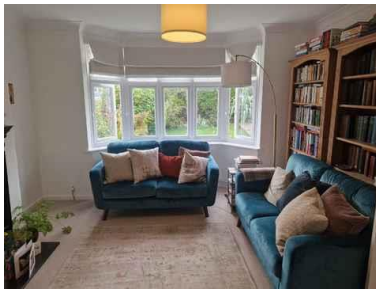
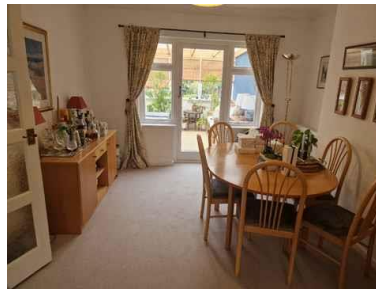
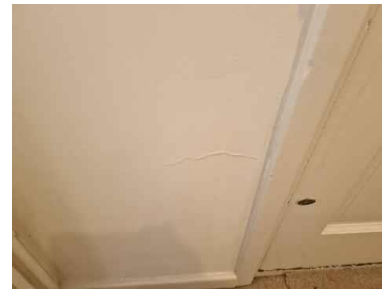
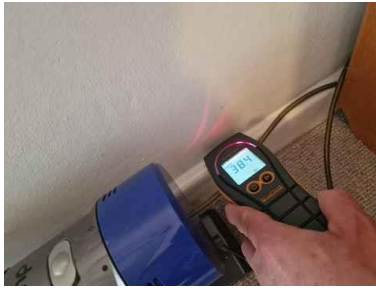
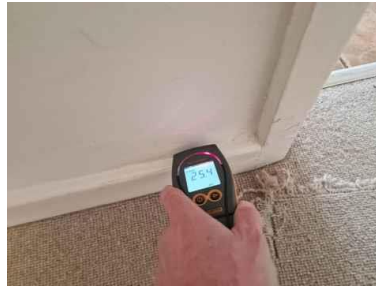
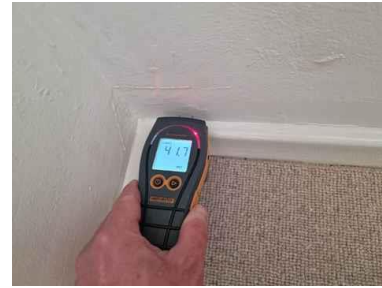
Please be aware that older properties are likely to suffer a degree of dampness, and you will have to decide on what level of dampness you are prepared to accept before proceeding.

Condition Rating: **3**

It should also be noted that remedial treatments, such as chemical injection, are not always sympathetic a period property. There are often a number of remedial measures which can be undertaken in order to alleviate the burden of moisture and possible dampness without the need for any chemical or other forms of treatment, and a specialist contractor will be able to advise accordingly in this regard.

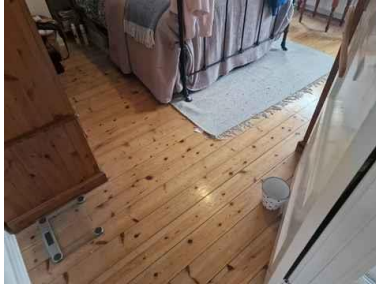
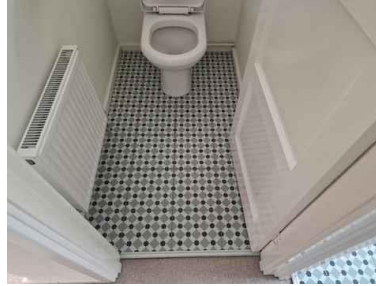
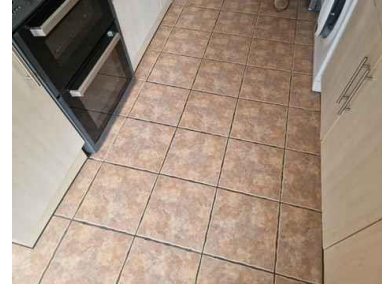
Ceramic tiles have been laid in the bathroom and WC. These tiles are currently in a sound condition, but it must be recognised that they are inherently brittle and can become cracked when laid on timber flooring due to the natural springiness of the floor construction. Future defects may occur, and you may wish to replace these coverings with a more suitable finish in the long-term.

The flooring beneath the sanitary fittings could not be inspected as this would involve damaging investigations which are beyond the scope of a normal survey. If there has been leakage, such as from concealed pipework or through gaps in wall tiles, or around the bath, dampness may have caused serious rot in the floor. We found no evidence of timber decay, but further investigations would be necessary to establish whether any defects exist. If such work is to be undertaken, there will be some resultant damage and appropriate contractors should be appointed to undertake this work, with the vendor's permission, so that any replacement of panelling or flooring can be carefully undertaken.

Condition Rating: 1

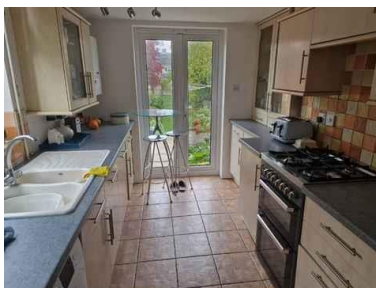
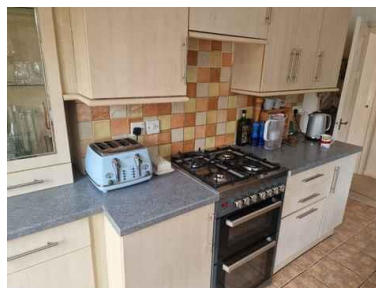
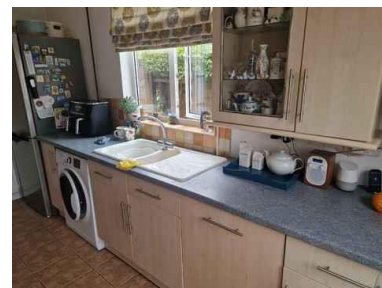
There is a gas hob fitted, and you should confirm with your Legal Advisor whether this has any Gas Safety Certification. See Section F2 of this report.

Most of the distribution and waste pipework is concealed behind the units and leaking pipework or other defects may not be readily apparent.

Condition Rating: 2

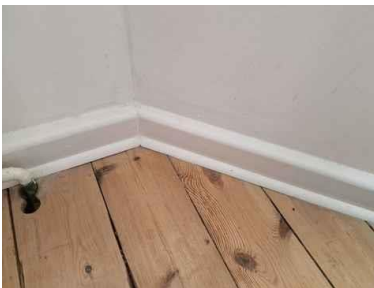
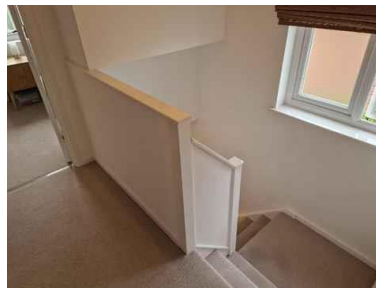
Banisters and balustrading appear to be complete with no signs of any defect noted. The gaps between spindles are 100mm or less which will comply with current Building Regulation standards.

Please note in a property of this age there may be evidence of wood-boring insect activity (historic or active) in concealed areas, although we did not find any during the inspection. You may wish to arrange for a precautionary inspection as part of your due diligence prior to purchase. Your legal advisor should also seek evidence of any previous treatments and associated guarantees.

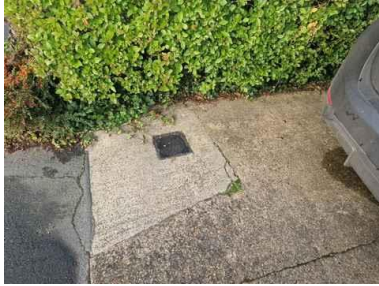
Condition Rating: **3**

Most of the internal distribution pipework is concealed within the structure or behind fittings and whilst there were no obvious signs of significant leaks, the possibility of concealed defects exists.

The internal rising main and stop tap are located in the kitchen cupboard to the left of the washing machine (as stated by the vendor). Personal effects prevented observation of the stop tap and the risk of unseen defects exists.

The external stop tap is located in the front path. You should confirm whether a water meter is provided.

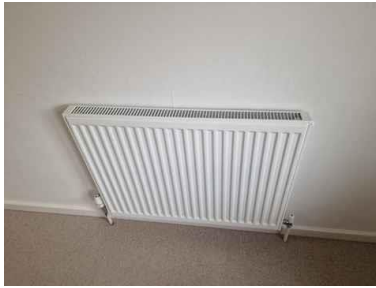
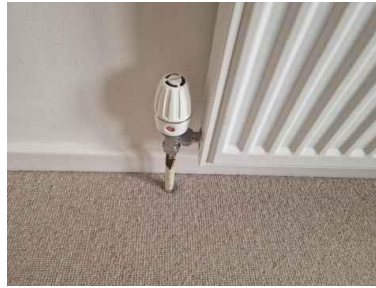
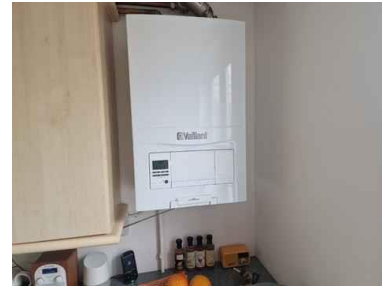
Condition Rating: **2**

Heat is provided to a number of pressed steel radiators via 15mm pipework. The radiators and visible pipework appear in satisfactory condition, with no significant corrosion or leakages noted.

A significant amount of the central heating pipework is buried within the construction and whilst there were no signs of leakage, this can occur undetected beneath floor finishes, particularly if pipework is not adequately protected.

We have not carried out any calculations and cannot confirm the heating is adequate to achieve satisfactory temperatures. We recommend that the system be assessed and if found to be inadequate, upgrading may be required.

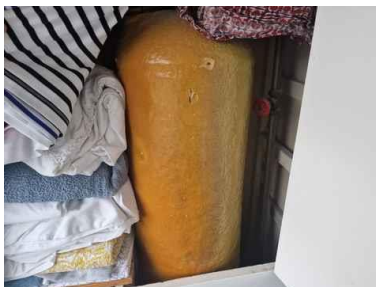
Condition Rating: 3

The cylinder is a modern insulated unit. There was no evidence of leakages at the time of inspection.

You should be aware that hot water systems require regular maintenance, and it is recommended that they are serviced annually alongside the central heating boiler installation. You should request a copy of any recent service history through your Legal Advisor. In the absence of such documentation dated within the last 12 months, you should arrange for a precautionary inspection through a reputable plumber or heating engineer.

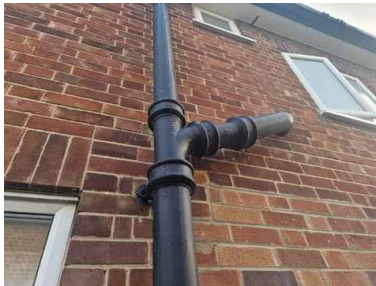
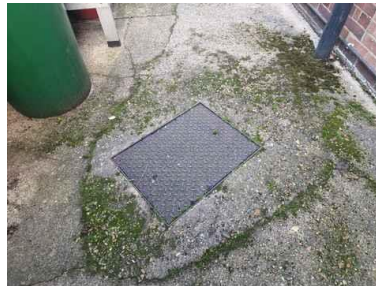
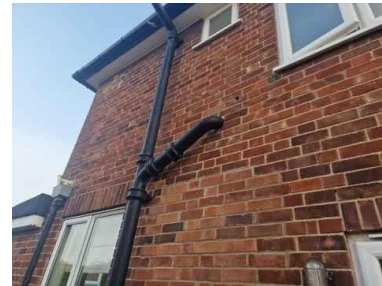
Condition Rating: 3

There were no above ground signs of blockage or damage or other significant defect at the time of our inspection however without a full inspection by a drainage specialist, you must accept the risk of such defects existing.

The soil and vent pipe is of cast iron construction and is in serviceable condition at present

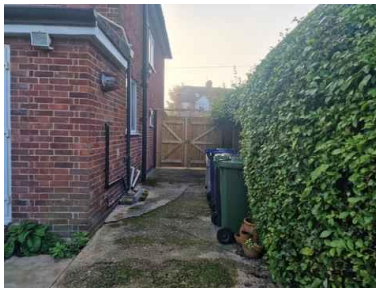
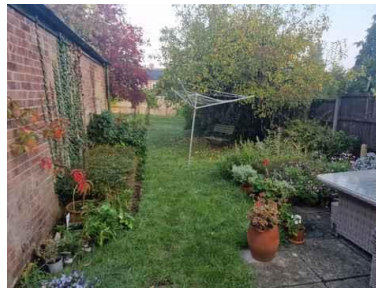
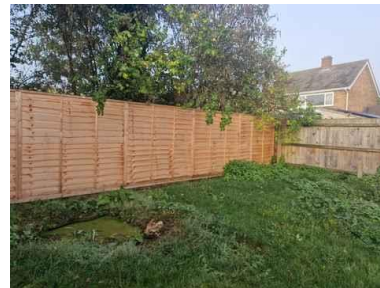
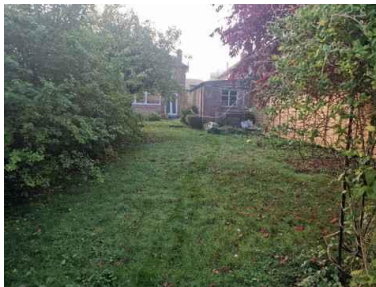
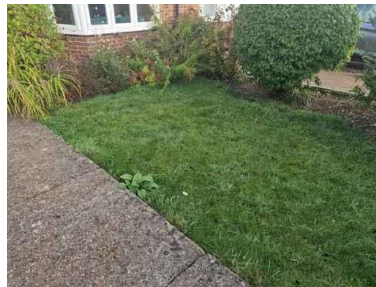
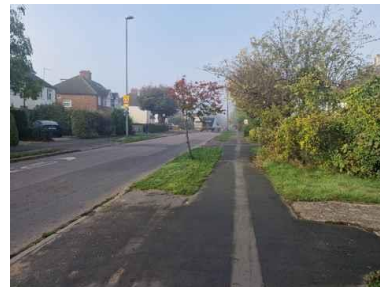
The outside areas and gardens appear to be adequately maintained.
