**RICS HOME SURVEY
LEVEL 3**

DATE OF INSPECTION:

Thursday 10 October 2024

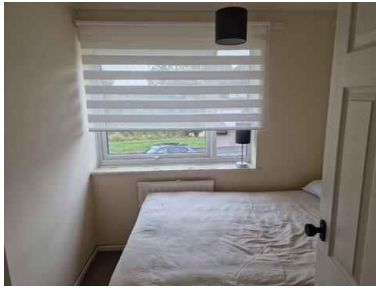
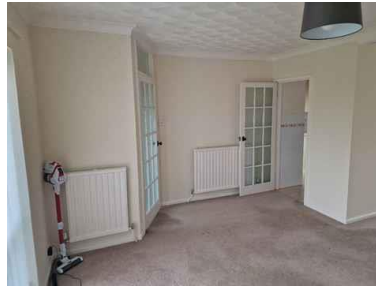
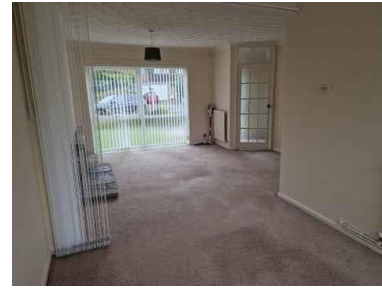
Moisture content readings were taken throughout the walls at regular intervals with an electronic damp meter and no significant dampness was recorded, suggesting the damp-proof course is operating effectively.

We also found no evidence of any significant penetrating dampness within the property.

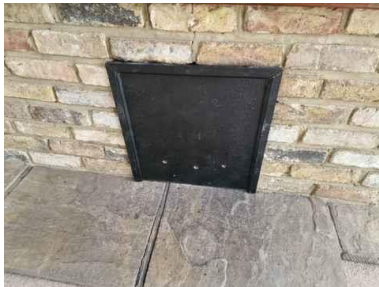
There is no fireplace within the property.

The chimney breast appears sound. However, it was not possible within the limits of this report to inspect the flues in detail or to assess the internal condition of flues or flue liners and we can give no assurances as to the practicalities of using the fireplaces. Further contractor's advice will need to be sought in this regard should you wish to utilise the fireplaces.

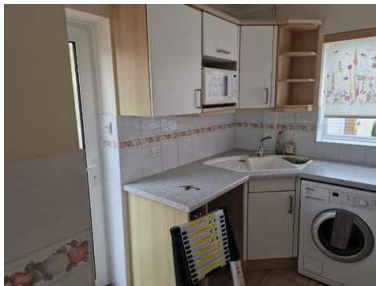
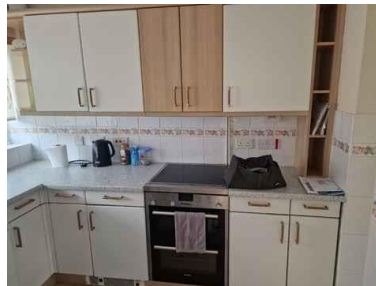
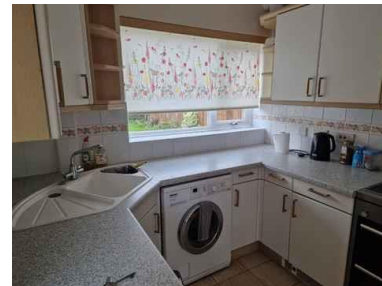
There is an electric hob fitted and you should confirm with your legal adviser whether this has any electrical safety certification. Please refer to section F1 of this report.

Most of the distribution and waste pipework is concealed behind the units and leaking pipework or other defects may not be readily apparent.

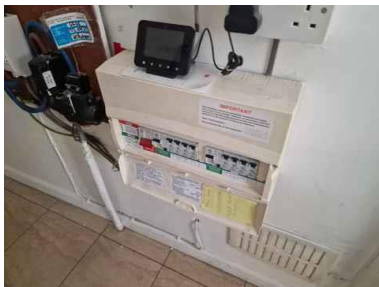
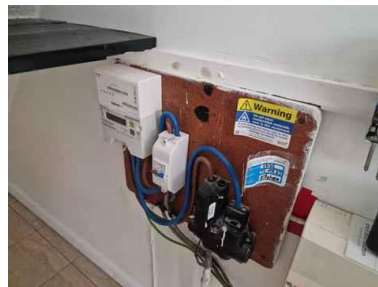
The electrical installation is provided with an RCD which is designed to protect the users from electric shock. These installations are extremely sensitive and consequently occasional tripping of switches will occur, effectively shutting down the affected circuit(s). It can often result when a light bulb fails, or it may be the result of a defective appliance. When this happens, the 'trip-switch' must be reset. If this occurs with any frequency, an electrician should be instructed to investigate.

Although there were no particular areas of concern, we do endorse the Electrical Safety Council's recommendations and a precautionary electrical inspection should therefore still be undertaken, to ensure that circuitry complies with current electrical regulations, prior to a legal commitment to purchase. All recommendations should be fully costed and implemented.

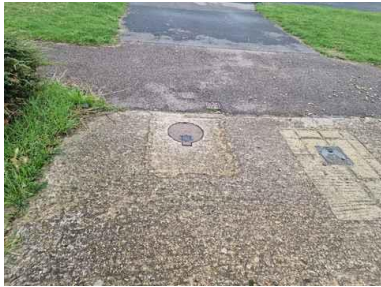
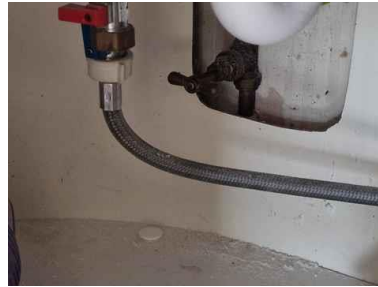
The internal rising main and stop tap are located under the kitchen sink.

The external stop tap is located in the front path. You should confirm whether a water meter is provided.

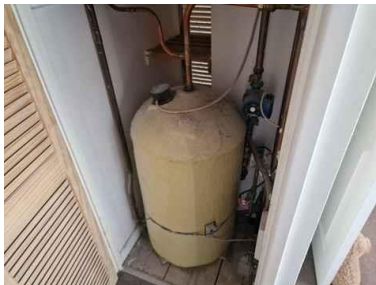
We are not suitably qualified to comment on the state and condition of the hot water installation and a test on the installation is outside the scope of this report.

You should be aware that hot water systems require regular maintenance, and it is recommended that they are serviced annually alongside the central heating boiler installation. You should request a copy of any recent service history through your legal adviser. In the absence of such documentation dated within the last 12 months, you should arrange for a precautionary inspection through a reputable plumber or heating engineer.

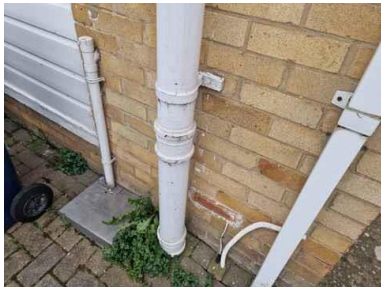
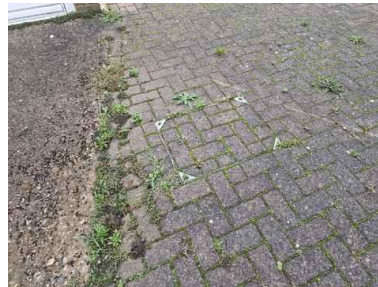
There were no above ground signs of blockage or damage or other significant defect at the time of our inspection however without a full inspection by a drainage specialist, you must accept the risk of such defects existing.

The soil and vent pipe is believed to be of uPVC construction and in serviceable condition at present

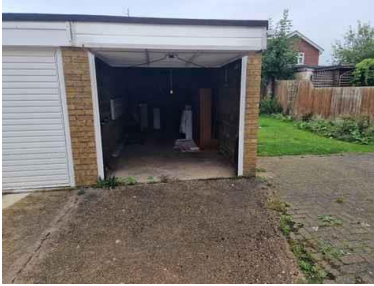
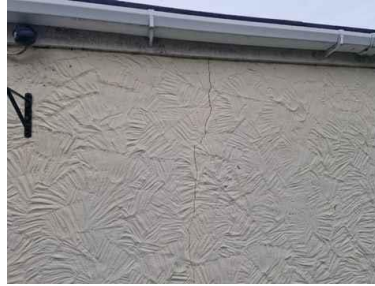
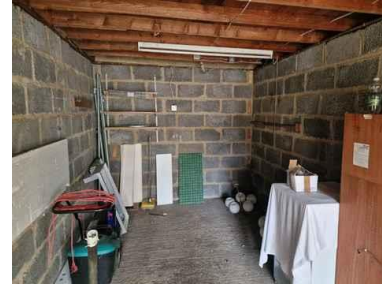
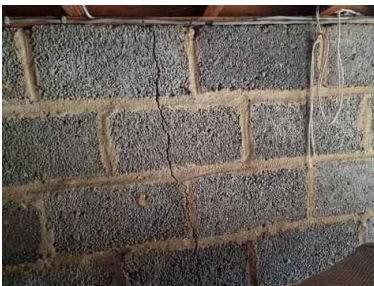
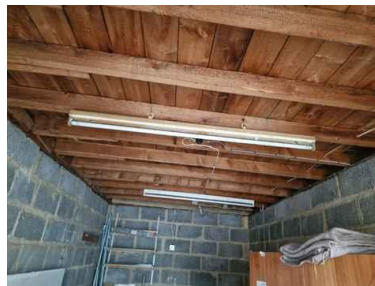
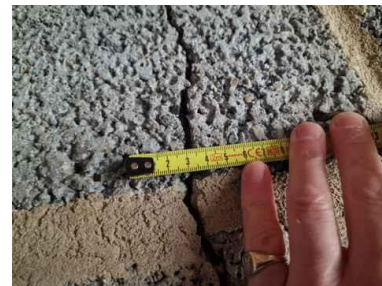
The party wall between the subject and neighbouring property is complete and fully sealed, provided adequate fire and security separation.

The electrical services to the garage should be tested by a qualified electrician alongside the electrics to the property. Please see also section F1 of this report.
