**RICS HOME SURVEY
LEVEL 2**
- SURVEY ONLY

Wednesday 18 September 2024

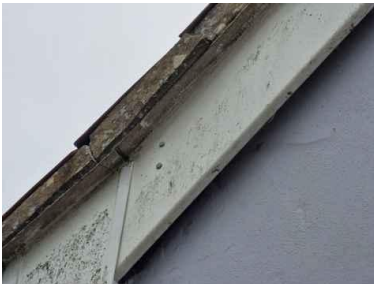
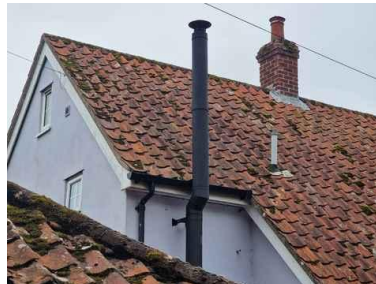
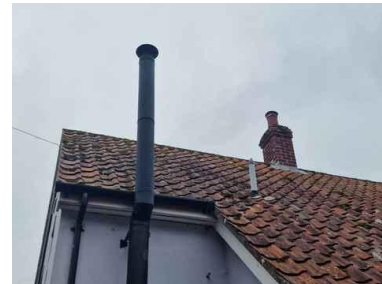
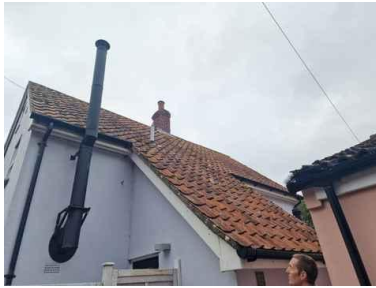
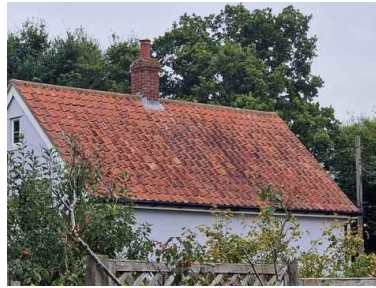
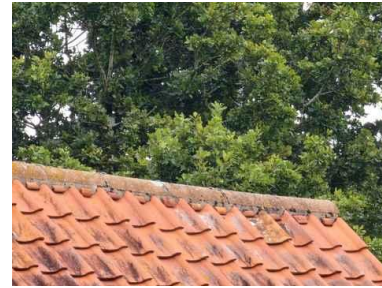
It is now standard practice to insulate lofts in order to conserve energy and reduce heating costs. With the increase in insulation, it has become necessary to reduce the risks of condensation problems by ventilating roof spaces.

Ventilation is a requirement under current regulations, and this is achieved via soffit vents.

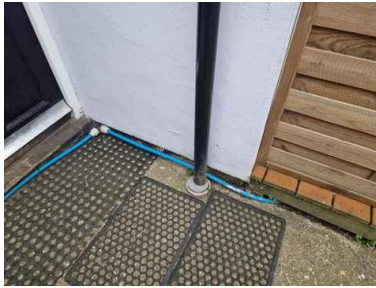
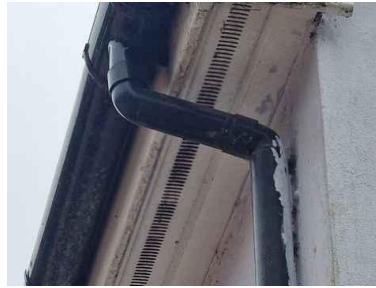
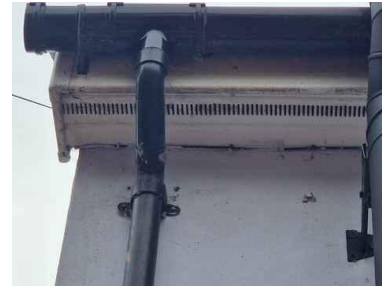
Please note it was not raining during the course of the inspection so we cannot confirm that rainwater goods are watertight at the joint sections. It is recommended that you inspect rainwater goods during a period of heavy rain in order to establish their effectiveness, with repairs addressed as found to be necessary.

You should ensure that the gutters are seasonally unblocked of moss and other debris.

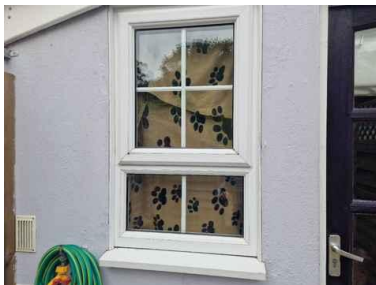
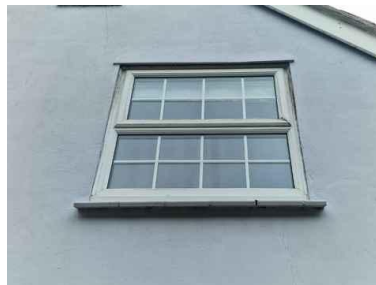
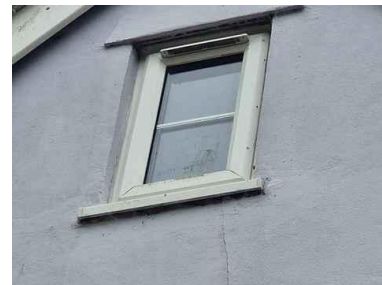
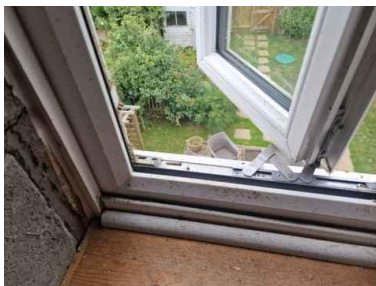
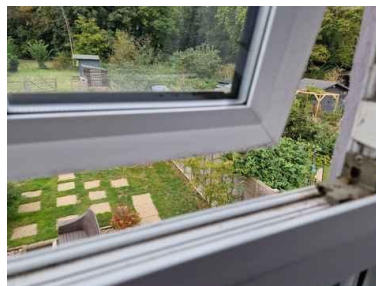
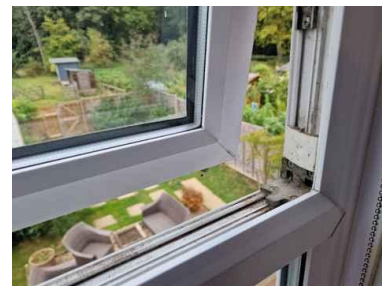
Where trickle ventilation has been provided to windows, this should allow a degree of natural ventilation when windows are closed.

You should ensure that you are provided with a full set of window keys on occupation.

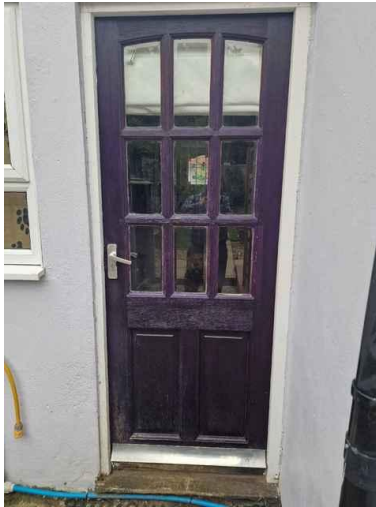
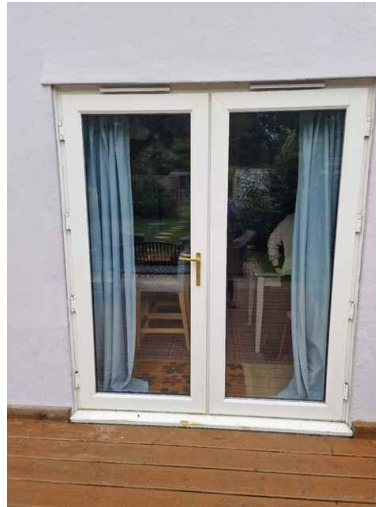
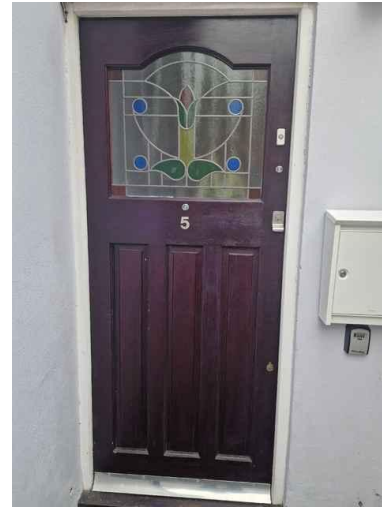
Doors open square to the eye with no signs of any significant movement or distortion noted.

We recommend you change all locks upon occupation to enhance security.

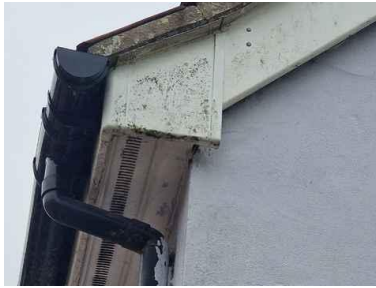
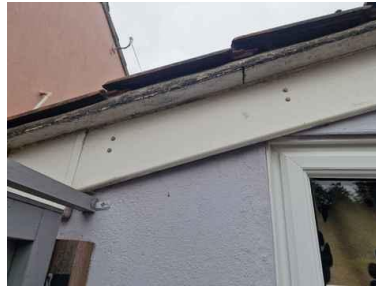
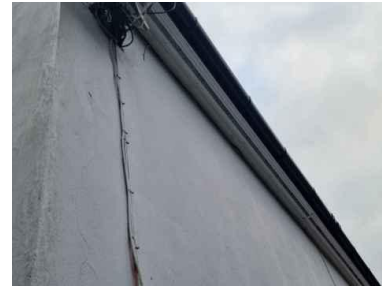
Where these uPVC replacement boards have been provided, it is not possible to determine whether they are fixed directly on top of any original decaying joinery. It is not possible to comment on any concealed section of woodwork which can only be examined by the removal of the uPVC covering.

Given the age of the property materials containing asbestos may be concealed beneath the PVC although we are unable to confirm this, and care should be taken during future maintenance.

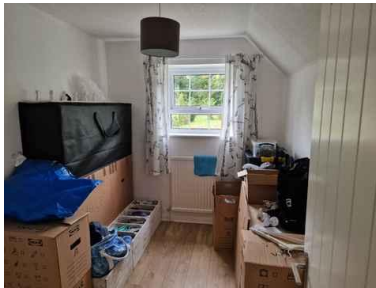
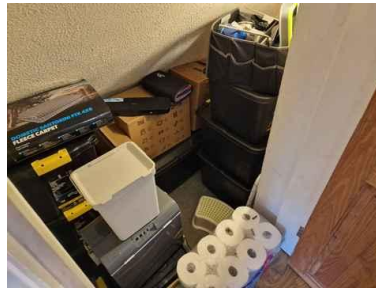
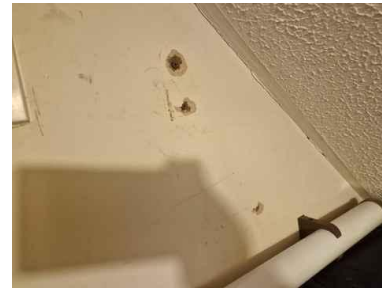
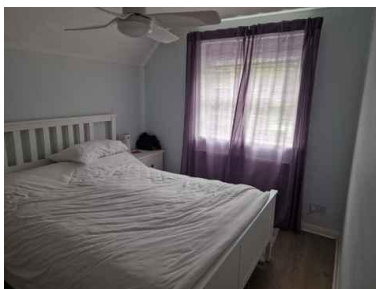
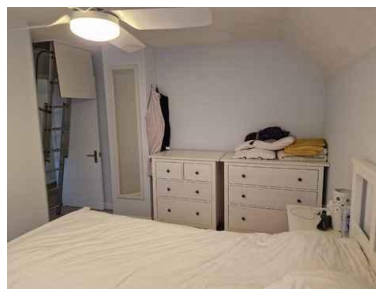
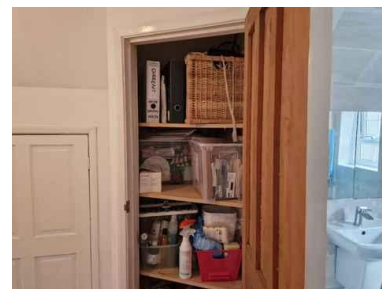
Moisture content readings were taken throughout the walls at regular intervals with an electronic damp meter and no significant dampness was recorded, suggesting the damp-proof course is operating effectively.

We also found no evidence of any significant penetrating dampness within the property.

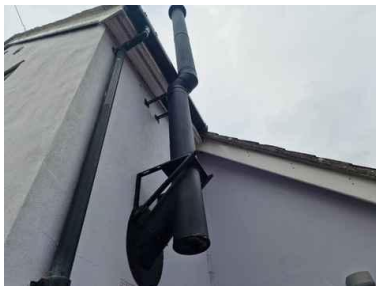
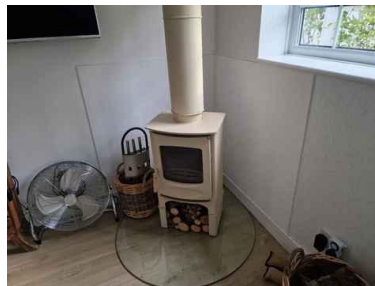
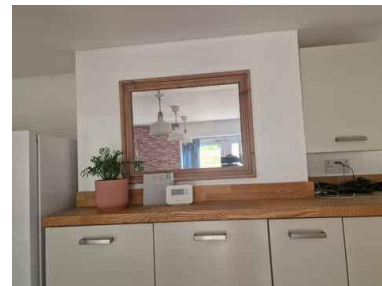
We cannot confirm whether the flue liners have been provided where appliances are fitted to open flues and recommend that a specialist be instructed to check that the installation complies with current regulations.

Where fireplaces are redundant, the chimney pots have been capped and ventilated at roof level to protect against rain penetration. The redundant flues have also been ventilated internally with air bricks at fireplace level (behind kitchen units as stated by the vendor) to ensure a constant positive airflow through the redundant flue structure, to prevent the development of stagnating air and dampness within the stack.

Condition Rating: 2

You should make enquiries with a HETAS engineer to ensure the burner complies according to Part J – Combustion Appliances and Fuel Storage Systems.

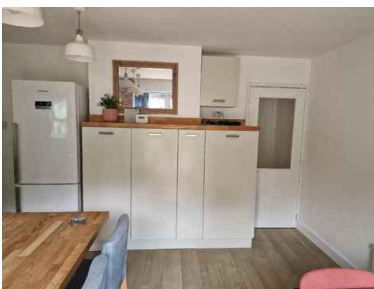
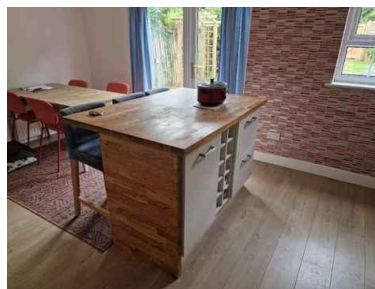
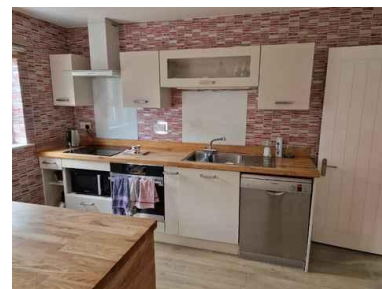
The fitted units appear to be modern and of good quality to which no significant defects were apparent and there may be guarantees which could transfer with title.

The carcassing to the units is made of chipboard, which can deteriorate if it becomes wet. It is therefore necessary to protect the chipboard by maintaining the seals and laminating coverings in good condition. The seals were found to be in a serviceable condition.

Most of the distribution and waste pipework is concealed behind the units and leaking pipework or other defects may not be readily apparent.

Condition Rating: 1

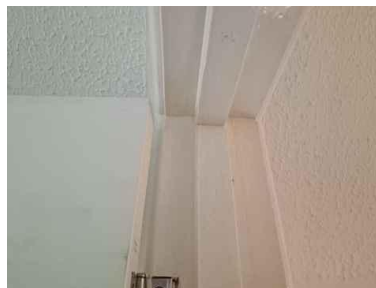
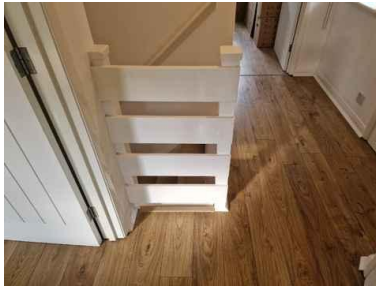
The property a timber staircase which is carpeted on the upper surface and enclosed beneath. Treads and risers appear to be firm and level and within normal tolerances, with no signs of any significant spring or undulation noted.

The banister rails have been constructed at horizontals which does not comply with current regulations as they are potentially climbable, and a particular hazard to young children. The banisters rails should be altered on taking occupation so that the railings are enclosed by boarding or replaced with uprights.

Condition Rating: 3

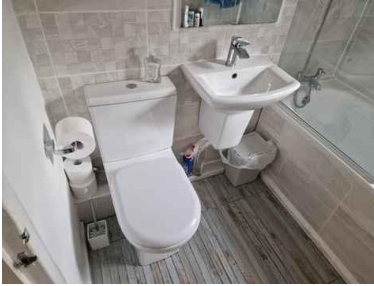
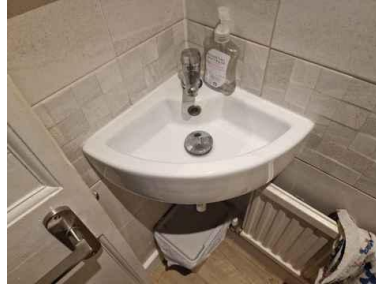
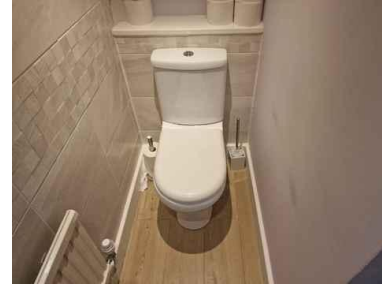
The seals around the sanitaryware were found to be in a serviceable condition and should be maintained.

The water pressure was checked to several draw-off points and found to be adequate. Water pressure can vary seasonally and during times of high demand, both within the property and in the locality. It is recommended that should you wish to install water pressure sensitive items, such as a power shower, that further enquiries are made initially.

Most of the distribution and waste pipework is concealed beneath or behind sanitary ware items and whilst there were no obvious signs of leaks, the risk of hidden defects exists.

Condition Rating: **2**

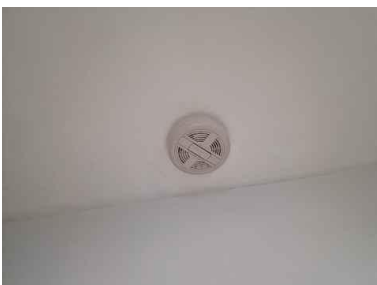
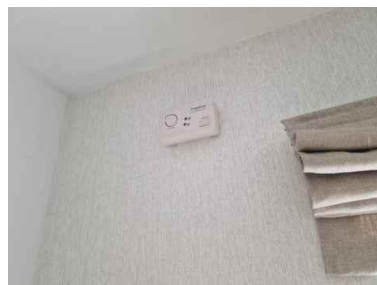
There is a battery smoke detector installed. It is recommended the smoke detectors are serviced in accordance with the manufacturer's instructions. You should consider upgrading the installation with a mains wired system after taking occupation.

Where there is a solid fuel appliance, carbon monoxide alarms have been installed and should be maintained in line with the alarm manufacturer's guidelines.

Condition Rating: **3**

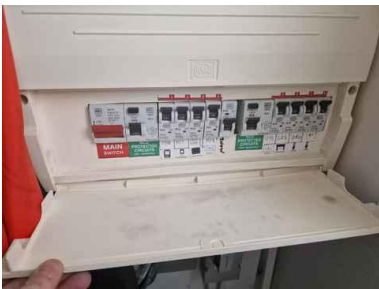
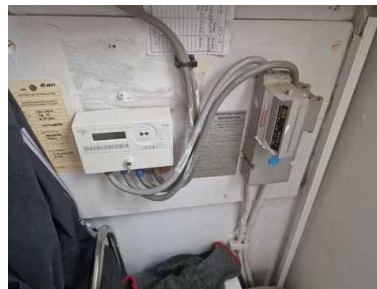
Although there were no particular areas of concern, we do endorse the Electrical Safety Council's recommendations and a precautionary electrical inspection should therefore still be undertaken, to ensure that circuitry complies with current electrical regulations, prior to a legal commitment to purchase. All recommendations should be fully costed and implemented.

The electrical installation is provided with an RCD which is designed to protect the users from electric shock. These installations are extremely sensitive and consequently occasional tripping of switches will occur, effectively shutting down the affected circuit(s). It can often result when a light bulb fails, or it may be the result of a defective appliance. When this happens, the 'trip-switch' must be reset. If this occurs with any frequency, an electrician should be instructed to investigate.

Condition Rating: **3**

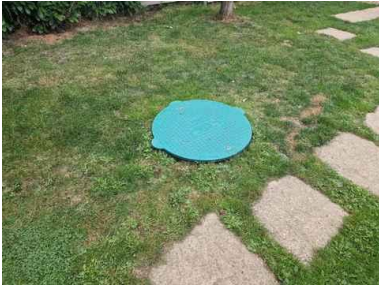
There is a large LPG storage tank buried in the rear garden. The LPG effectively replaces a typical domestic gas supply and will require annual servicing and inspection. Appliances using LPG produce Carbon Monoxide which is extremely poisonous and very dangerous because you cannot see, smell or taste it, therefore it is highly recommended that hard wired Carbon Monoxide detectors are installed within the property at any location where there is a LPG appliance. All LPG appliances must be serviced every year by a Gas Safe Engineer who is qualified to work on the appliances within the property, the storage tank and the LPG pipework and flues must also be inspected and tested as part of the service work.

Condition Rating: **2**

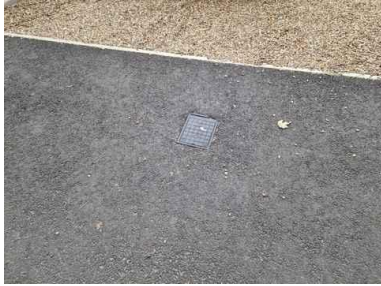
The vendor stated there is no internal stop tap.

The external stop tap is located in the front drive. You should confirm whether a water meter is provided.

Condition Rating: **2**

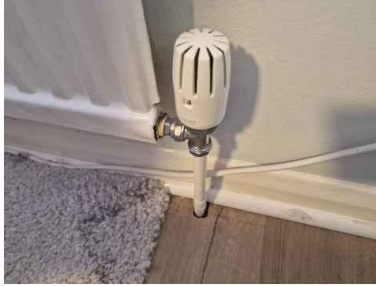
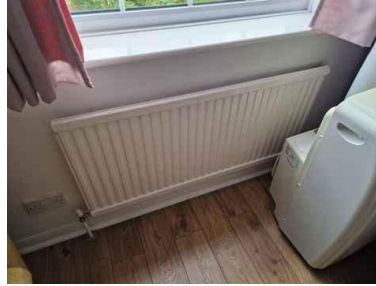
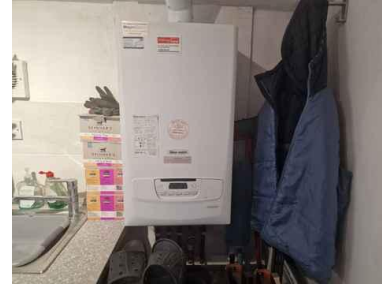
We believe that the replacement boiler was installed approximately 10 years ago. You should request a copy of the Building Regulations Compliance certificate for the installation prior to purchase. In the absence of any such paperwork, the installation may not comply with Building Regulations, and this would need to be investigated further by an appropriately registered heating engineer.

Heat is provided to a number of pressed steel radiators via 15mm pipework. The radiators and visible pipework appear in satisfactory condition, with no significant corrosion or leakages noted.

Thermostatic radiator valves (TRVs) have been provided to radiators. These will allow for individual control over each unit which will improve the thermal efficiency of the dwelling.

A significant amount of the central heating pipework is buried within the construction and whilst there were no signs of leakage, this can occur undetected beneath floor finishes, particularly if pipework is not adequately protected.

Condition Rating: **3**

We have not seen documentary evidence that a test of the gas heating system has been undertaken in the last 12 months. It would be prudent for you to arrange for a Gas Safe registered engineer to inspect the entire system prior to purchase, with all recommendations fully costed.

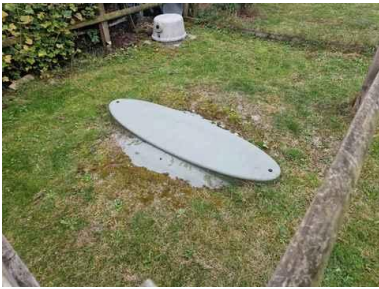
There were no above ground signs of blockage or damage or other significant defect at the time of our inspection however without a full inspection by a drainage specialist, you must accept the risk of such defects existing.

The soil and vent pipe is ducted internally and therefore hidden from view.

Condition Rating: **3**
