RICS HOME SURVEY LEVEL 2

- SURVEY & VALUATION

DATE OF INSPECTION:

Friday 27 September 2024

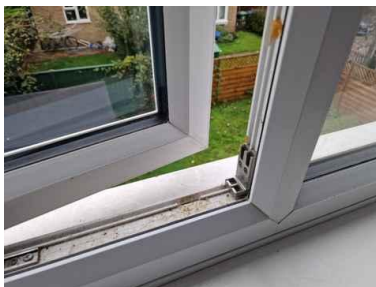
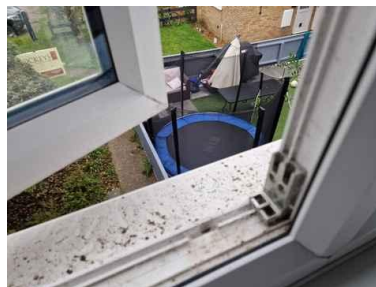
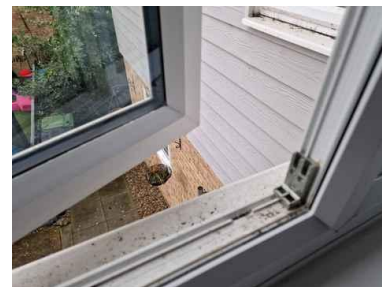
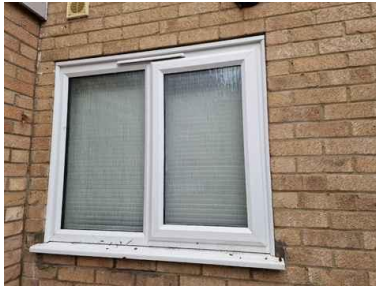
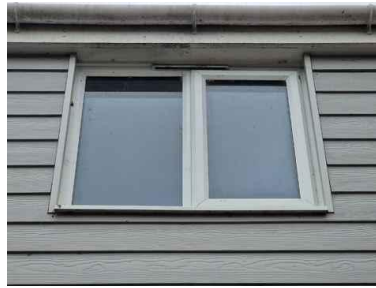
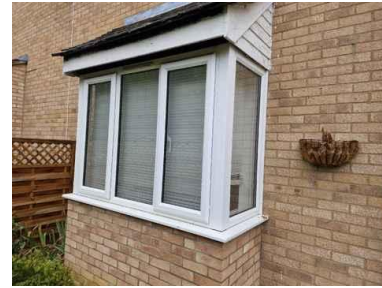
Where trickle ventilation has been provided to windows, this should allow a degree of natural ventilation when windows are closed.

Condition Rating: 2

You should ensure that you are provided with a full set of window keys on occupation.

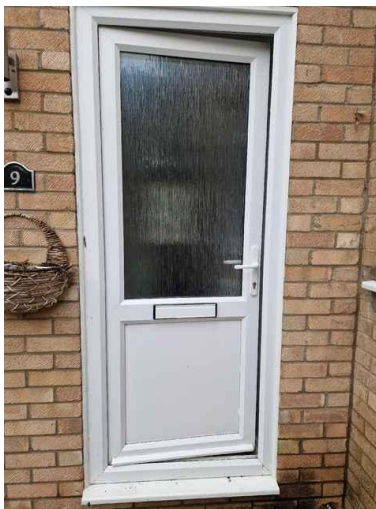
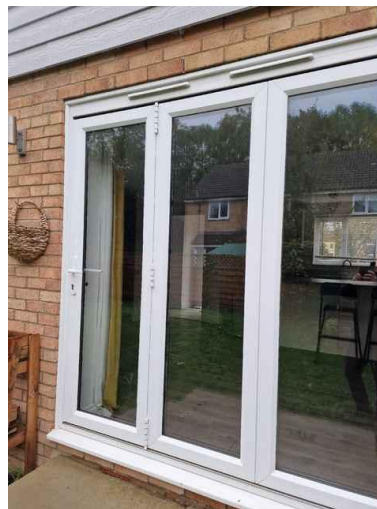
Doors open square to the eye with no signs of any significant movement or distortion noted.

Condition Rating: 2

We recommend you change all locks upon occupation to enhance security.

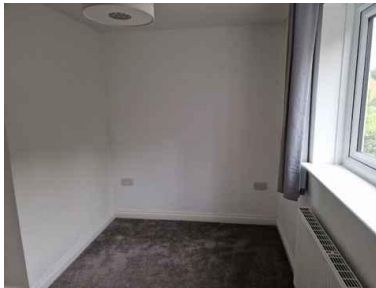
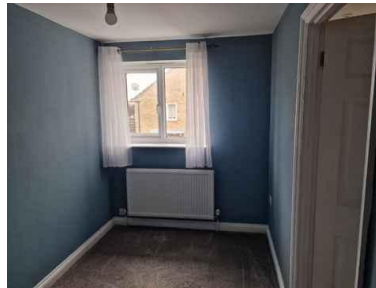
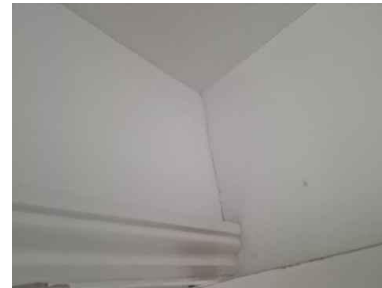
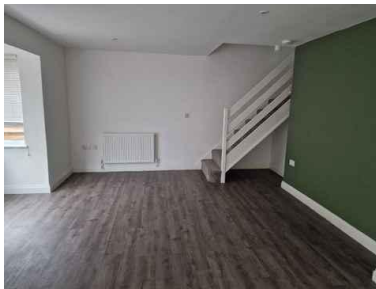
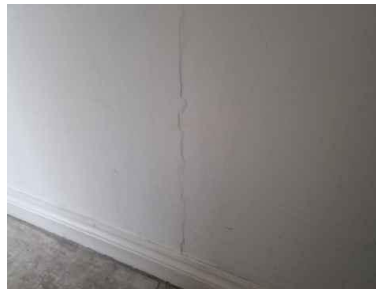
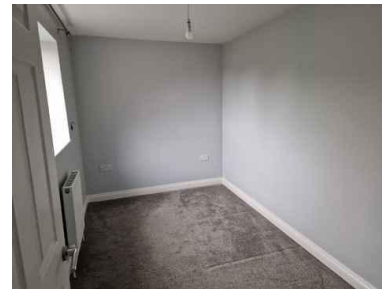
Moisture content readings were taken throughout the walls at regular intervals with an electronic damp meter and no significant dampness was recorded, suggesting the damp-proof course is operating effectively.

We also found no evidence of any significant penetrating dampness within the property.

Condition Rating: **2**

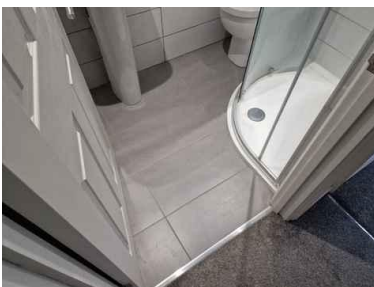
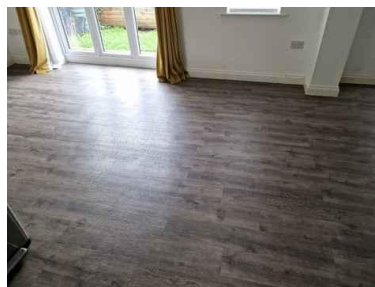
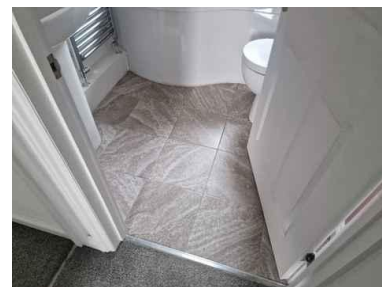
Ceramic tiles have been laid in the upstairs bathrooms. These tiles are currently in a sound condition, but it must be recognised that they are inherently brittle and can become cracked when laid on timber flooring due to the natural springiness of the floor construction. Future defects may occur, and you may wish to replace these coverings with a more suitable finish in the long-term.

The flooring beneath the sanitary fittings could not be inspected as this would involve damaging investigations which are beyond the scope of a normal survey. If there has been leakage, such as from concealed pipework or through gaps in wall tiles, or around the bath/shower, dampness may have caused serious rot in the floor. We found no evidence of timber decay, but further investigations would be necessary to establish whether any defects exist. If such work is to be undertaken, there will be some resultant damage and appropriate contractors should be appointed to undertake this work, with the vendor's permission, so that any replacement of panelling or flooring can be carefully undertaken.

Condition Rating: 1

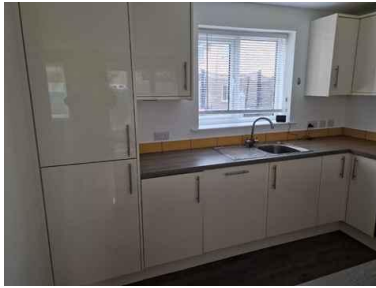
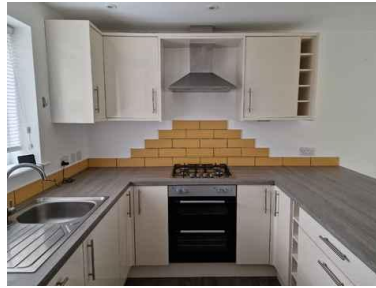
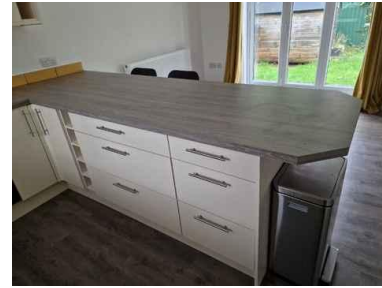
There is a gas hob fitted and you should confirm with your legal adviser whether this has any Gas Safety Certification. See Section F2 of this report.

Most of the distribution and waste pipework is concealed behind the units and leaking pipework or other defects may not be readily apparent.

Condition Rating: **1**

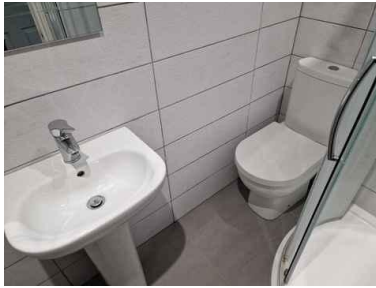
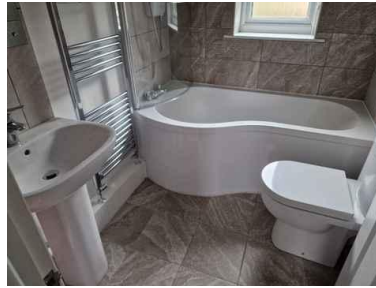
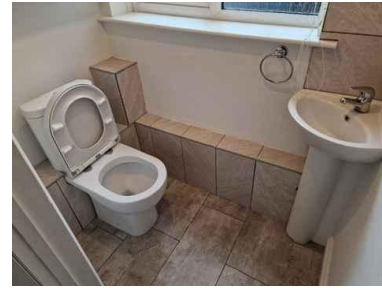
The water pressure was checked to several draw-off points and found to be adequate. Water pressure can vary seasonally and during times of high demand, both within the property and in the locality. It is recommended that should you wish to install water pressure sensitive items, such as a power shower, that further enquiries are made initially.

Most of the distribution and waste pipework is concealed beneath or behind sanitary ware items and whilst there were no obvious signs of leaks, the risk of hidden defects exists.

Condition Rating: **2**

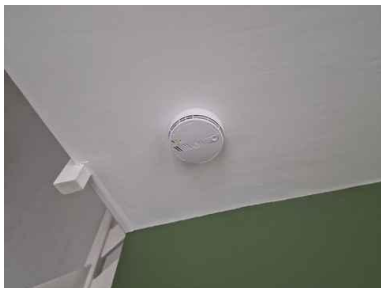
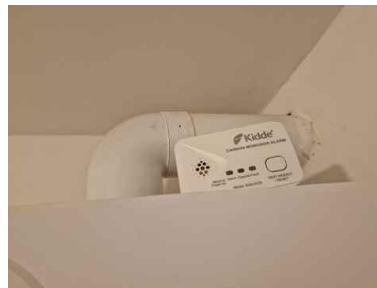
Carbon monoxide alarms should be provided in all rooms which house a fuel-burning appliance.

Where there is a gas-fired boiler, carbon monoxide alarms have been installed and should be maintained in line with the alarm manufacturer's guidelines.

Condition Rating: **2**

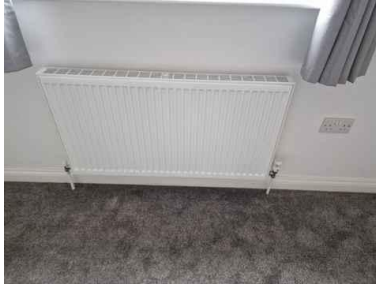
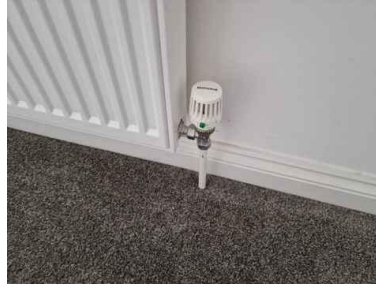
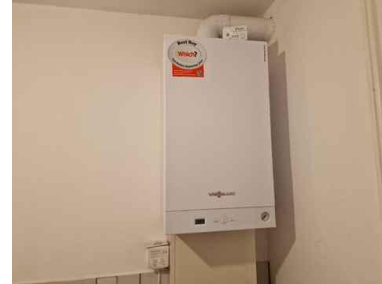
Thermostatic radiator valves (TRVs) have been provided to radiators. These will allow for individual control over each unit which will improve the thermal efficiency of the dwelling.

A significant amount of the central heating pipework is buried within the construction and whilst there were no signs of leakage, this can occur undetected beneath floor finishes, particularly if pipework is not adequately protected.

Condition Rating: **3**

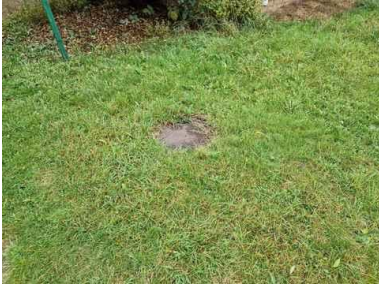
There were no above ground signs of blockage or damage or other significant defect at the time of our inspection however without a full inspection by a drainage specialist, you must accept the risk of such defects existing.

The soil and vent pipe is ducted internally and therefore hidden from view.

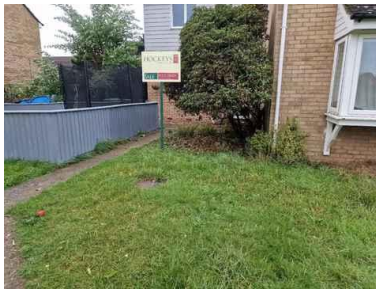
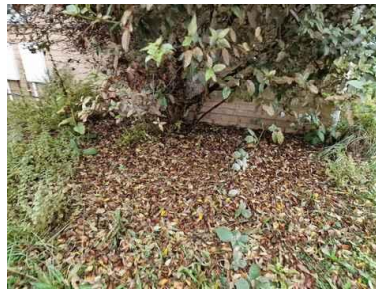
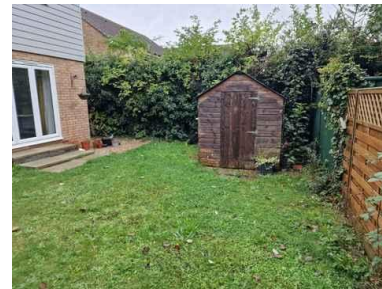
Whilst there was no evidence of any adverse easements, servitudes or wayleaves affecting the property your legal advisers should be asked to verify. See Section H2.

The outside areas and gardens appear to be adequately maintained.
