**RICS HOME SURVEY
LEVEL 3**

DATE OF INSPECTION:

Monday 28 October 2024

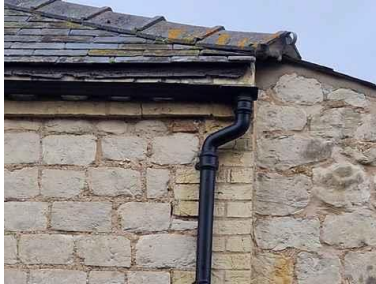
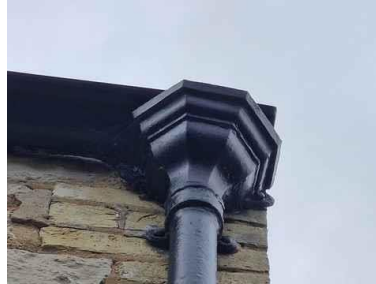
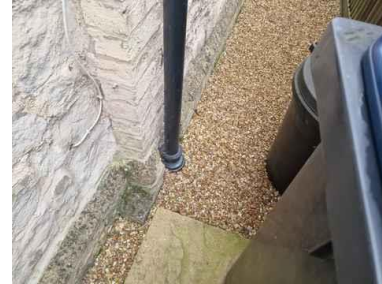
rainwater goods during a period of heavy rain in order to establish their effectiveness, with repairs addressed as found to be necessary.

You should ensure that the gutters are seasonally unblocked of moss and other debris.

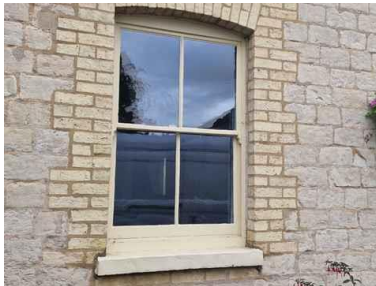
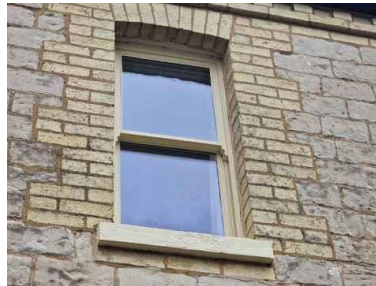
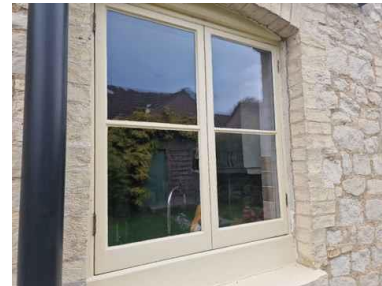
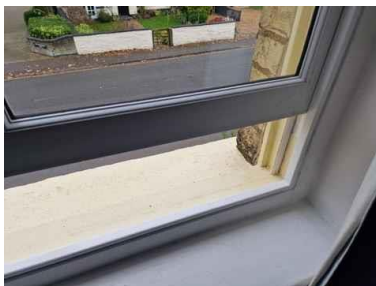
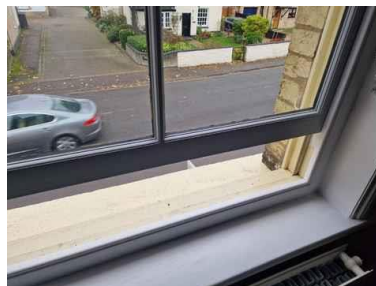
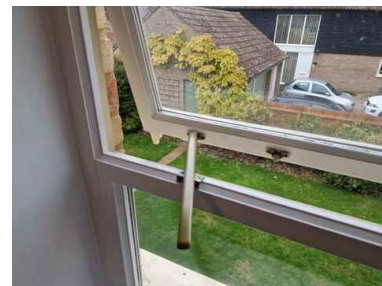
There is a requirement for ongoing maintenance to the sash frames, to check the cording and ensure that they function satisfactorily. Sash windows can permit paint build-up around the edges with each decoration, which will require maintenance and repair, to permit adequate opening and closing.

Where trickle ventilation has been provided to windows, this should allow a degree of natural ventilation when windows are closed.

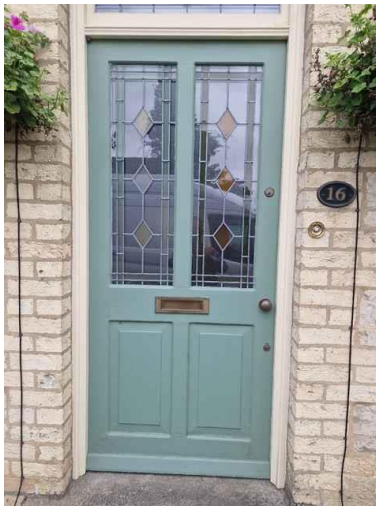
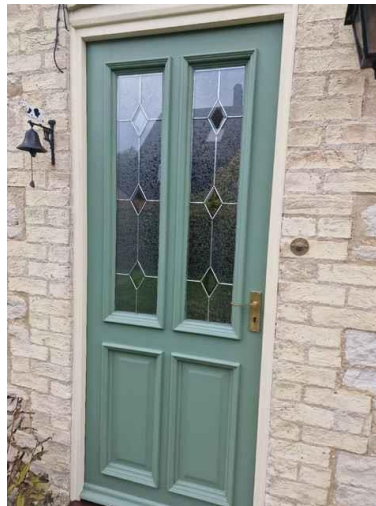
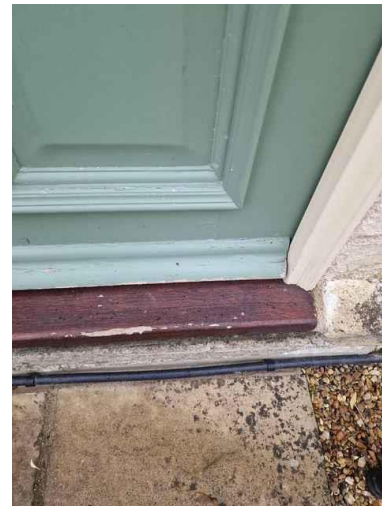
Doors open square to the eye with no signs of any significant movement or distortion noted.

We recommend you change all locks upon occupation to enhance security.

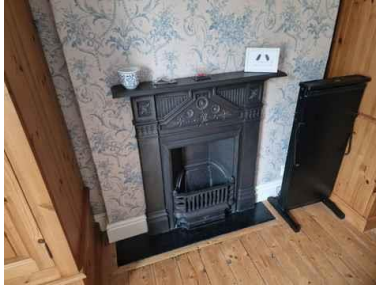
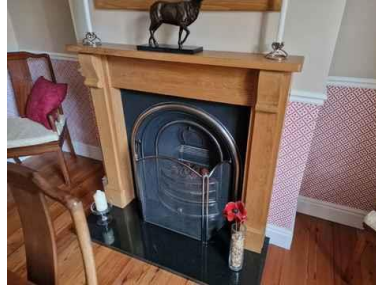
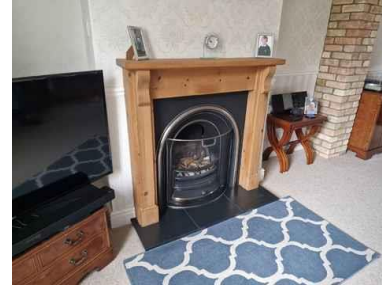
The chimney breasts appear sound. However, it was not possible within the limits of this report to inspect the flues in detail or to assess the internal condition of flues or flue liners and we can

give no assurances as to the practicalities of reinstating the fireplaces. Further contractor's advice will need to be sought in this regard should you wish to utilise the fireplaces.

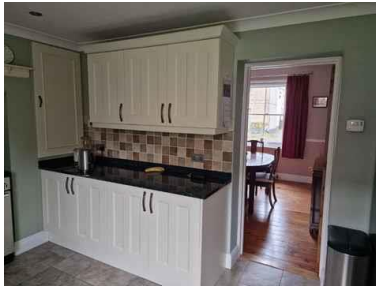
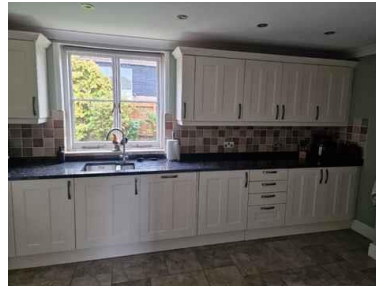
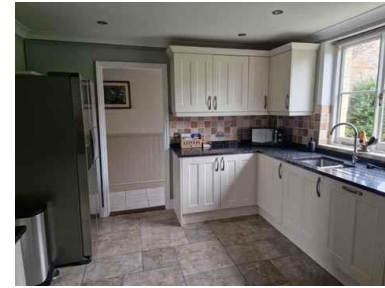
There is a gas hob fitted, and you should confirm with your Legal Advisor whether this has any Gas Safety Certification. See Section F2 of this report.

Most of the distribution and waste pipework is concealed behind the units and leaking pipework or other defects may not be readily apparent.

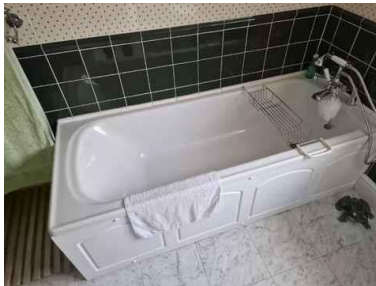
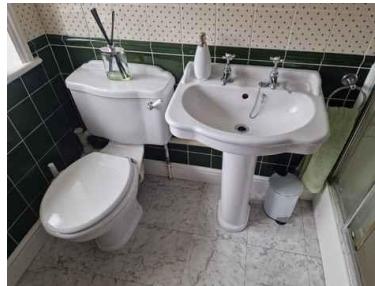
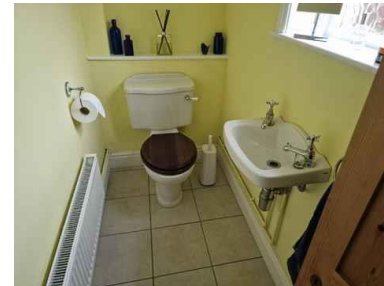
The water pressure was checked to several draw-off points and found to be adequate. Water pressure can vary seasonally and during times of high demand, both within the property and in the locality. It is recommended that should you wish to install water pressure sensitive items, such as a power shower, that further enquiries are made initially.

Most of the distribution and waste pipework is concealed beneath or behind sanitary ware items and whilst there were no obvious signs of leaks, the risk of hidden defects exists.

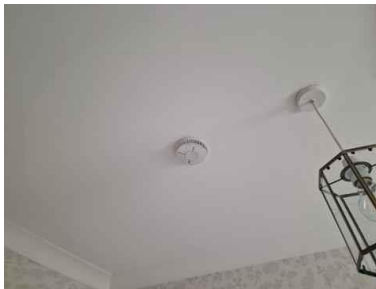
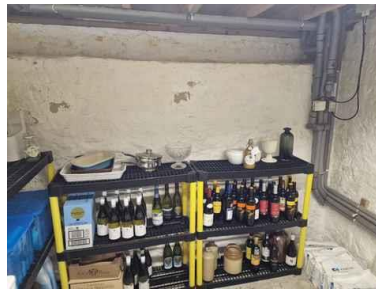
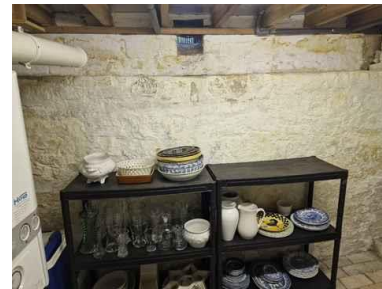
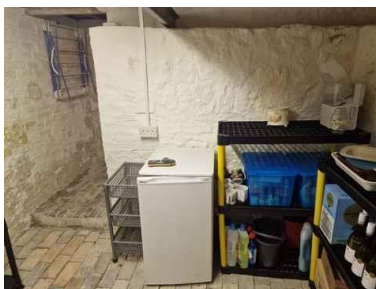
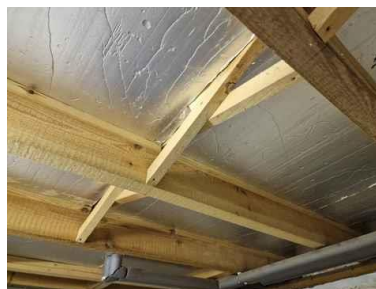
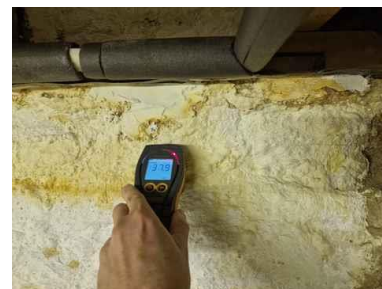
Whilst no remedial action is necessary, excessive condensation can result in unsightly mould growth forming. However, you may consider tanking the cellar walls to mitigate damp penetration on the internal surfaces of walls.

Further specialist advice would be required in this regard, and consideration would need to be given to the foundations of the property which can be adversely affected by changes in ground moisture levels causing a build-up of additional pressure that can cause structural damage if not properly investigated prior to the introduction of cellar tanking. If in any doubt after speaking with a specialist tanking contractor, the advice of a structural engineer should be sought prior to committing to any works.

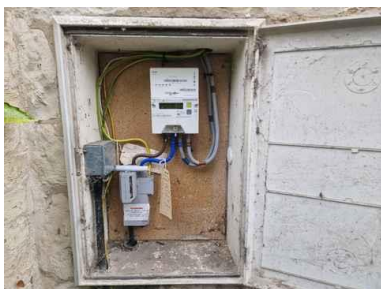
Although there were no particular areas of concern, we do endorse the Electrical Safety Council's recommendations and a precautionary electrical inspection should therefore still be undertaken, to ensure that circuitry complies with current electrical regulations, prior to a legal commitment to purchase. All recommendations should be fully costed and implemented.

The electrical installation is provided with an RCD which is designed to protect the users from electric shock. These installations are extremely sensitive and consequently occasional tripping of switches will occur, effectively shutting down the affected circuit(s). It can often result when a light bulb fails, or it may be the result of a defective appliance. When this happens, the 'trip-switch' must be reset. If this occurs with any frequency, an electrician should be instructed to investigate.

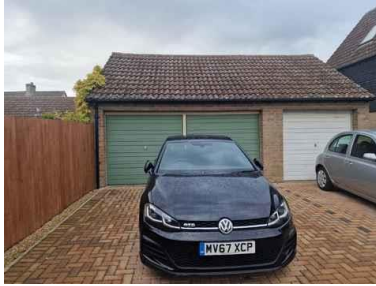
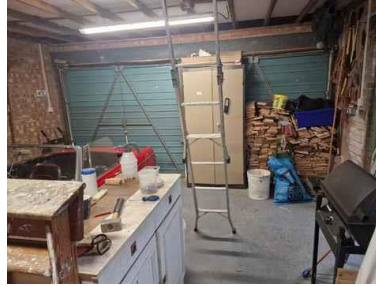
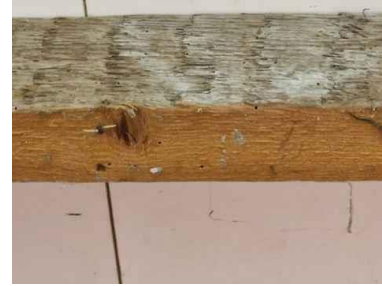
Stored items and personal effects within the garage severely limited our internal inspection and the risk of unseen defects exists.

There is limited access to the rear of the garage and the risk of unseen defects must exist.

No significant defects were apparent to the garage at the time of inspection.

There is an up and over door that was operated and appears to be in a serviceable condition.

The electrical services to the garage should be tested by a qualified electrician alongside the electrics to the property. Please see also section F1 of this report.
