SAGE
CHARTERED SURVEYORS

RICS HOME SURVEY LEVEL 2

- SURVEY & VALUATION

Thursday 26 September 2024

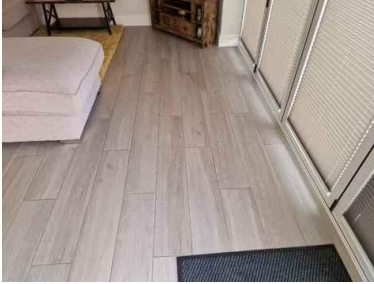
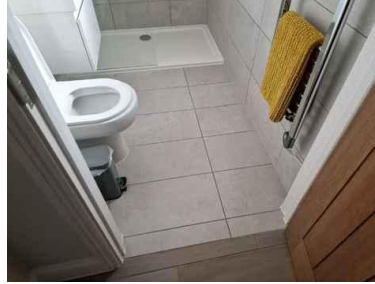
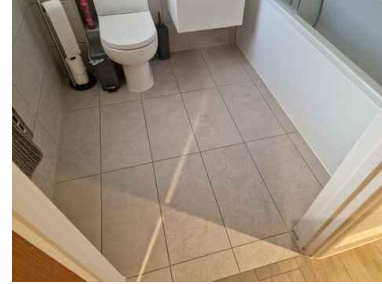
Suspended concrete floors appear to be firm and level with no signs of any significant hollowness noted.

Ventilation to the ground floor is adequate.

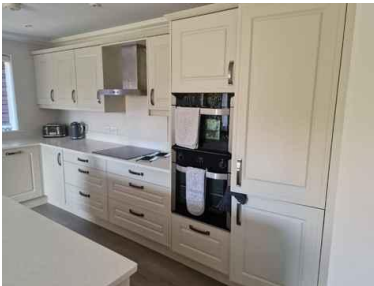
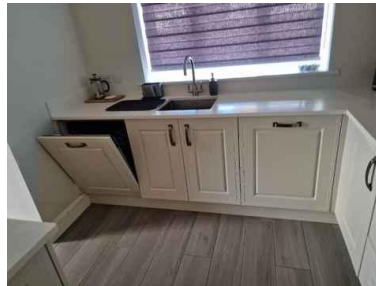
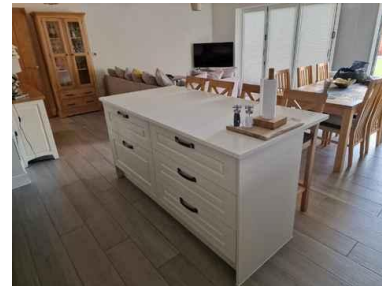
There is an electric hob fitted and you should confirm with your legal adviser whether this has any electrical safety certification. Please refer to section F1 of this report.

Most of the distribution and waste pipework is concealed behind the units and leaking pipework or other defects may not be readily apparent.

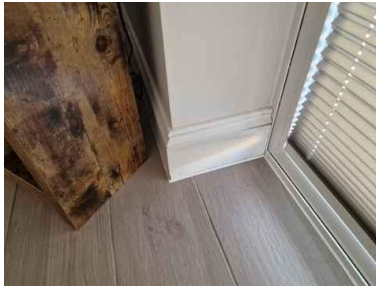
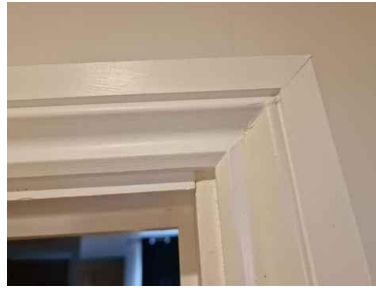
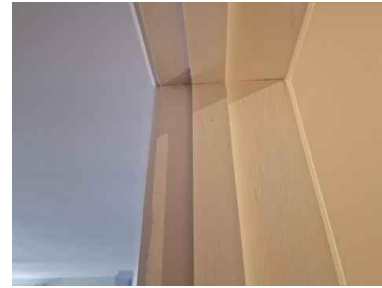
The provision of floor coverings and personal effects where present limited the extent of our inspection.

In general, the internal joinery items appear reasonably modern and serviceable.

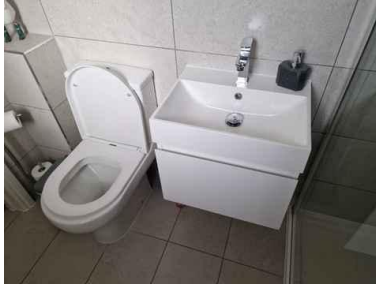
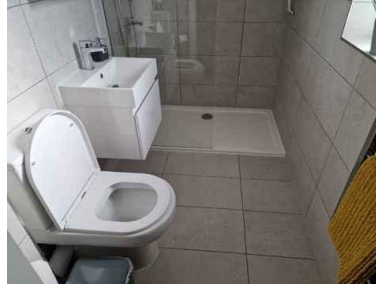
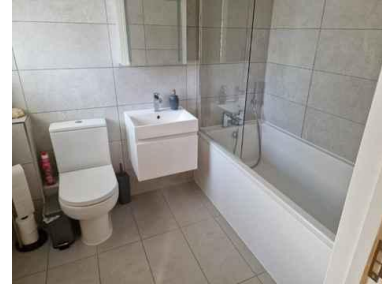
The water pressure was checked to several draw-off points and found to be adequate. Water pressure can vary seasonally and during times of high demand, both within the property and in the locality. It is recommended that should you wish to install water pressure sensitive items, such as a power shower, that further enquiries are made initially.

Most of the distribution and waste pipework is concealed beneath or behind sanitary ware items and whilst there were no obvious signs of leaks, the risk of hidden defects exists.

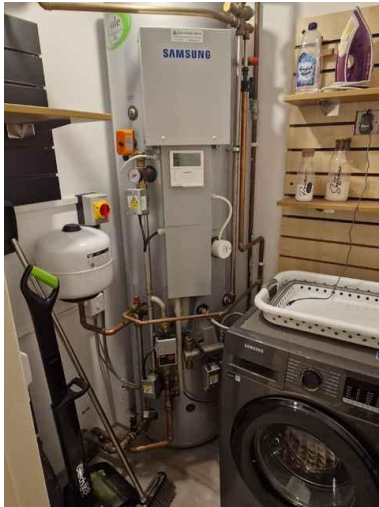
We are not suitably qualified to comment on the state and condition of the hot water installation and a test on the installation is outside the scope of this report.

You should be aware that hot water systems require regular maintenance, and it is recommended that they are serviced annually alongside the central heating boiler installation. You should request a copy of any recent service history through your legal adviser. In the absence of such documentation dated within the last 12 months, you should arrange for a precautionary inspection through a reputable plumber or heating engineer.

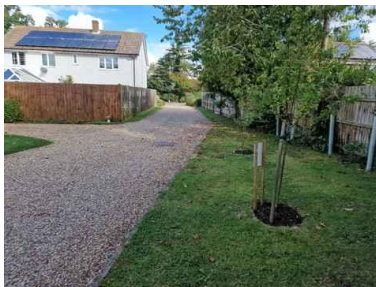
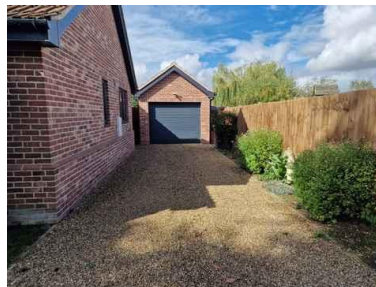
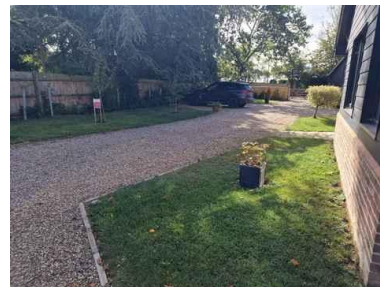
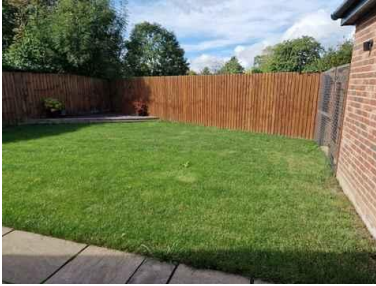
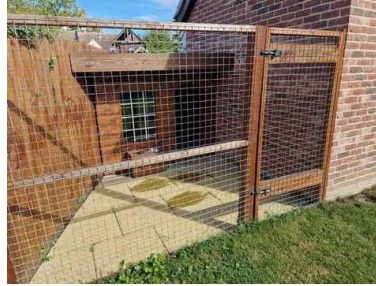
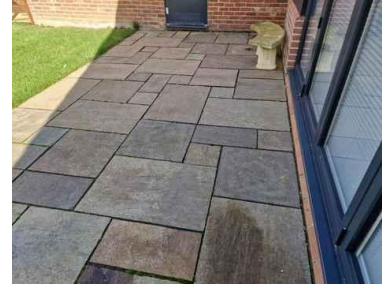
Whilst there was no evidence of any adverse easements, servitudes or wayleaves affecting the property your legal advisers should be asked to verify. See Section H2.

The outside areas and gardens appear to be adequately maintained.
